# FULL RESERVE STUDY

## Meadows at Morris Farm Community Association

**Gainesville, Virginia**

**August 28, 2018**

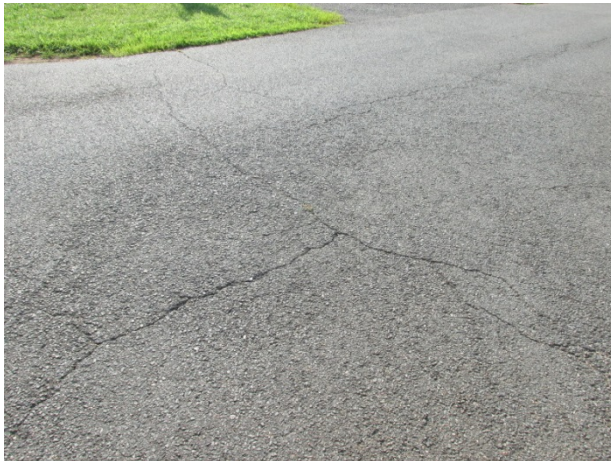
**Pavement cracks at alley**

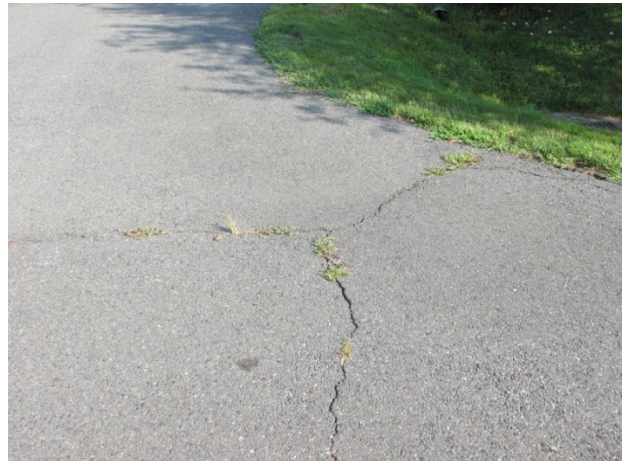
**Pavement cracks at alley**

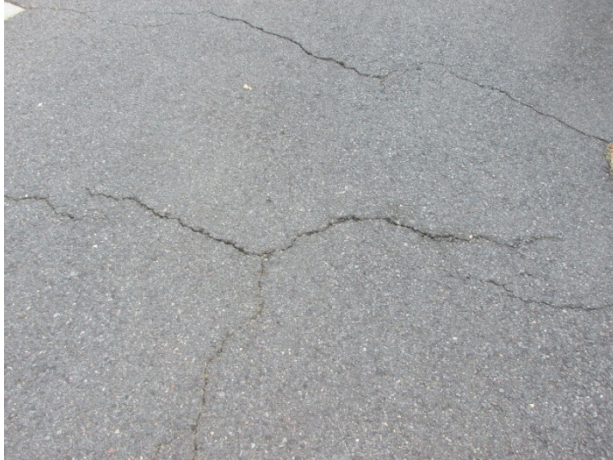
**Pavement cracks at alley**

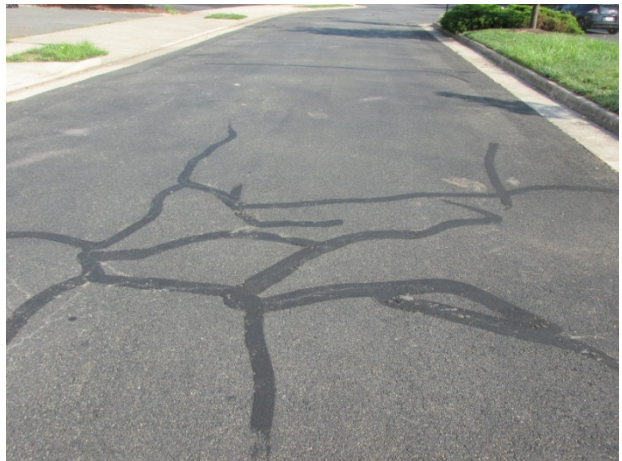
**Previous repairs at townhome pavement**

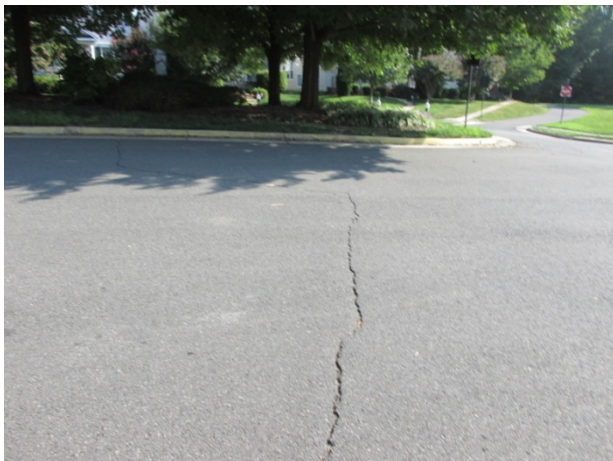
**Pavement cracks at townhome pavement**

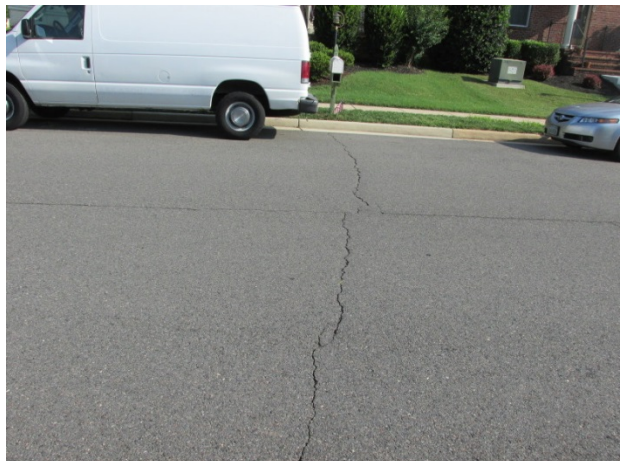
**Pavement cracks at townhome pavement**

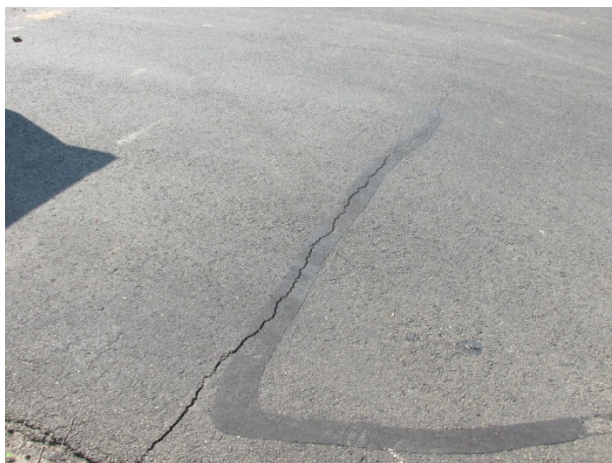
Cracks and previous repairs

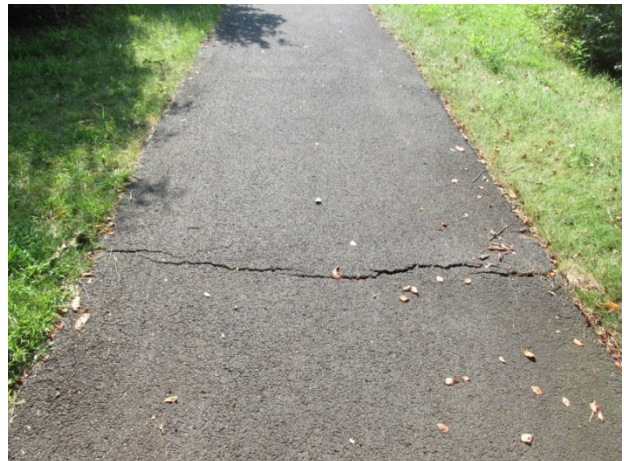
Walking path cracks

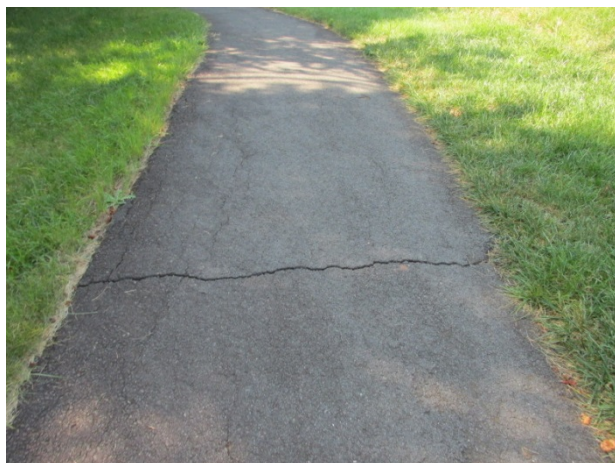
**Walking path crack**

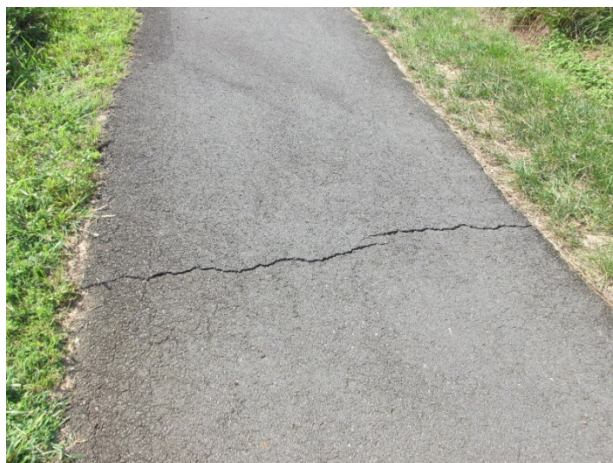
**Walking path cracks**

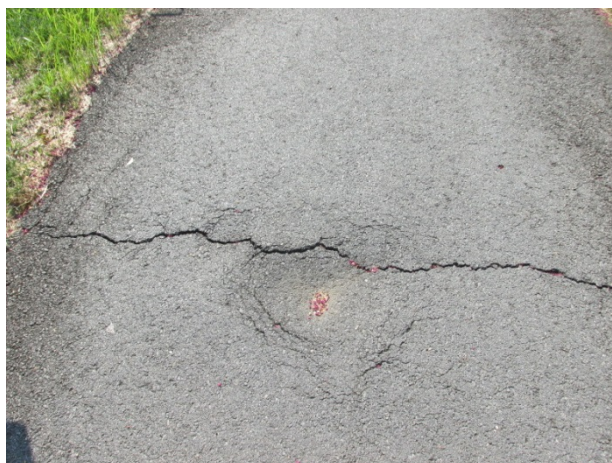
**Walking path cracks and settlement**

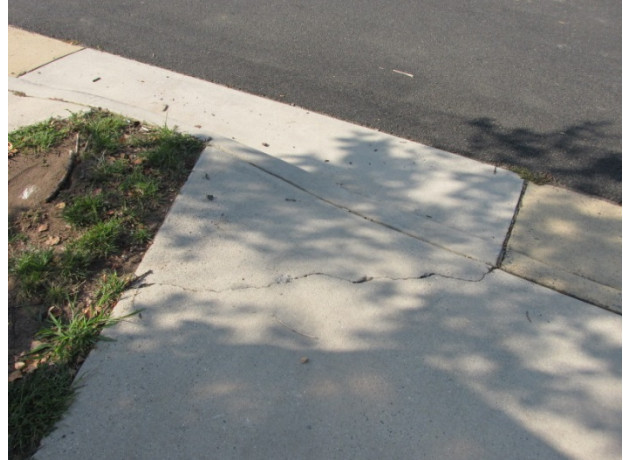
**Condition:** Good overall with isolated cracks evident

**Apron crack**

**Expenditure Detail Notes:** Expenditure timing and costs are depicted in the **Reserve Expenditures** table in Section 3. We estimate that up to 1,470 square feet of concrete aprons, or thirty-five percent (35%) of the total, will require replacement during the next 30 years.

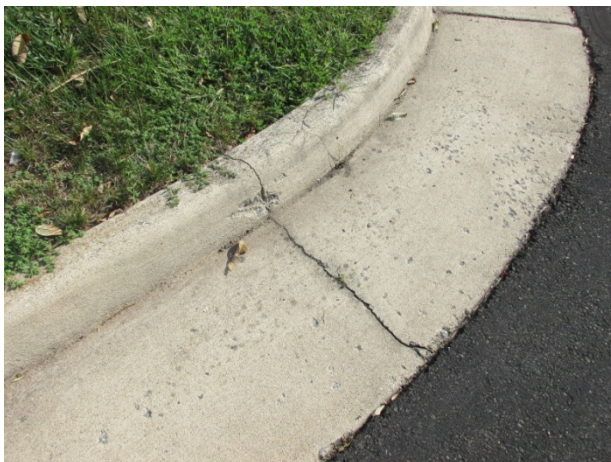
**Curb and gutter crack**

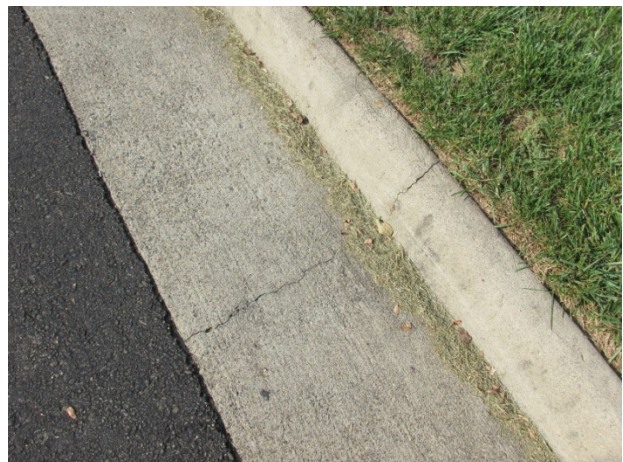
**Curb and gutter crack**

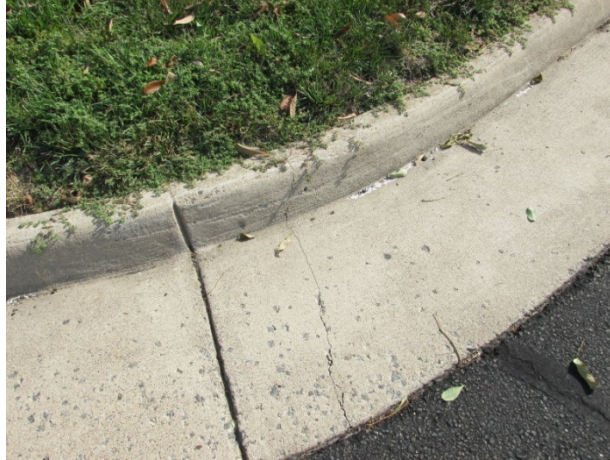
**Curb and gutter crack**

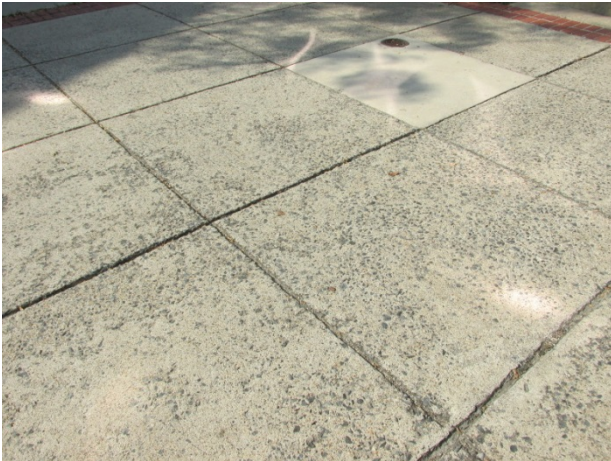
**Concrete spall**

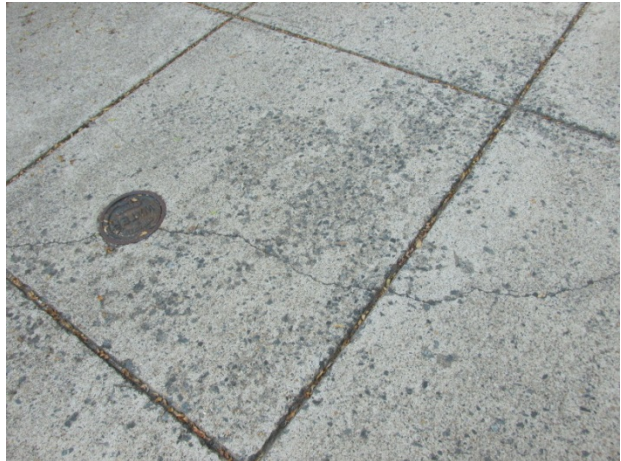
**Concrete spall and cracks**

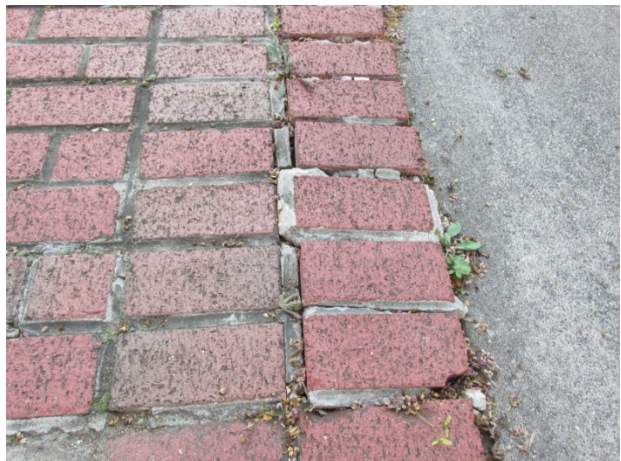
**Mortar deterioration at pavers**

**Expenditure Detail Notes:** Expenditure timing and costs are depicted in the **Reserve Expenditures** table in Section 3. We estimate that up to 19,950 square feet of concrete driveways, or thirty-five percent (35%) of the total, will require replacement during the next 30 years. Our estimate of cost includes an allowance for replacement of up to ten percent (10%) of the masonry pavers.

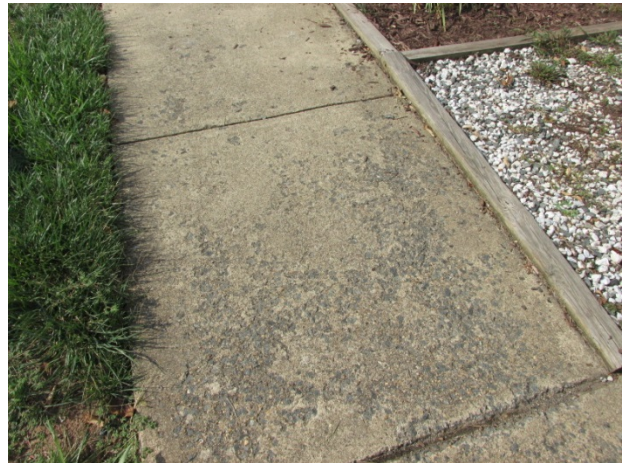
Sidewalk spall

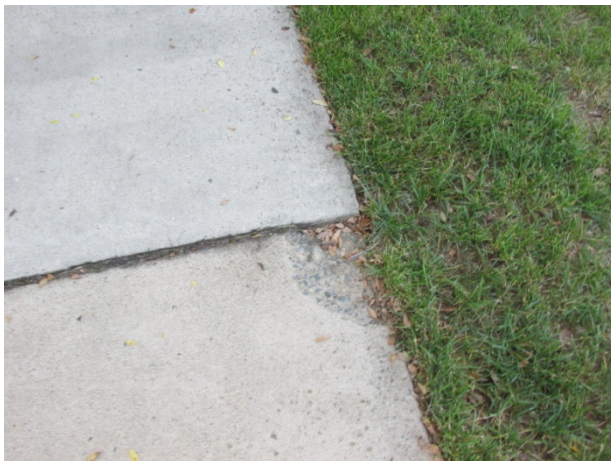
Edge deterioration

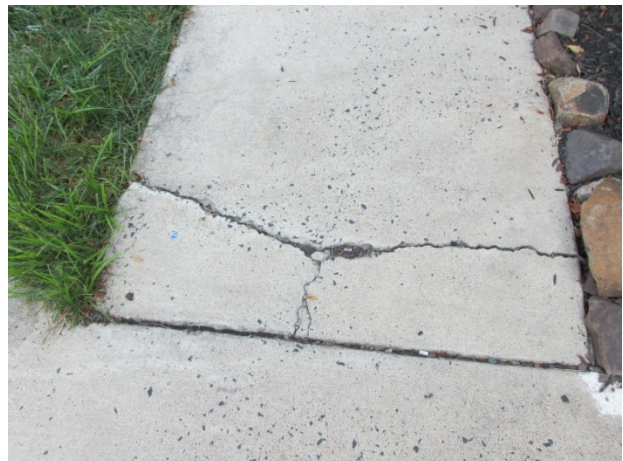
Sidewalk cracks

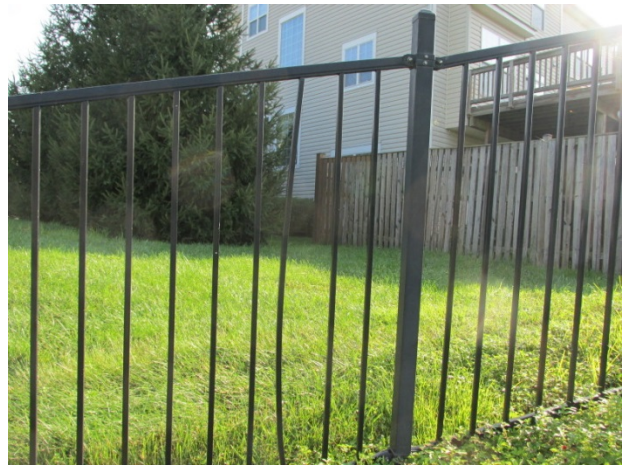
Fence damage

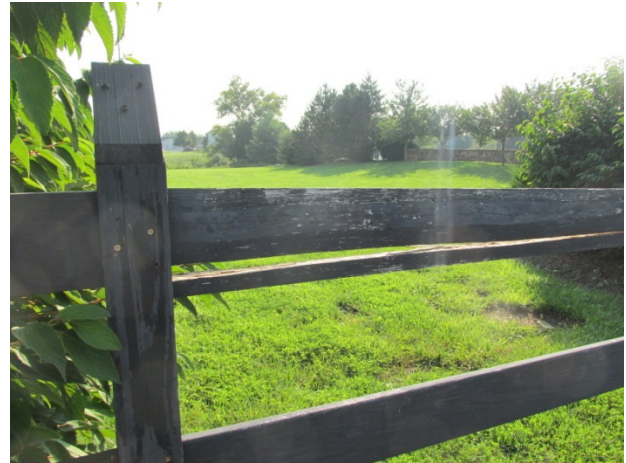
**Fence damage**

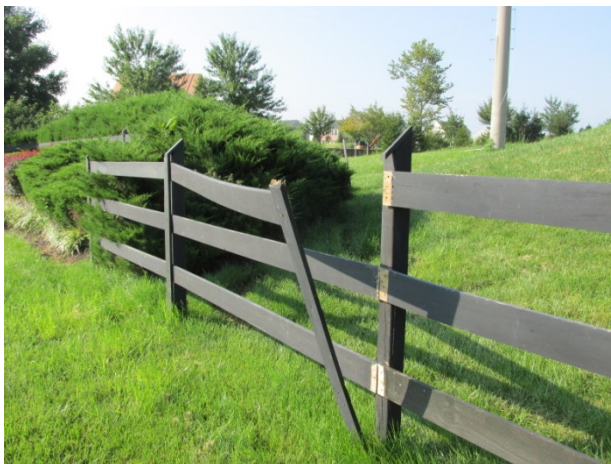
**Fence displacement**

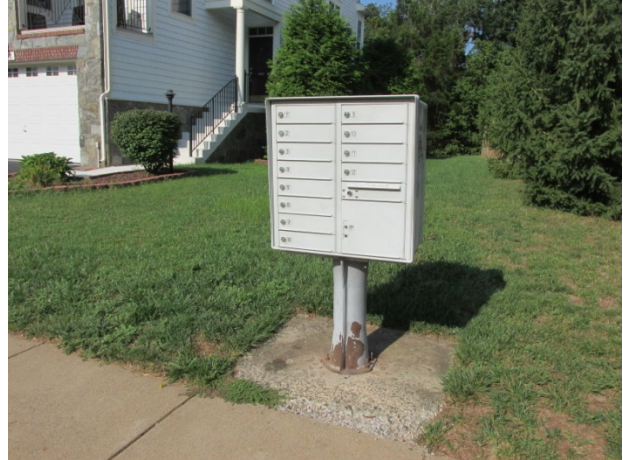
**Mailbox station (Note: Finish deterioration evident)**

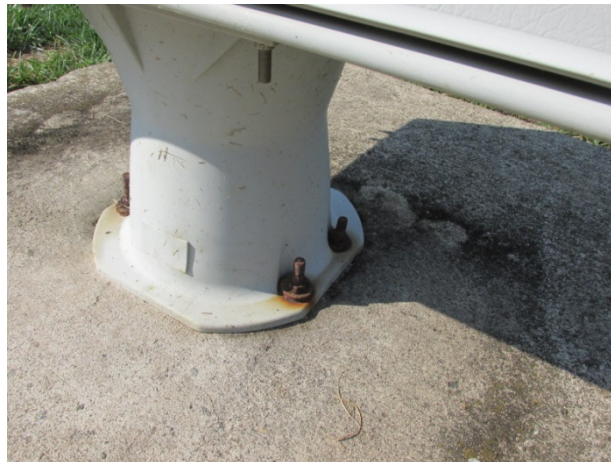
**Fastener rust**

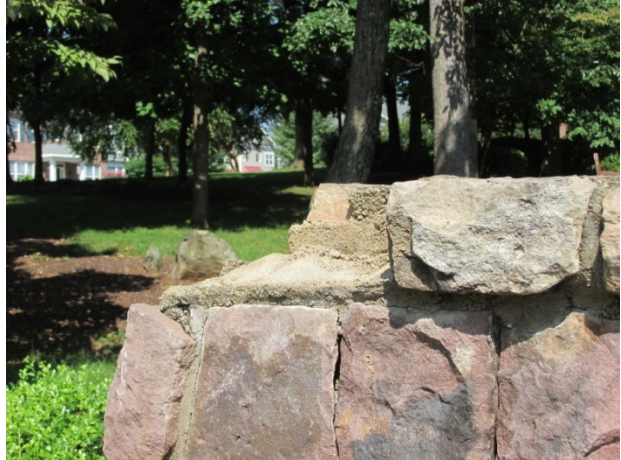
**Missing masonry block**

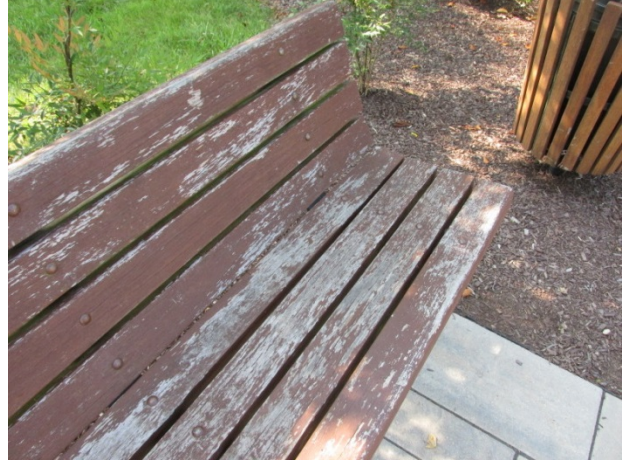
**Finish deterioration**

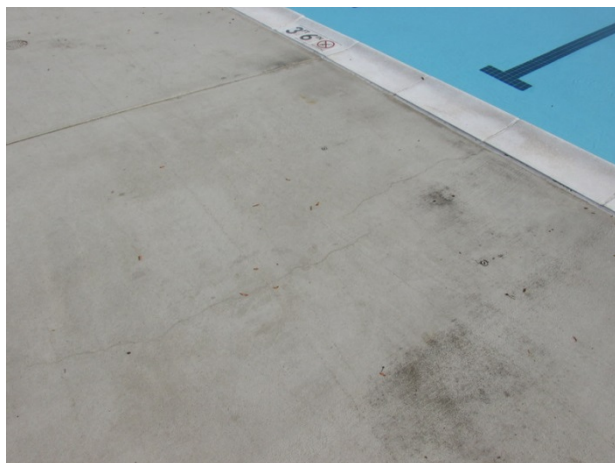
**Condition:** Good to fair condition with cracks evident

**Deck crack**

**Useful Life:** The useful life of a concrete pool deck is up to 60 years or more with timely repairs. We recommend the Association conduct inspections, partial replacements and repairs to the deck every 8- to 12-years.
