# Meadows at Morris Farm Community Association

March 15, 2024 • Gainesville, VA

RESERVE STUDY

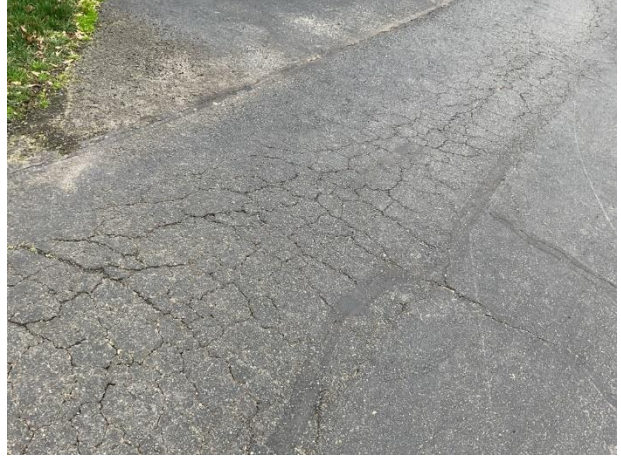
**Cracks at alley**

**Component Detail Notes:** Proposals should include mechanically routing and filling all cracks with hot emulsion. Repairs should also include patching at areas exhibiting settlement, potholes, or excessive cracking. The contractor should only apply seal coat applications after repairs are completed. A seal coat does not bridge or close cracks, therefore, unrepaired cracks render the seal coat applications useless. These activities minimize the damaging effects of vehicle fluids, maintain a uniform and positive appearance, and maximize the useful life of the pavement.

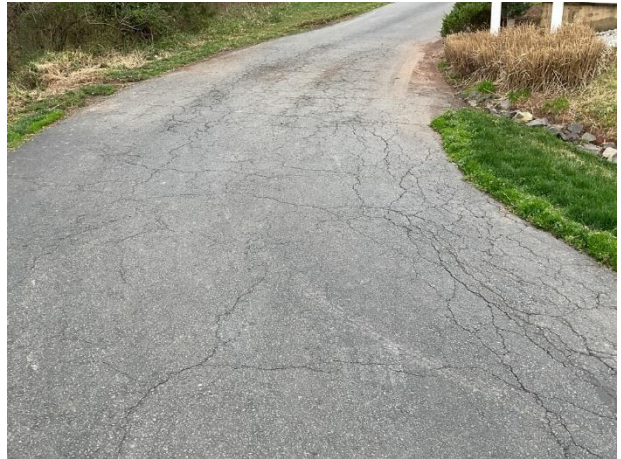
**Cracks at alley**

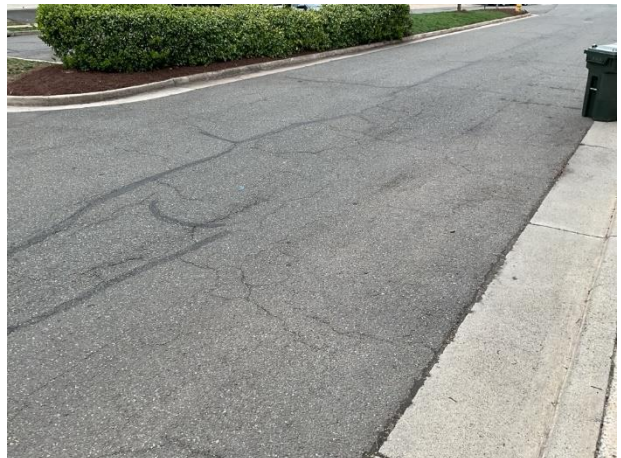
**Cracks and prior repairs at the townhomes**

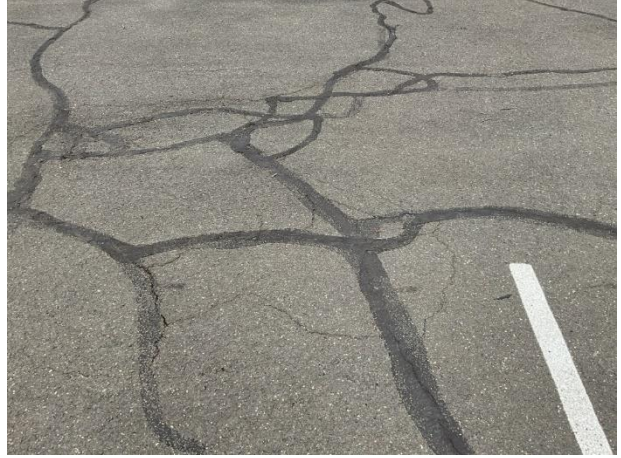
Cracks and prior repairs at the clubhouse parking area

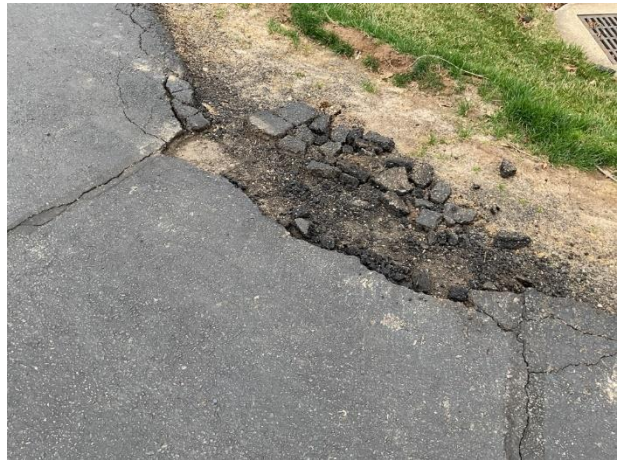
Edge deterioration and cracks at the alleys

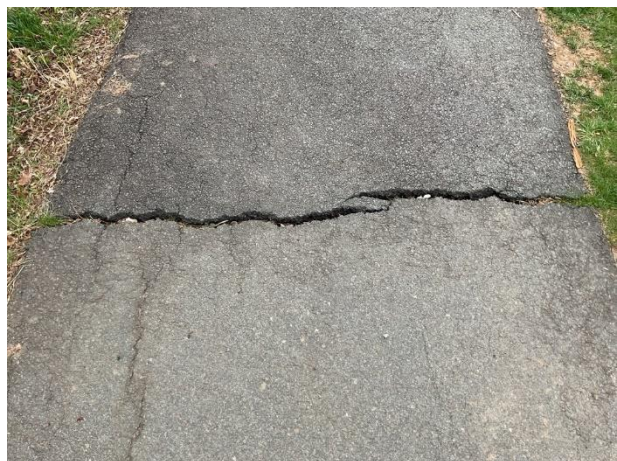
**Pavement cracks**

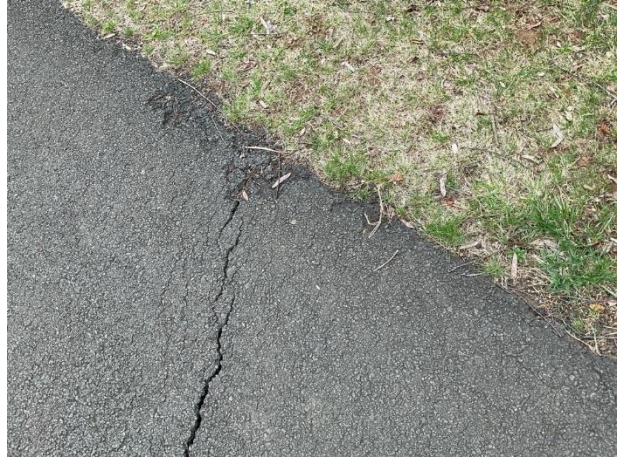
**Pavement cracks and edge deterioration**

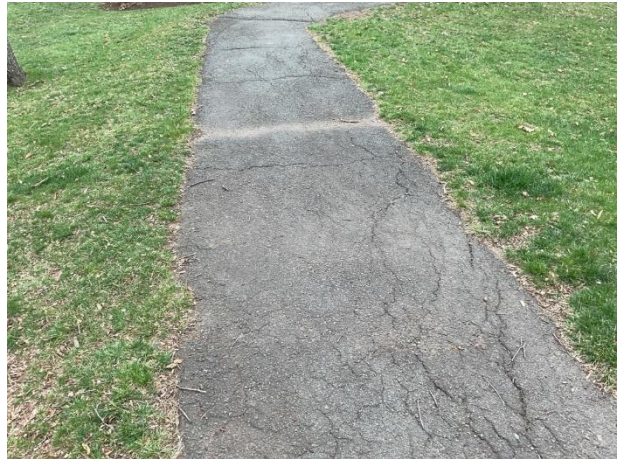
**Pavement cracks**

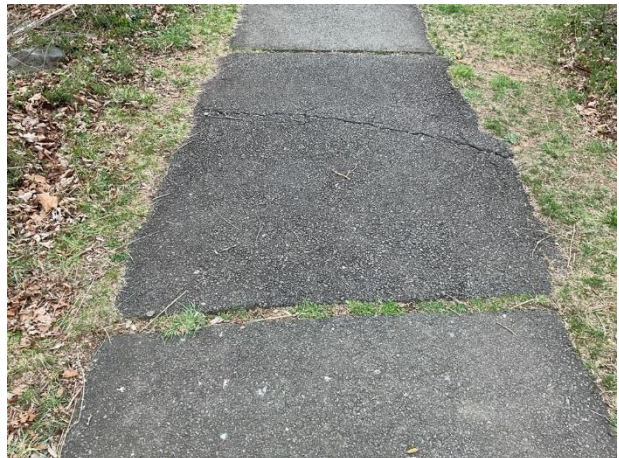
**Pavement cracks and organic growth**

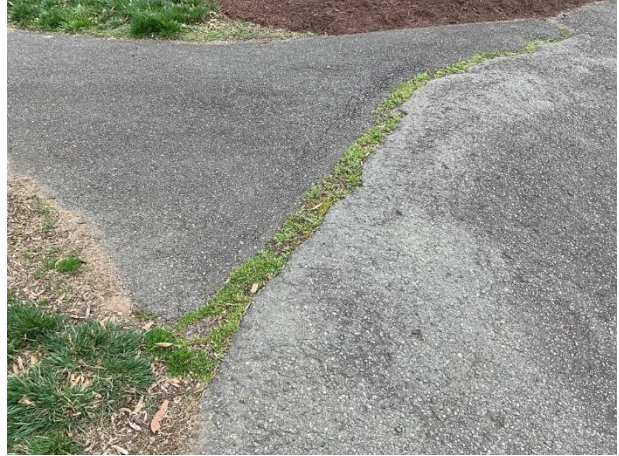
**Pavement cracks and organic growth**

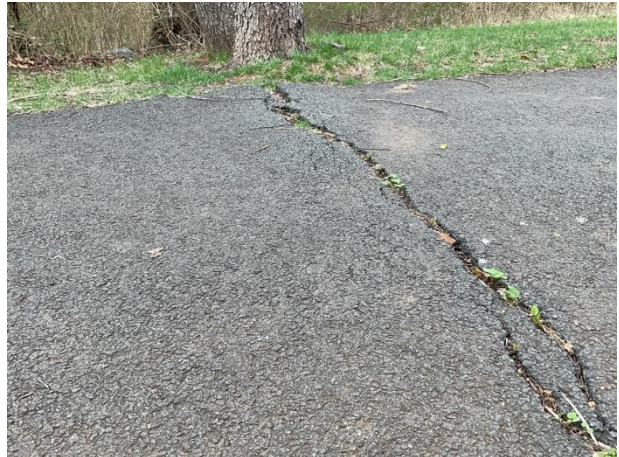
**Pavement cracks and heaving due to root intrusion**

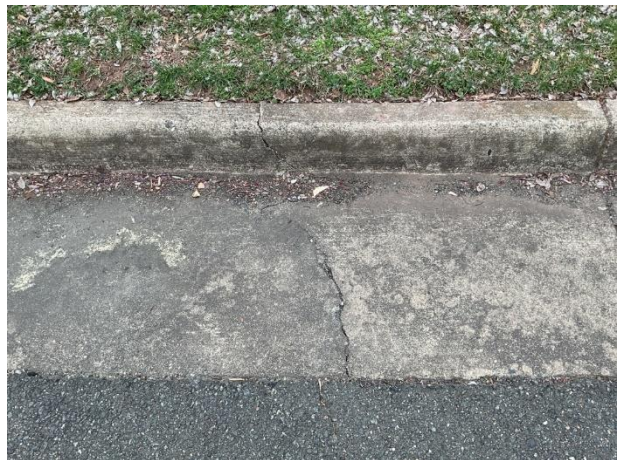
Concrete crack

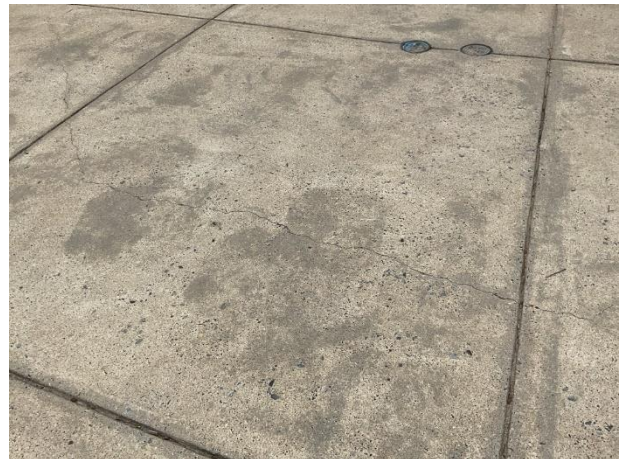
**Concrete crack**

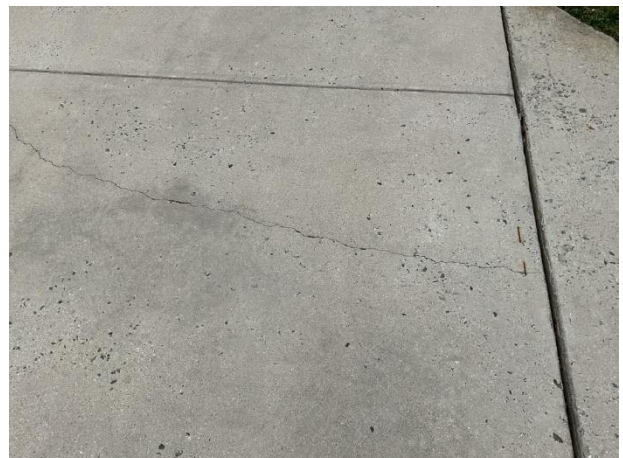
**Concrete crack**

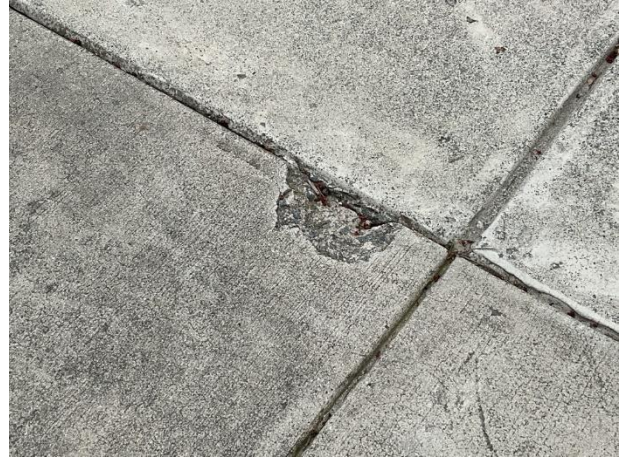
**Undermining**

**Concrete damage**

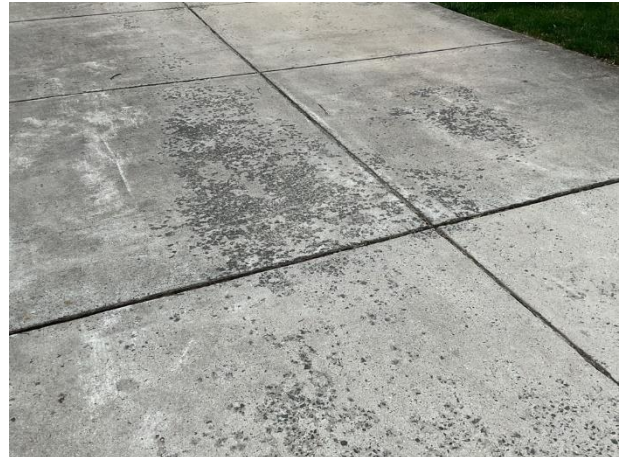
**Scaling**

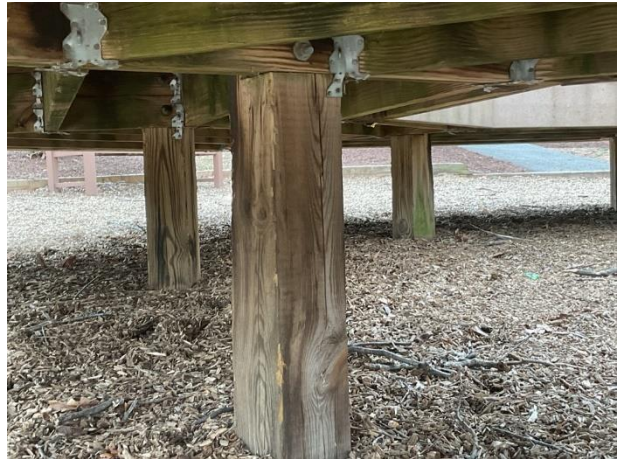
**Railing deterioration**

**Wood split**

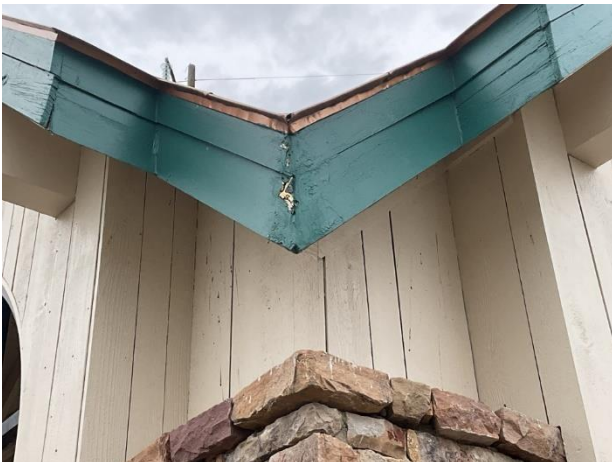
**Trim deterioration**

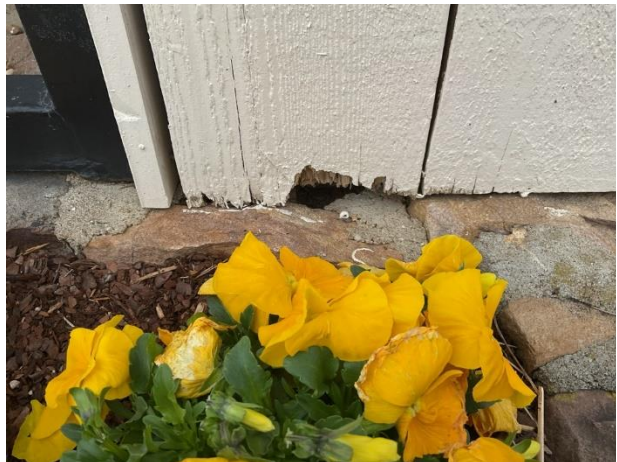
**Trim deterioration**

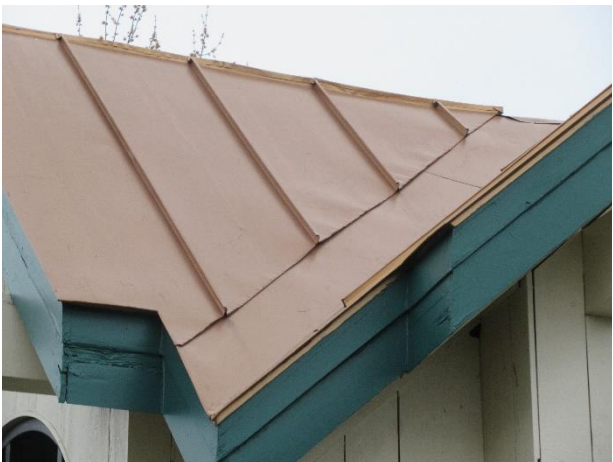
**Warping roof**

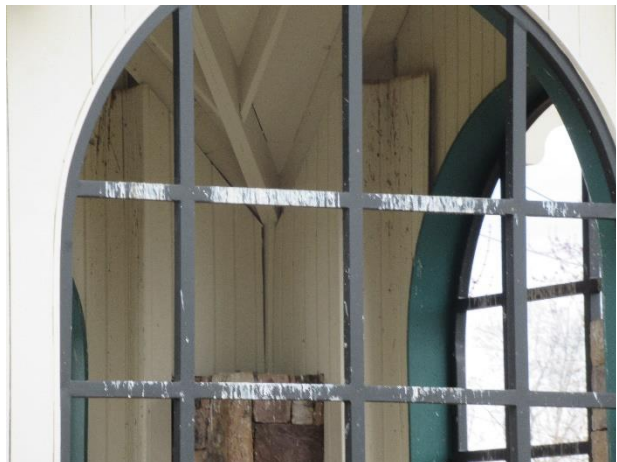
**Stained metal railings**

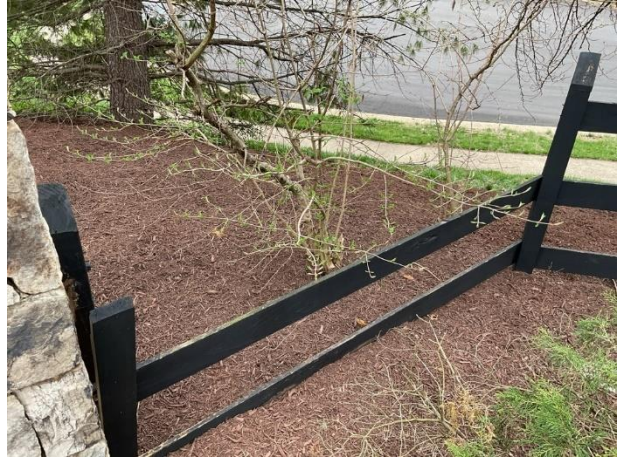
**Missing and loose boards at open rail fence**

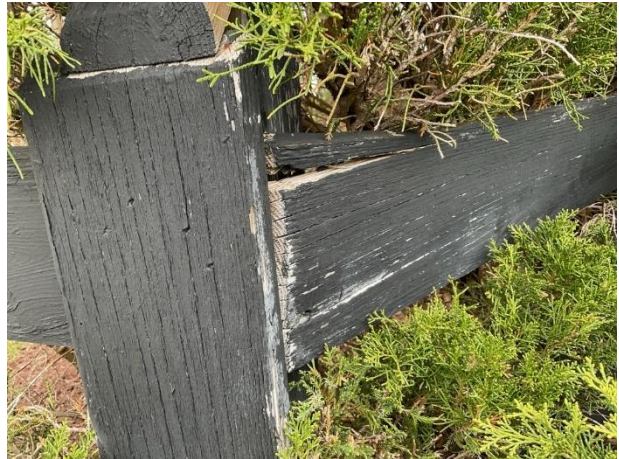
**Wood split and finish deterioration at open rail fence**

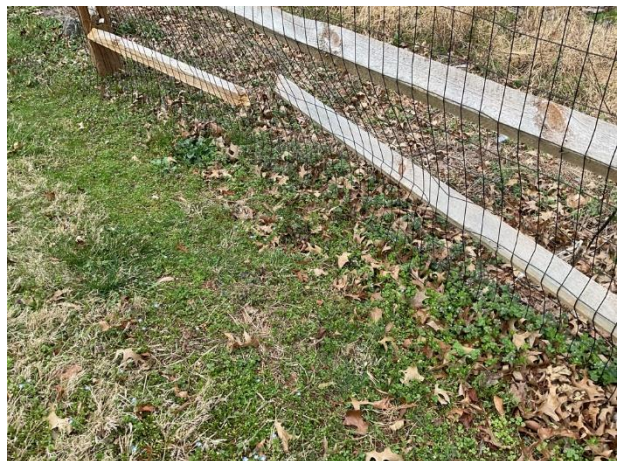
**Broken rail at split rail fence**

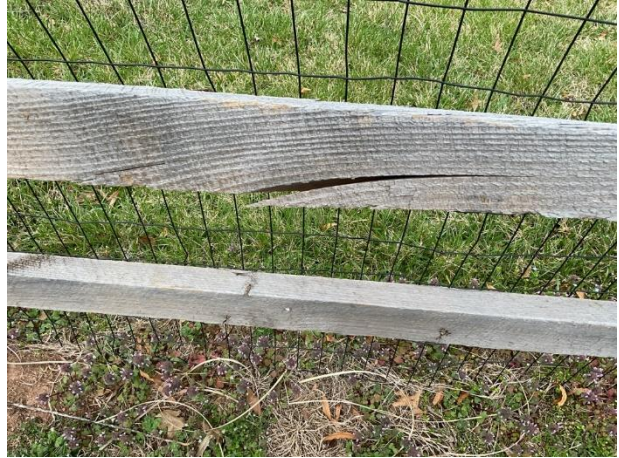
**Wood split at split rail fence**

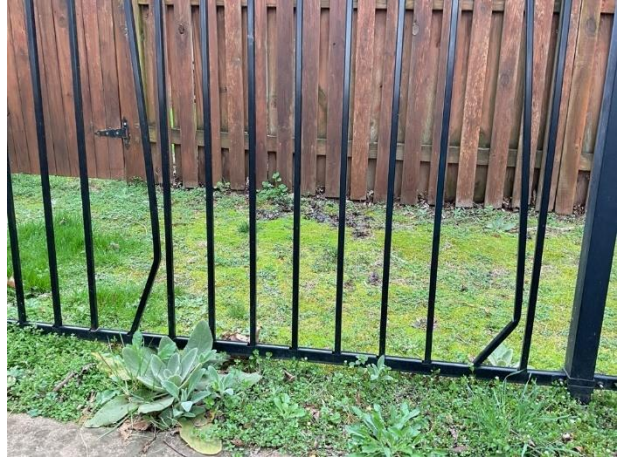
**Damaged pickets**

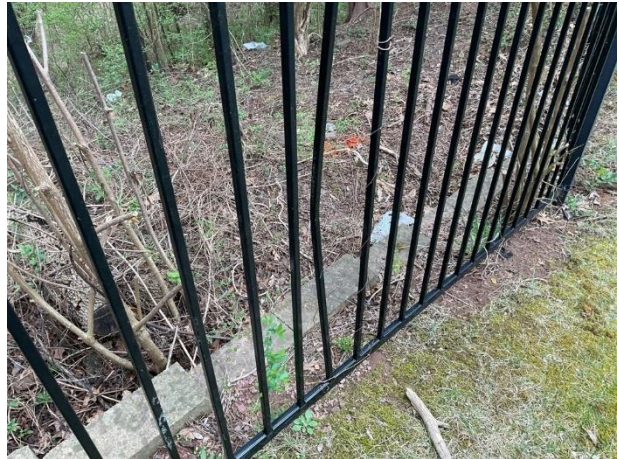
**Damaged pickets**

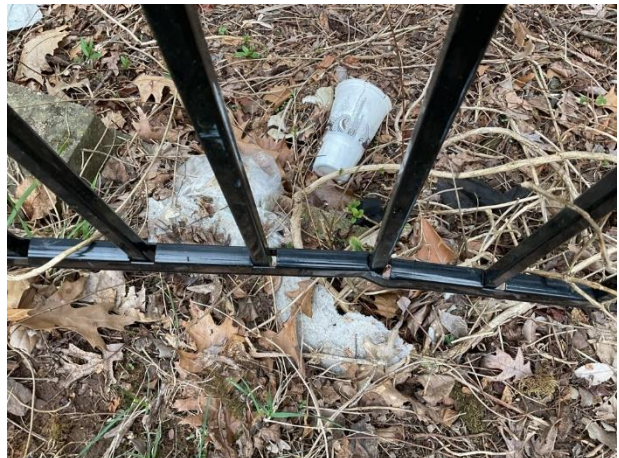
**Damaged rail**

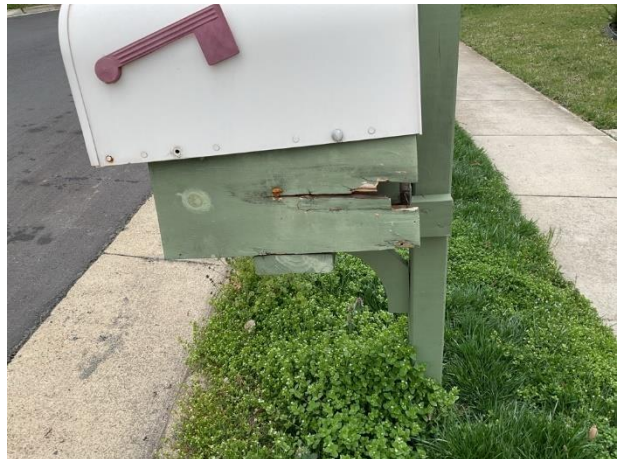
**Wood rot at cluster mailboxes**

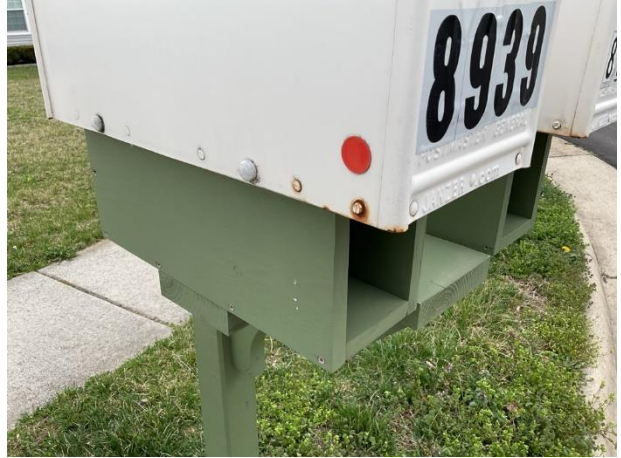
**Rust at cluster mailboxes**

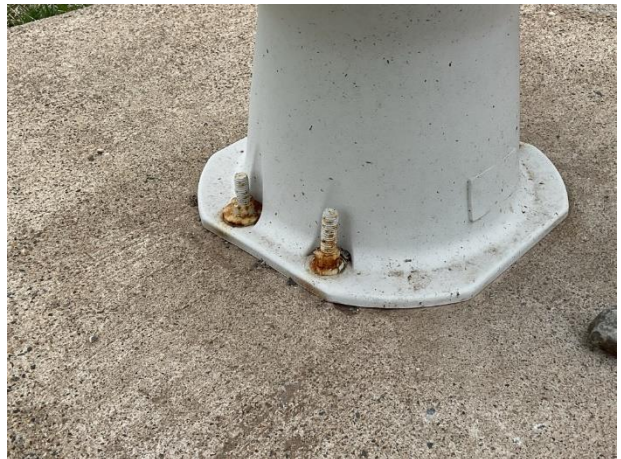
**Fastener rust at townhome mailboxes**

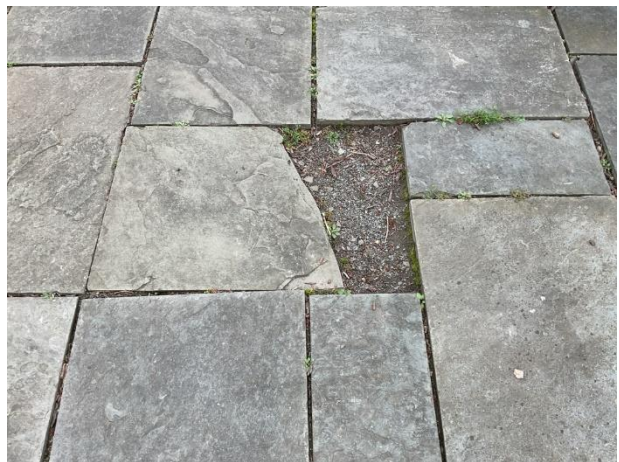
**Broken bluestone paver**

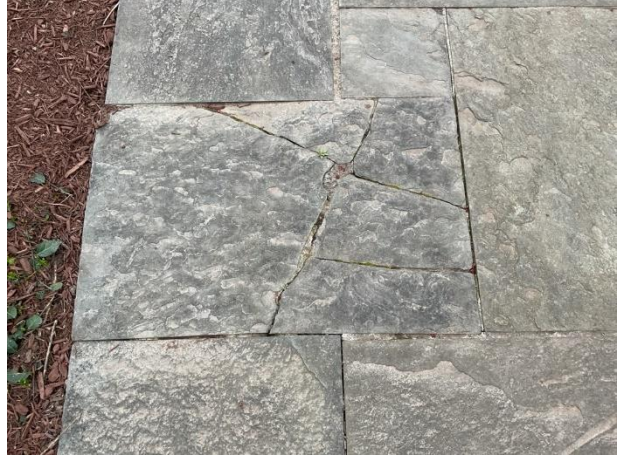
**Cracked bluestone paver**

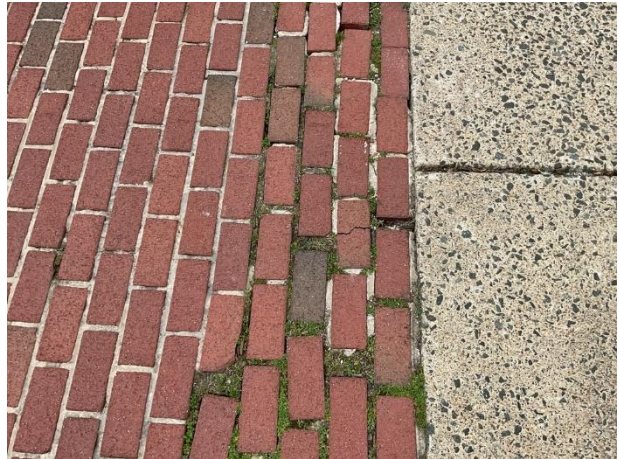
**Mortar deterioration, masonry crack and organic growth at masonry pavers**

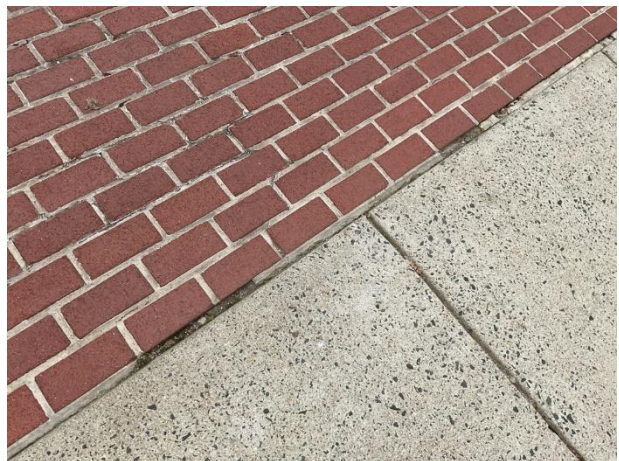
**Mortar deterioration**

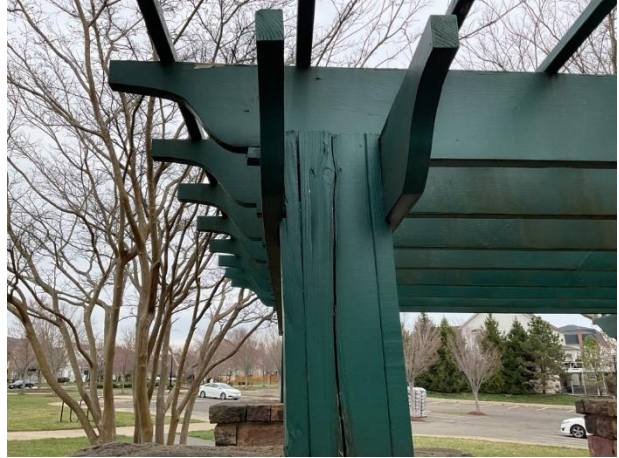
**Wood split at clubhouse**

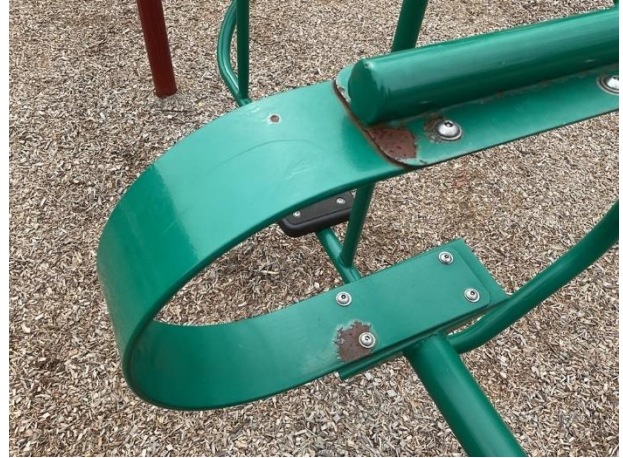
**Finish deterioration and rust at clubhouse playground**

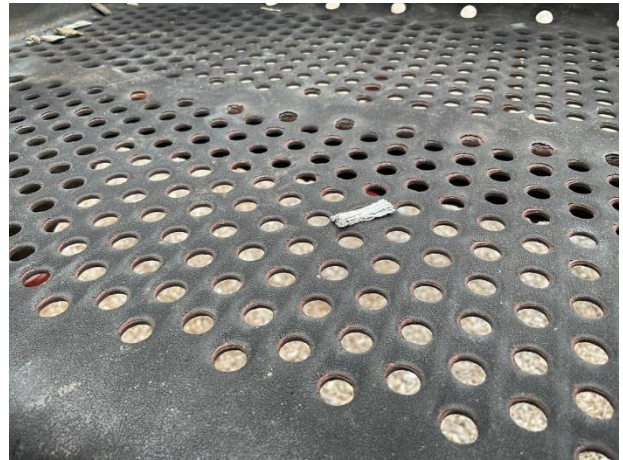
**Finish deterioration and rust at clubhouse playground**

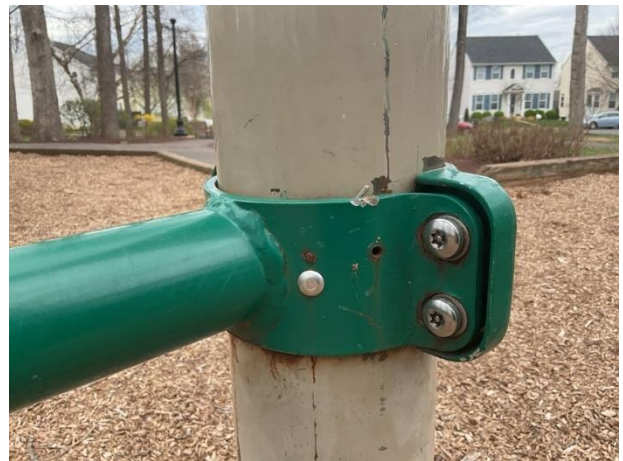
**Finish deterioration at Parula Way playground**

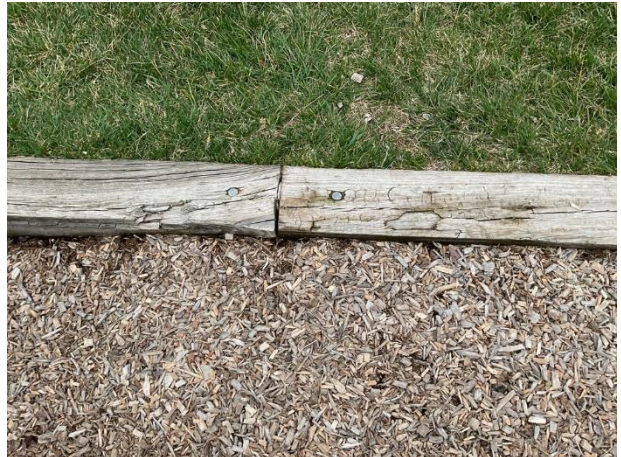
**Wood border deterioration at Brown Thrasher Court playground**

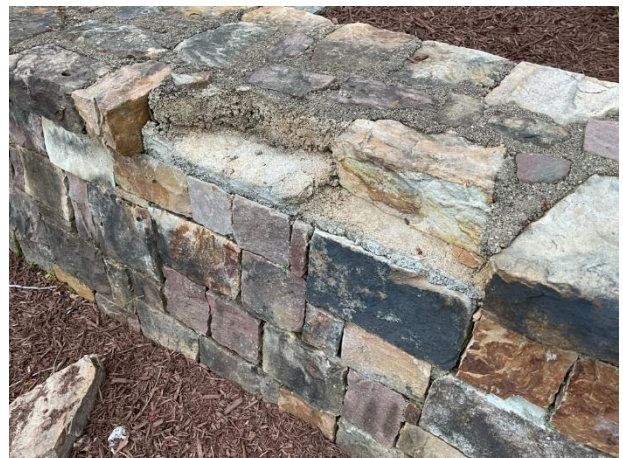
**Missing stones at the stone retaining walls**

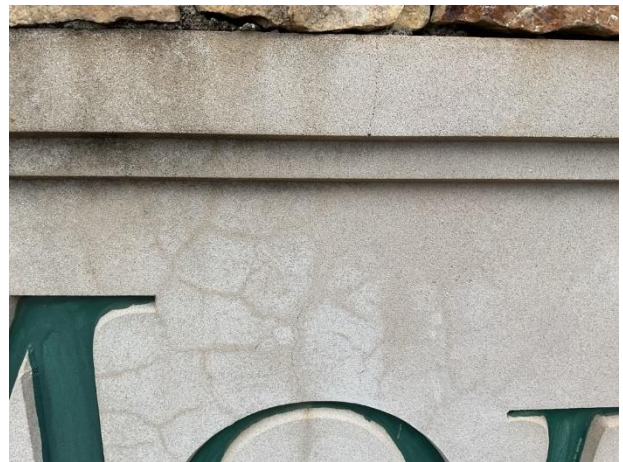
Sign cracks

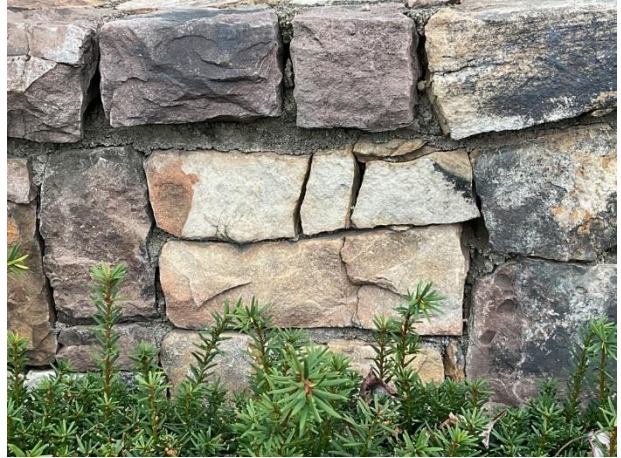
**Cracked stone**

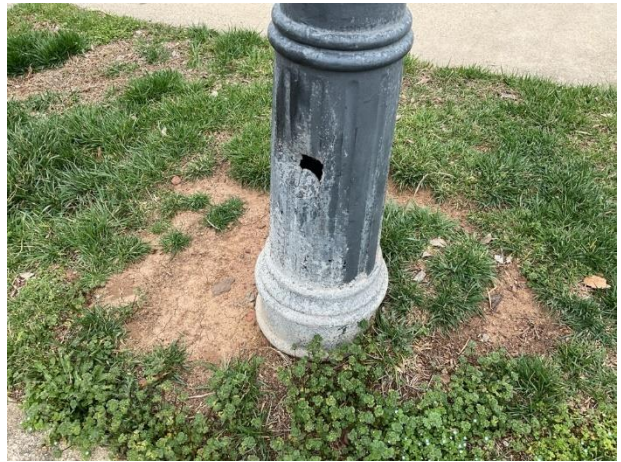
**Damaged base and finish deterioration**

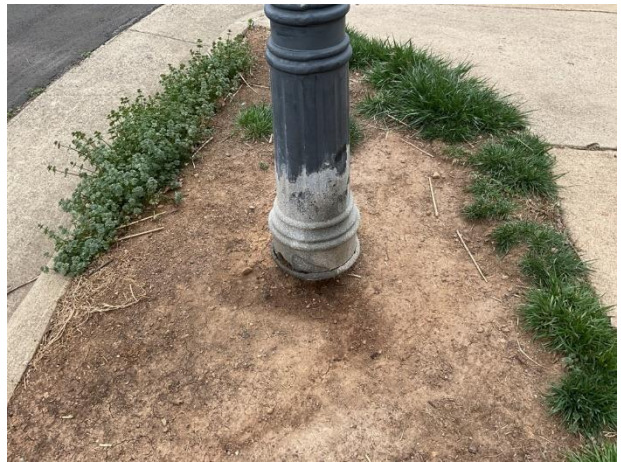
**Finish deterioration**

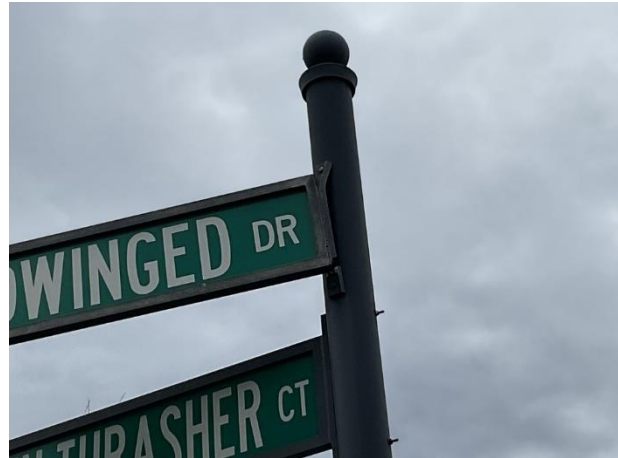
**Damaged sign**

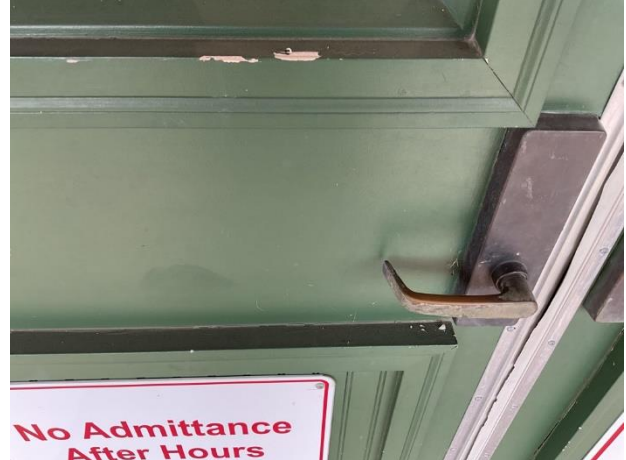
**Finish deterioration**

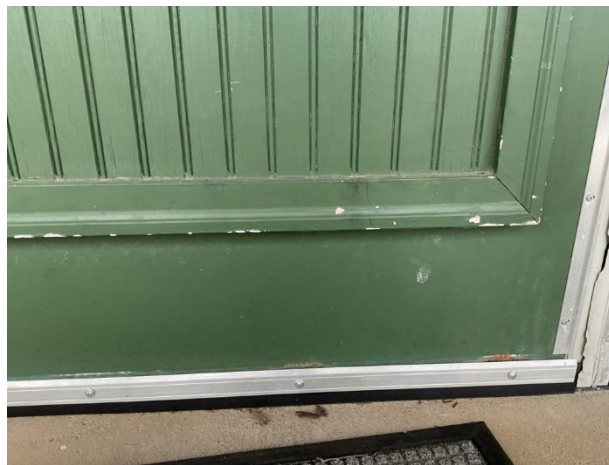
**Finish deterioration**

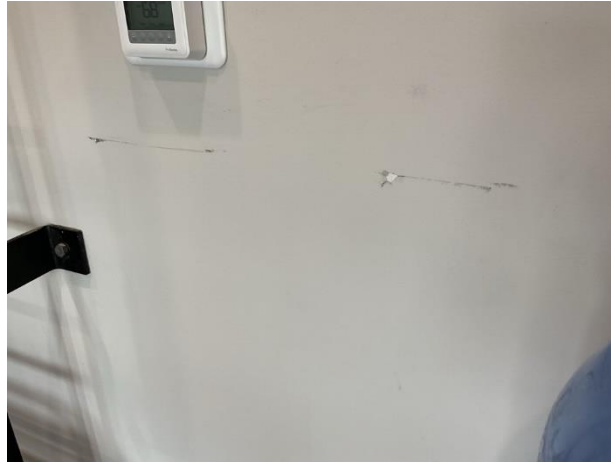
**Paint finishes deterioration**

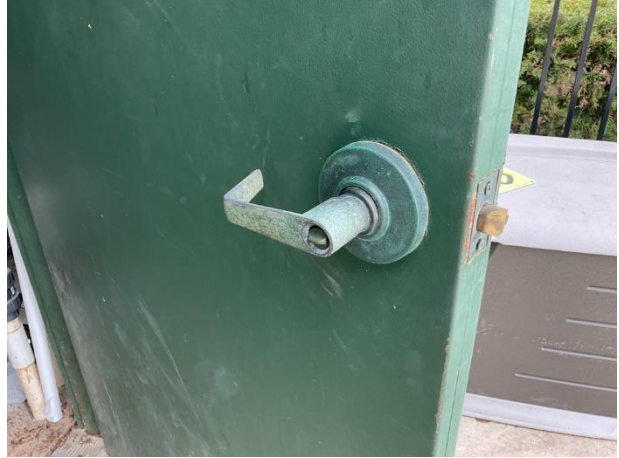
**Corroded handle**

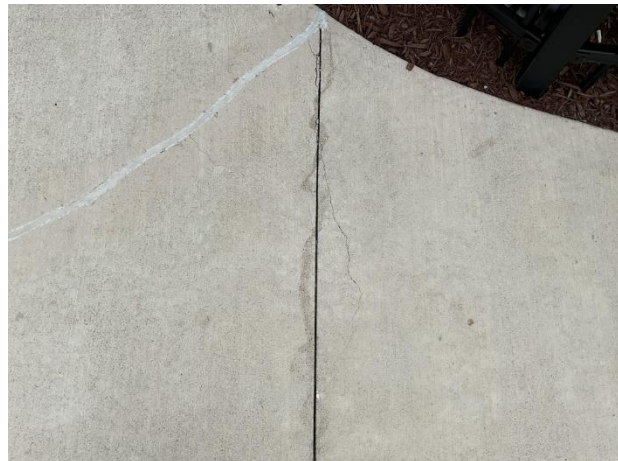
**Concrete cracks and prior repairs**

**Useful Life:** The useful life of a concrete pool deck is up to 60 years or more with timely repairs. We recommend the Association conduct inspections, partial replacements and repairs to the deck every 8- to 12-years.

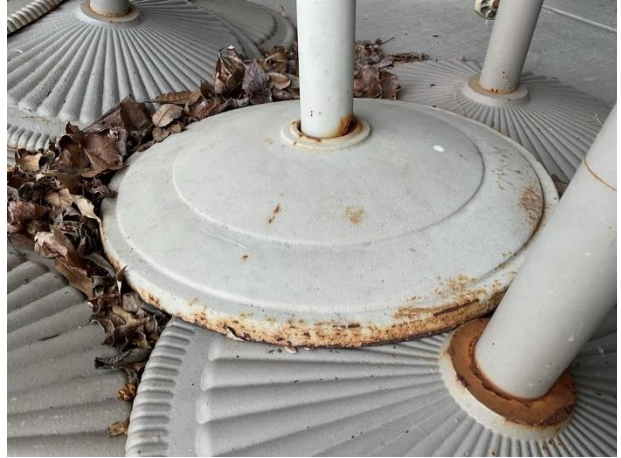
**Umbrella base rust**

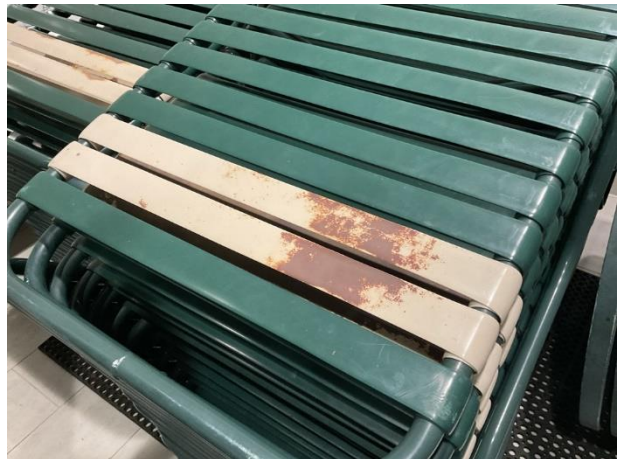
**Staining**

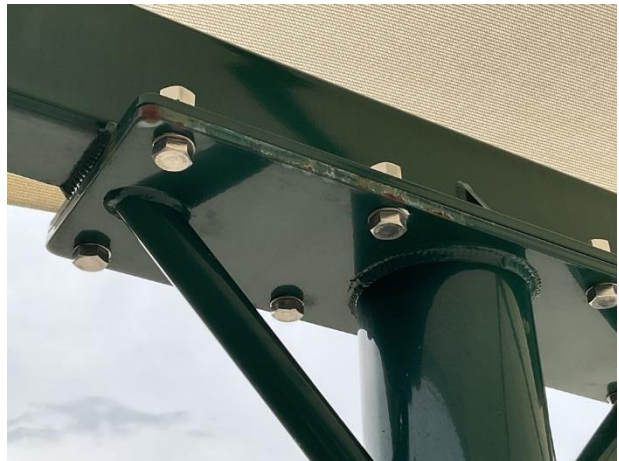
Finish deterioration and rust

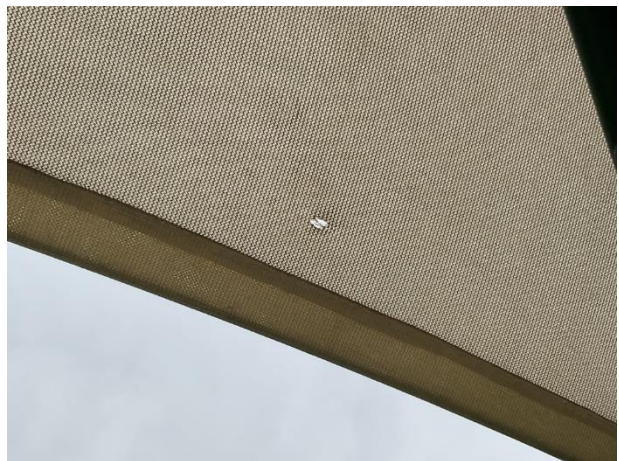
Canvas tear

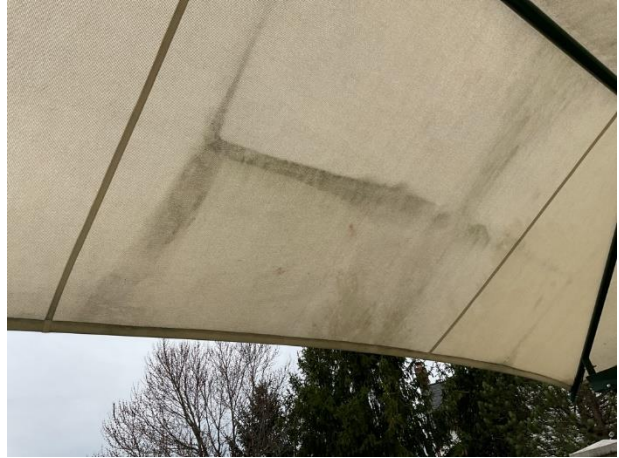
**Organic growth**

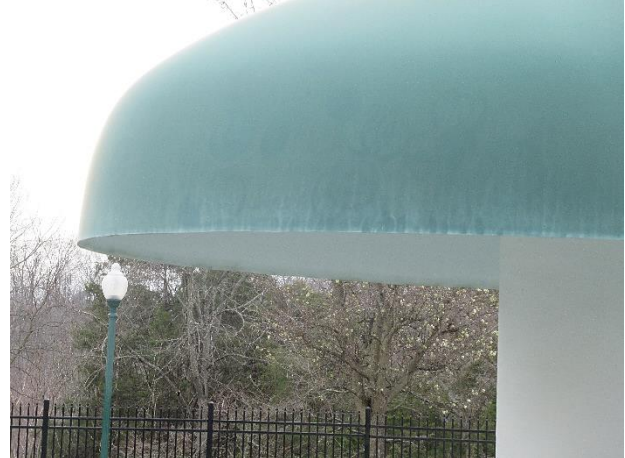
**Finish deterioration**

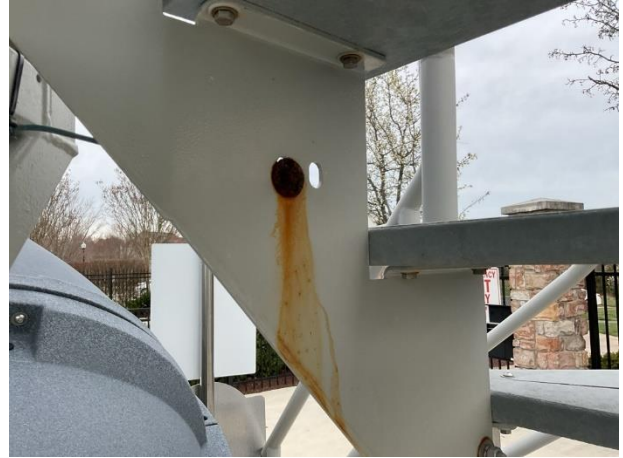
**Fastener rust and rust stains**
