# FULL RESERVE STUDY

## Meadows at Morris Farm Community Association

**Gainesville, Virginia**

**August 28, 2018**

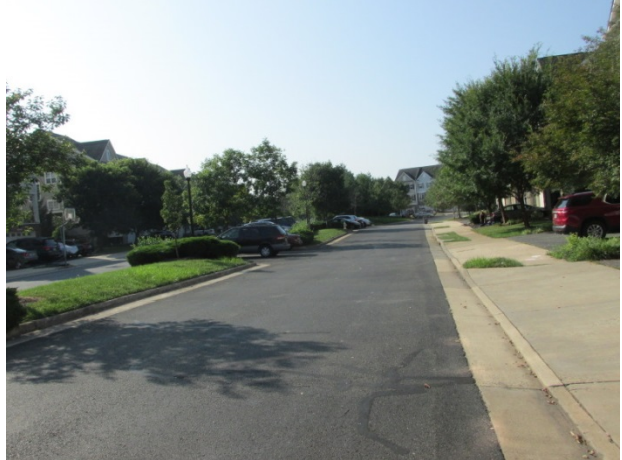
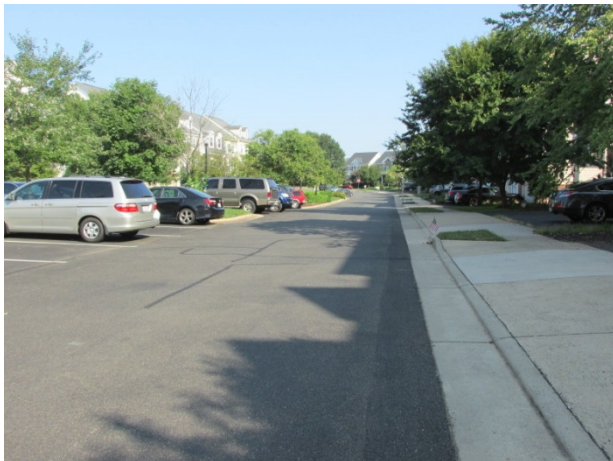
**Condition:** Good to fair overall with cracks evident at the alleys, and cracks and previous repairs evident at the streets and parking areas

**Townhome pavement overview**

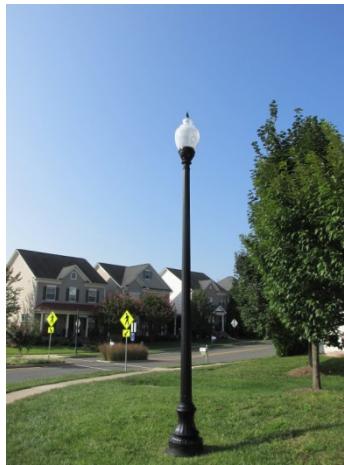
**Condition:** Good overall

Light pole and fixture

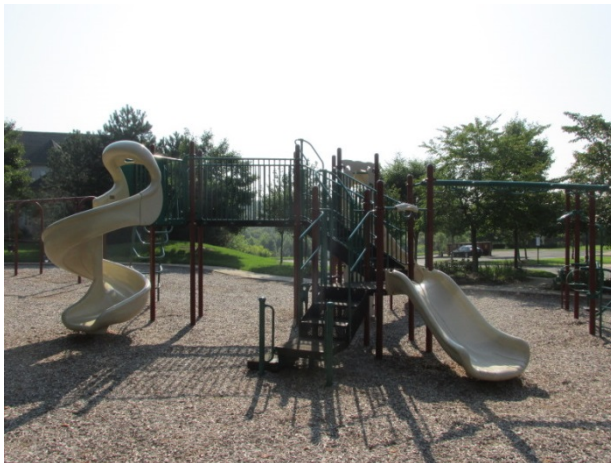
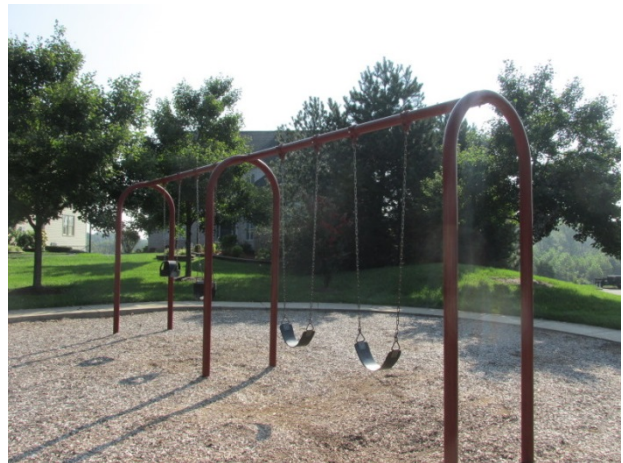
**Condition:** Good to fair overall minor scratches and scuff marks evident

**Playground equipment at Brown Thrasher Court**

**Playground equipment at clubhouse**

**Playground equipment at Parula Way**

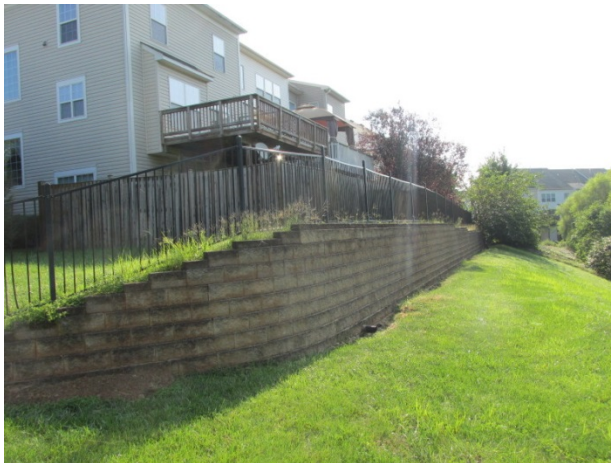
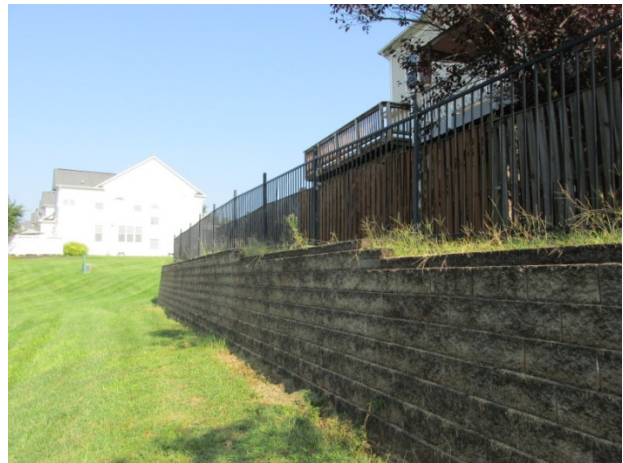
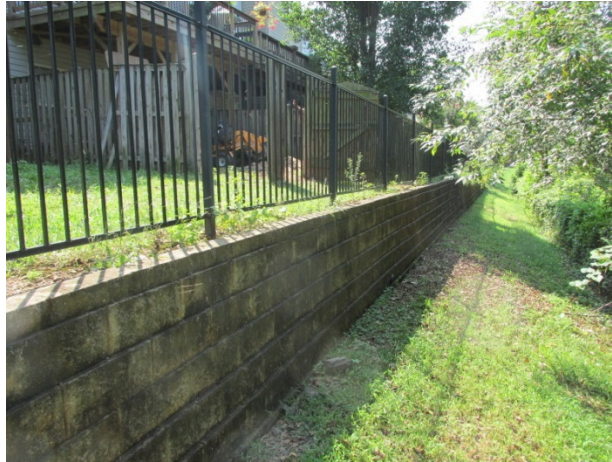
**Condition:** Good overall

Masonry retaining wall

**Masonry retaining wall**

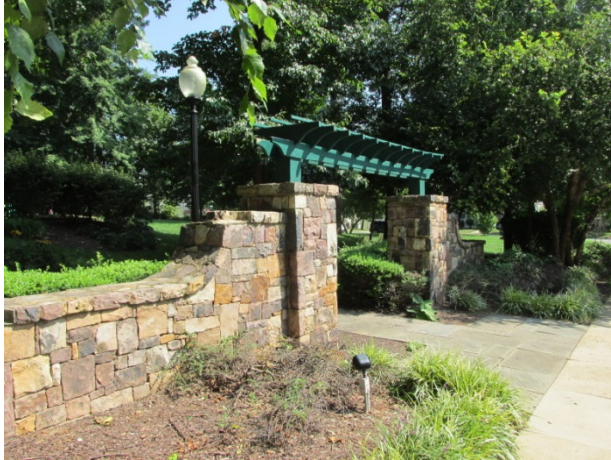
**Condition:** Good to fair overall with missing masonry blocks evident

**Entrance monument overview**

**Masonry wall**

**Arbor and masonry wall at Parula Park**

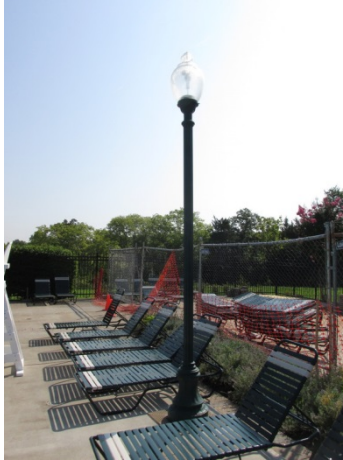
**Condition:** Good overall

**Light pole and fixture**

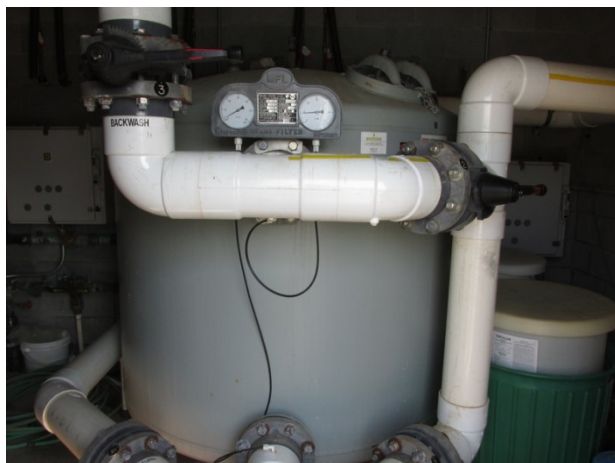
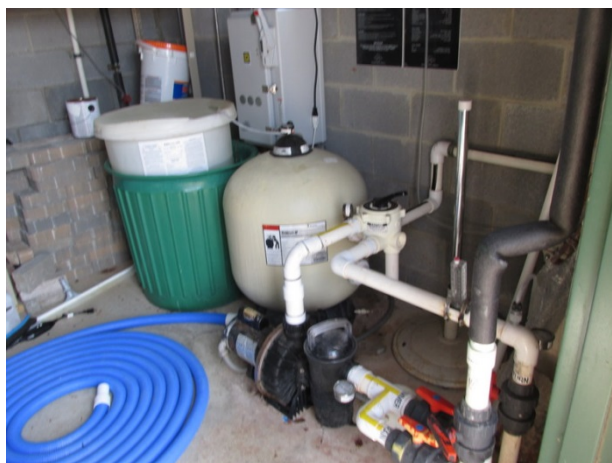
**Condition:** Reported satisfactory

**Main pool filter**

**Pumps**

**Wading pool mechanical equipment**

**Expenditure Detail Notes:** Expenditure timing and costs are depicted in the **Reserve Expenditures** table in Section 3. Failure of the pool mechanical equipment as a single event is unlikely. Therefore, we include replacement of up to thirty-three percent (33%) of the equipment per event. We consider interim replacement of motors and minor repairs as normal maintenance.
