# Meadows at Morris Farm Community Association

March 15, 2024 • Gainesville, VA

RESERVE STUDY

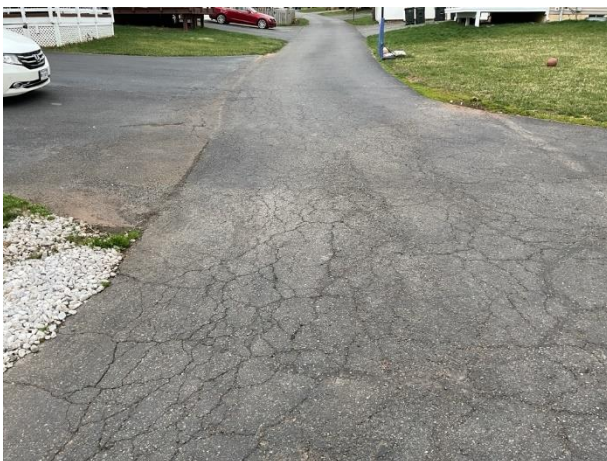
**Condition:** The alleys vary from fair to poor overall condition with cracks and deterioration evident, and the streets at the townhomes and parking area at the clubhouse are in fair overall condition with cracks and prior repairs evident.

Asphalt pavement alley overview

**Component Detail Notes:** Proposals should include mechanically routing and filling all cracks with hot emulsion. Repairs should also include patching at areas exhibiting settlement, potholes, or excessive cracking. The contractor should only apply seal coat applications after repairs are completed. A seal coat does not bridge or close cracks, therefore, unrepaired cracks render the seal coat applications useless. These activities minimize the damaging effects of vehicle fluids, maintain a uniform and positive appearance, and maximize the useful life of the pavement.

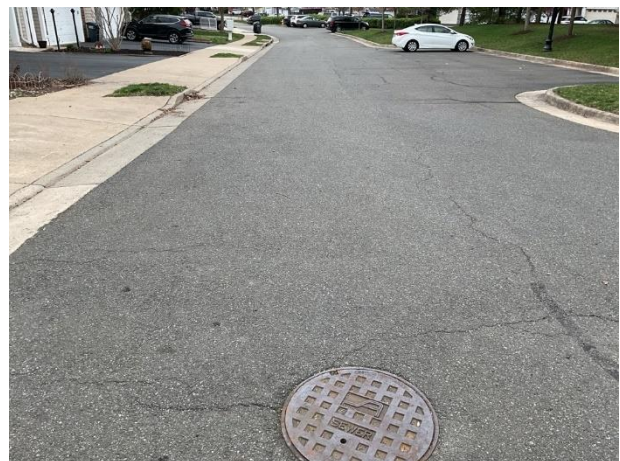
Asphalt pavement street at townhomes overview

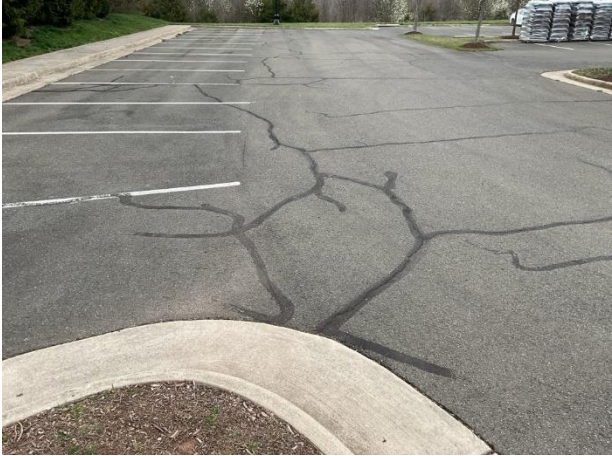
**Asphalt pavement at clubhouse parking area**

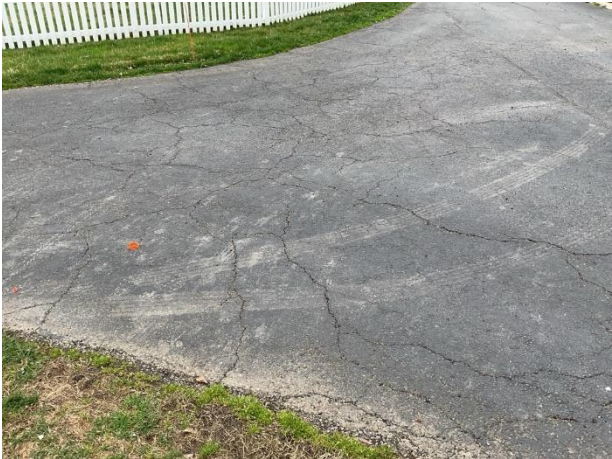
**Cracks at alley**

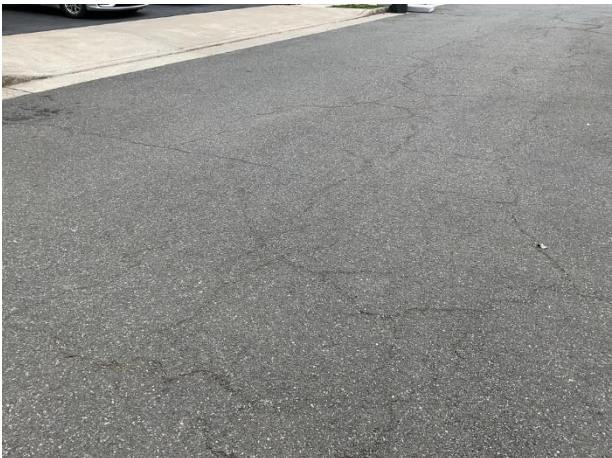
**Cracks at townhome streets**

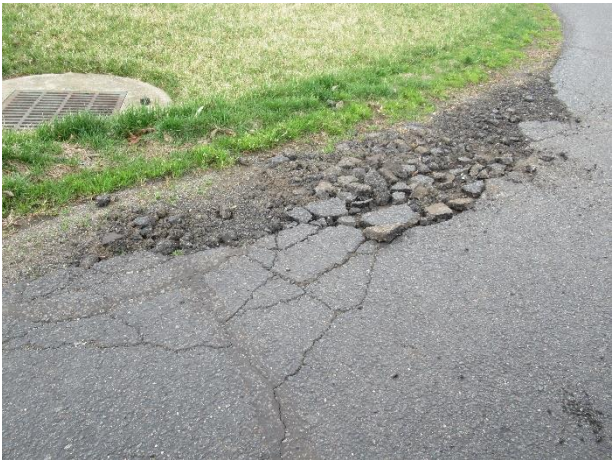
Edge deterioration and cracks at the alleys

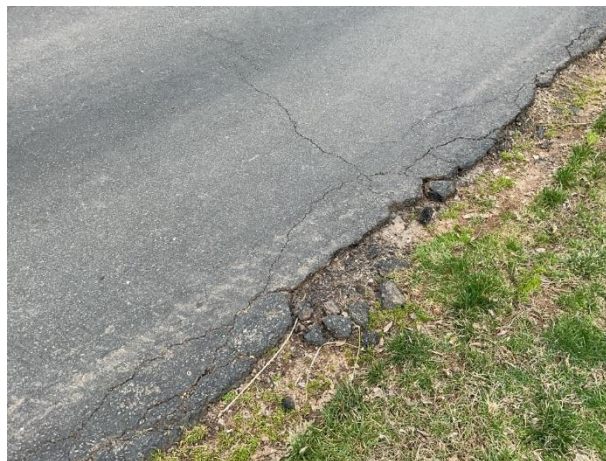
Edge deterioration and cracks at the alleys

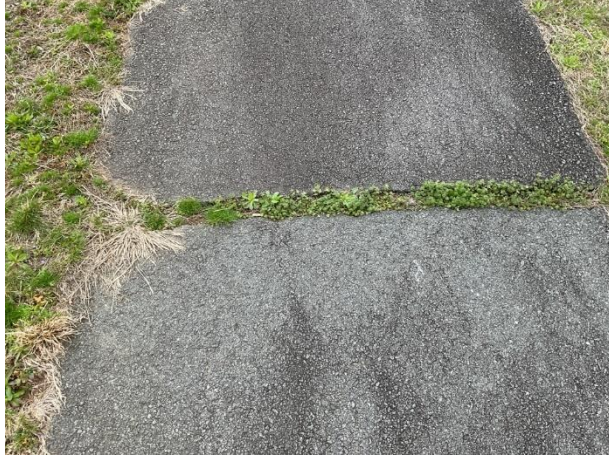
**Pavement cracks and organic growth**

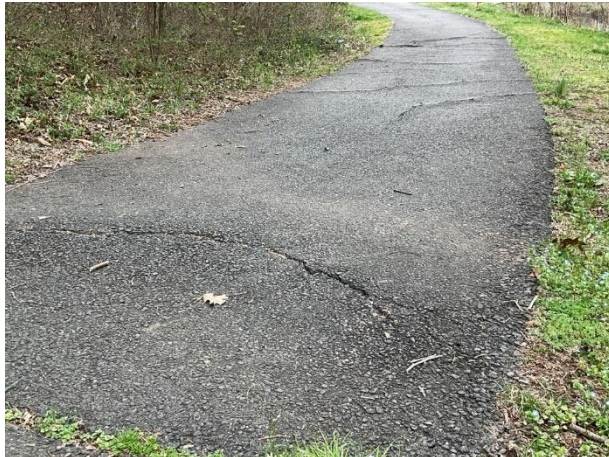
**Pavement cracks and heaving due to root intrusion**

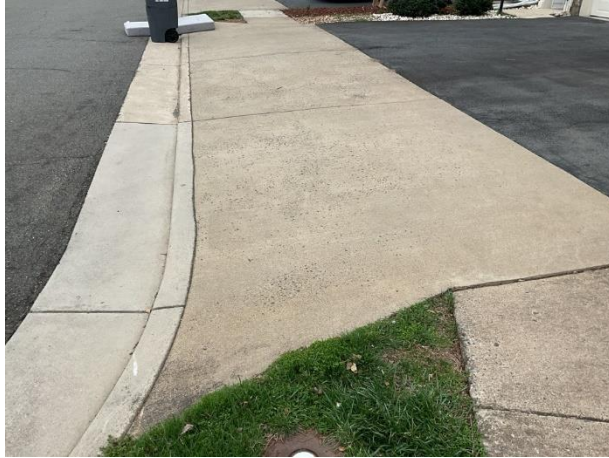
**Condition:** Good to fair overall with scaling and cracks evident.

**Concrete apron overview**

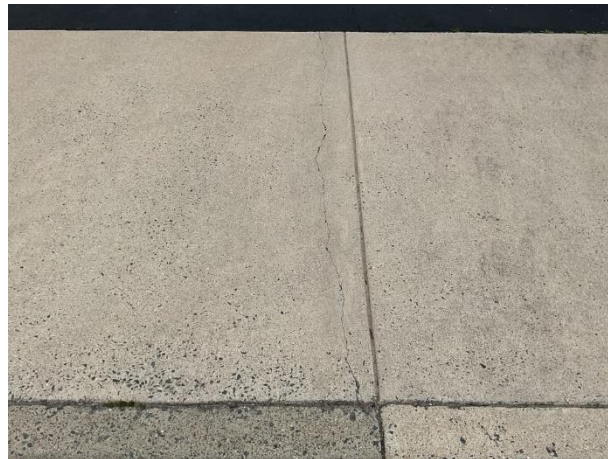
**Concrete crack and scaling**

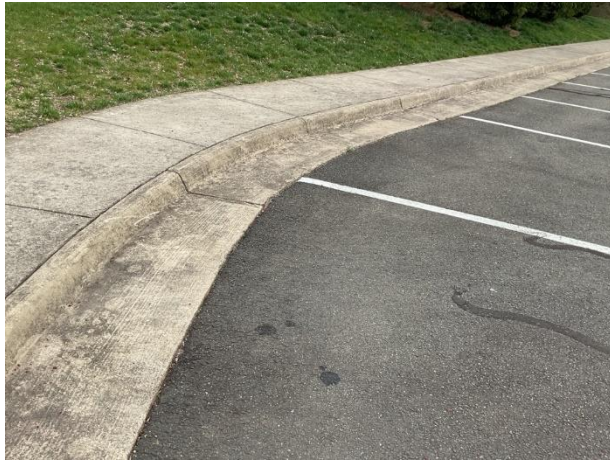
**Condition:** Good to fair overall

Curb and gutter overview

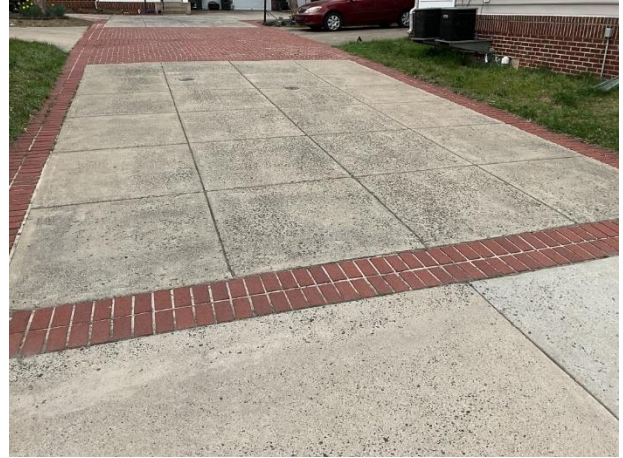
**Concrete driveway overview**

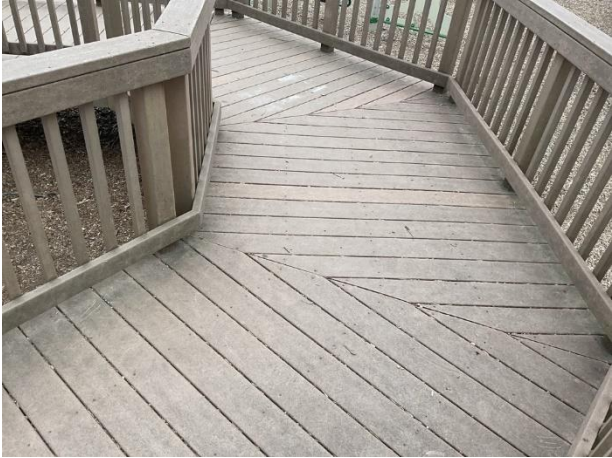
**Deck boards overview**

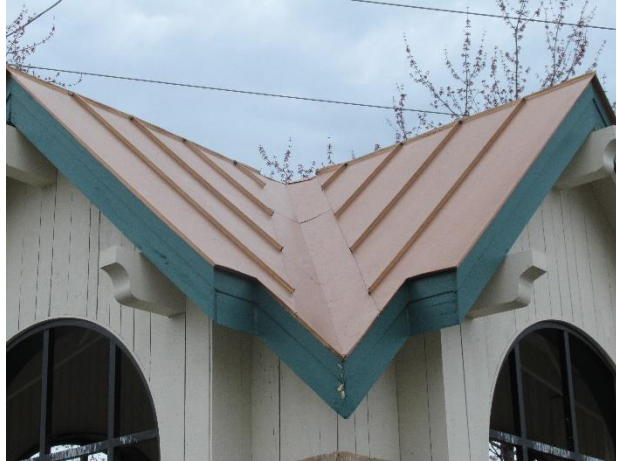
**Metal roof overview**

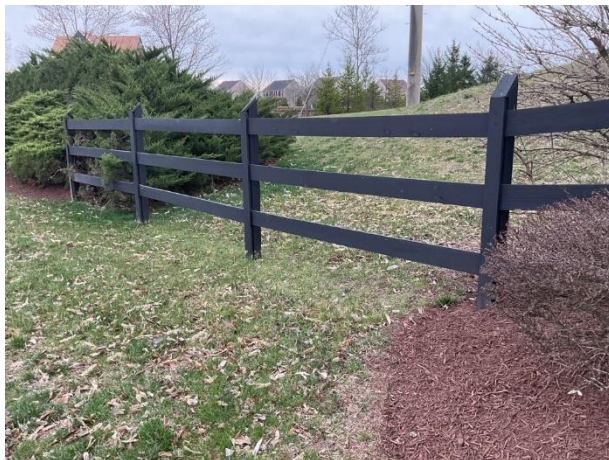
Open rail wood fence overview

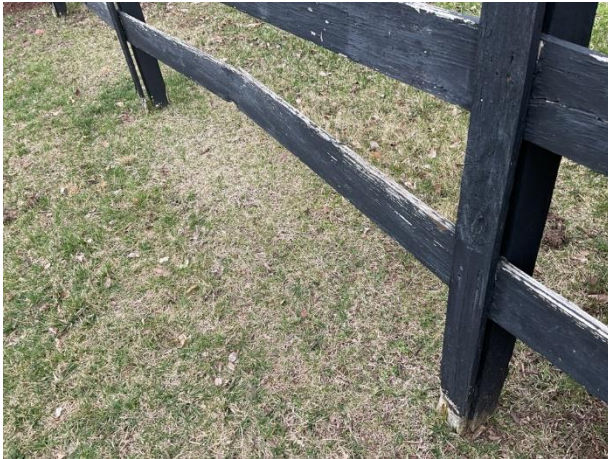
**Condition:** The open rail fence is in fair overall condition with missing boards, loose boards, damaged boards and finish deterioration evident. The split rail fence is in good to fair overall condition with broken rails and wood split evident.

**Damaged board and finish deterioration and open rail fence**

- Annually:
  - Inspect and repair loose sections, finish deterioration and damage
  - Repair leaning sections and clear vegetation from fence areas which could cause damage

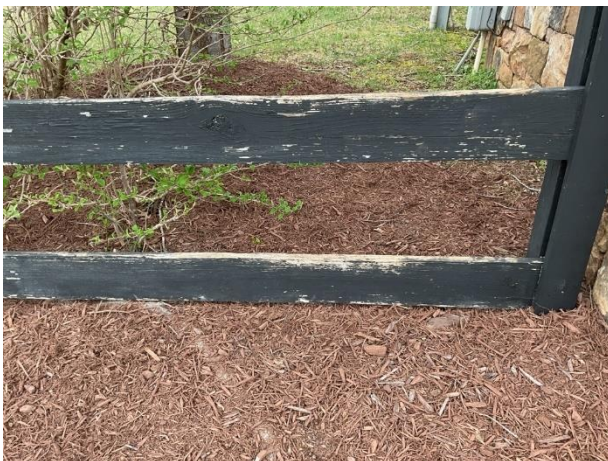
**Finish deterioration at open rail fence**

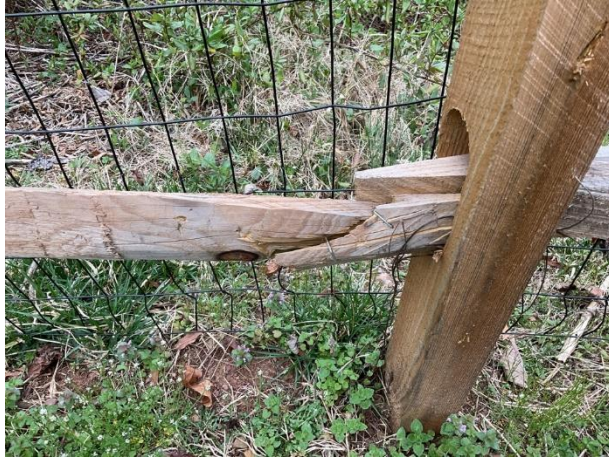
**Broken rail at split rail fence**

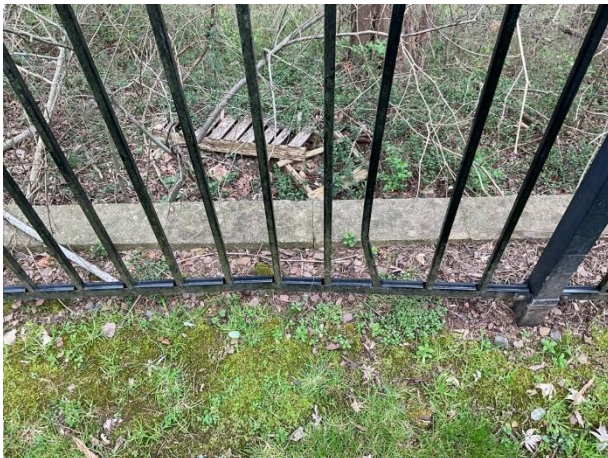
**Condition:** Fair overall with damaged pickets, damaged rail and leaning sections evident.

**Damaged pickets and rail**

- Annually:
  - Inspect and repair loose fasteners or sections, and damage
  - Repair leaning sections and clear vegetation from fence areas which could cause damage

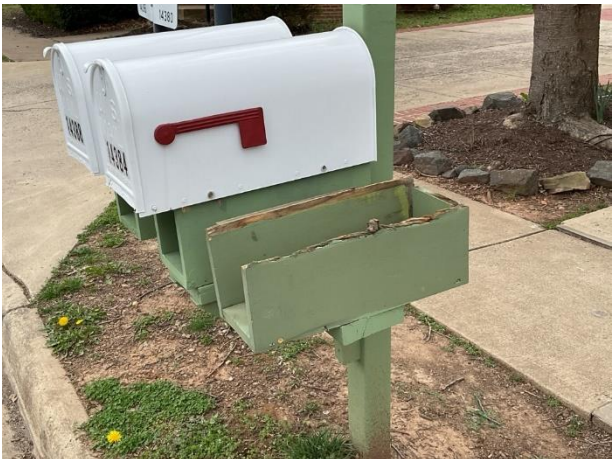
**Condition:** The cluster homes mailboxes are in fair to poor overall condition with missing mailboxes, wood rot, leaning mailboxes, wood split and rust evident. The mailbox stations at the townhomes are in good to fair overall condition with damage and fastener rust evident.

**Missing mailbox at cluster mailboxes**

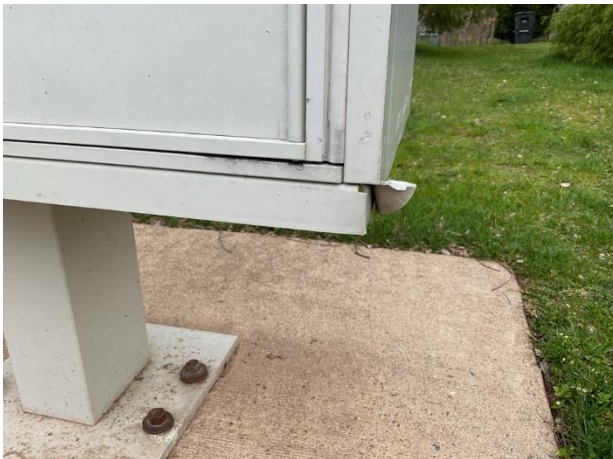
**Damaged station at townhome mailboxes**

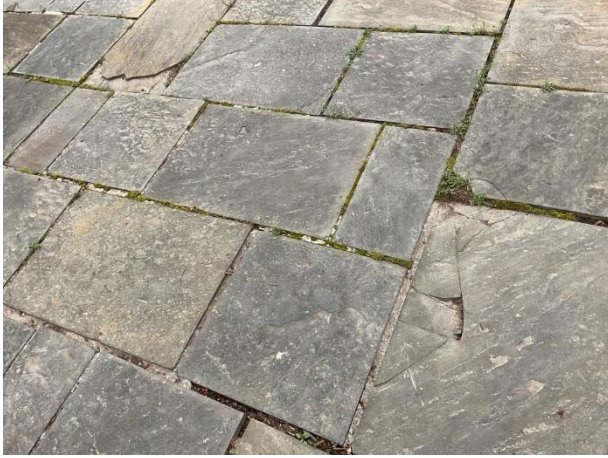
**Condition:** The bluestone pavers are in fair overall condition with broken stones, cracked stones and displaced pavers evident, and the masonry pavers are in good to fair overall condition with mortar deterioration, cracked masonry and organic growth evident.

**Cracked bluestone pavers**

- Annually:
  - Inspect and repair settlement, trip hazards and paver spalls at heavy traffic areas
  - Re-set and/or reseal damaged pavers as necessary
  - Periodically clean and remove overgrown vegetation as needed

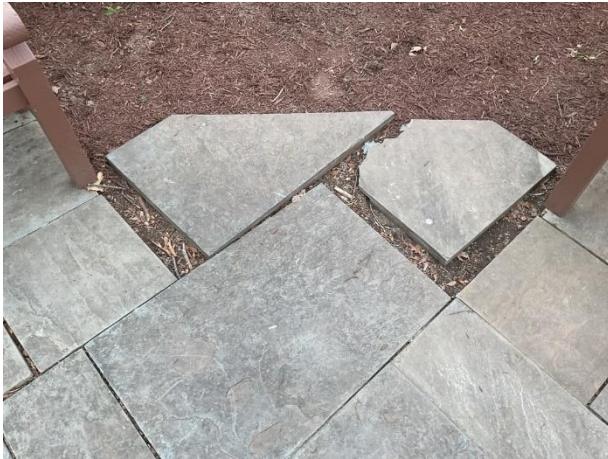
**Displaced bluestone paver**

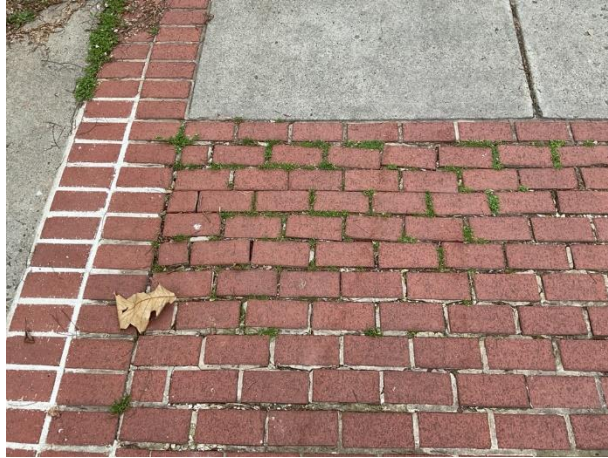
**Mortar deterioration and organic growth**

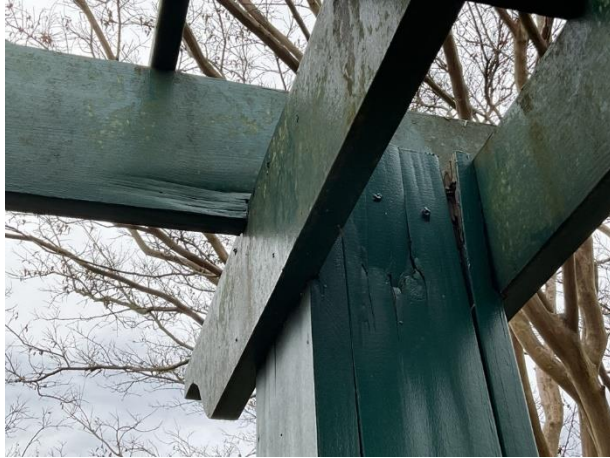
**Condition:** Fair overall with wood deterioration, wood split and warped boards evident.

**Wood deterioration at clubhouse**

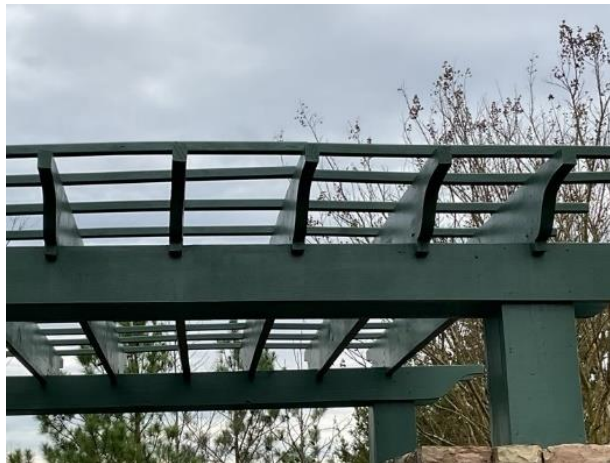
**Warped boards at Yellow Hammer Drive**

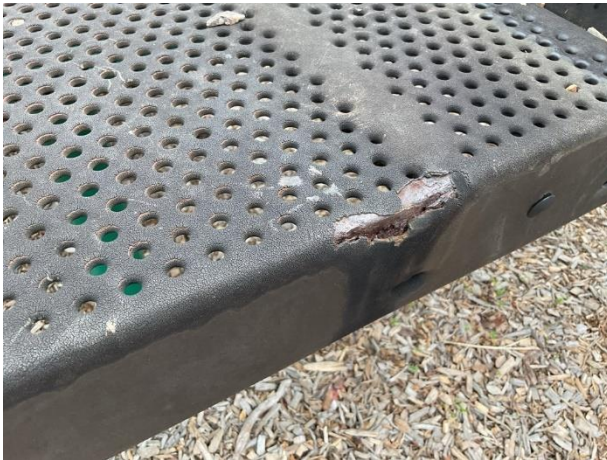
**Finish deterioration and rust at clubhouse playground**

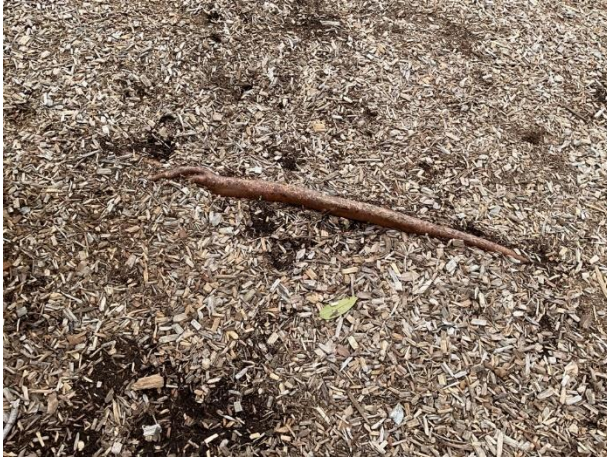
**Exposed tree root at clubhouse playground**

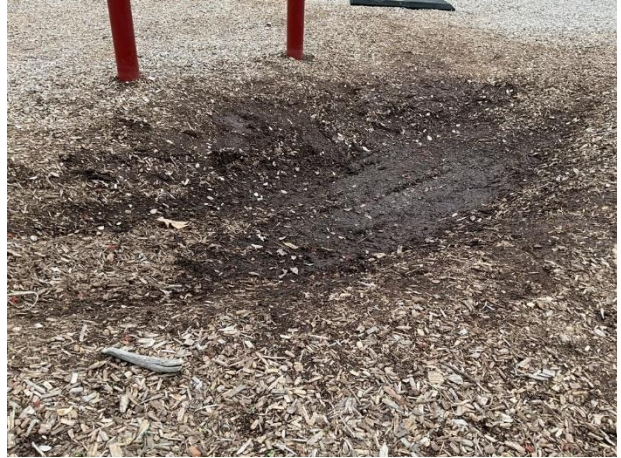
**Mulch depletion at clubhouse playground**

The Association plans to replenish the mulch at the playgrounds in 2024 funded outside of reserves. The playgrounds locations, ages and conditions can be found in the table below:

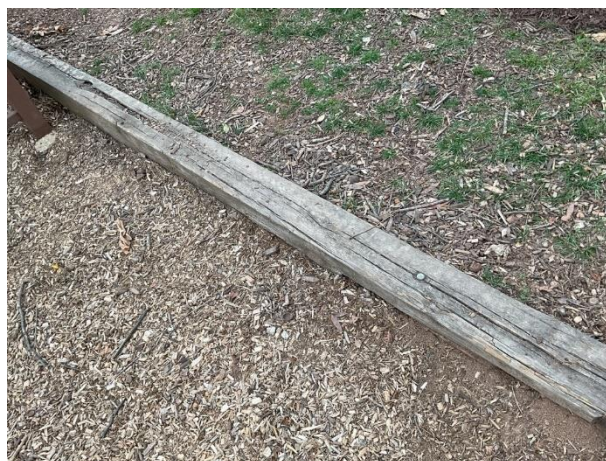
**Wood split and deterioration at Parula Way playground**

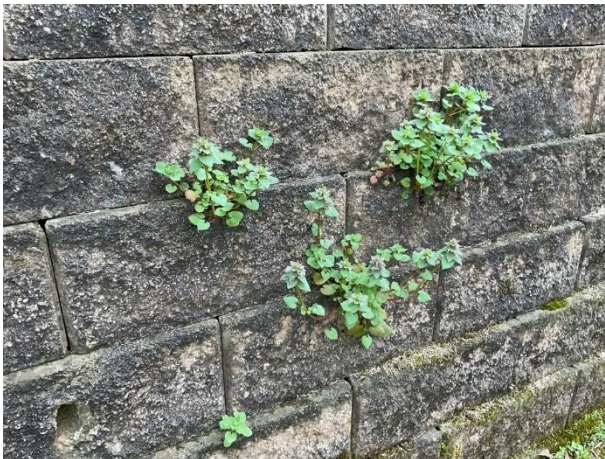
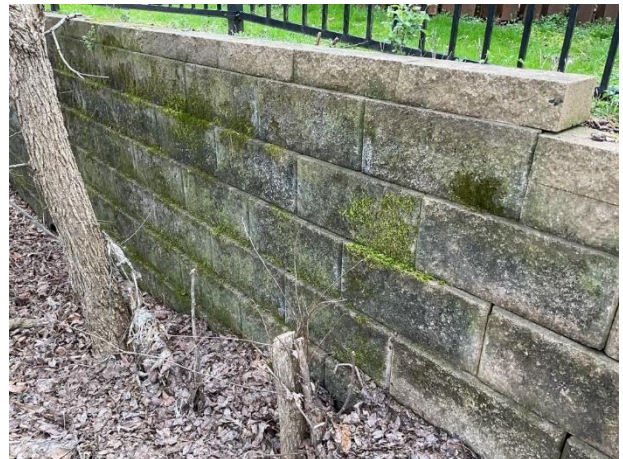
**Condition:** Good to fair overall with organic growth evident at the masonry retaining walls and missing stones at the stone retaining walls.

**Organic growth at the masonry retaining walls**

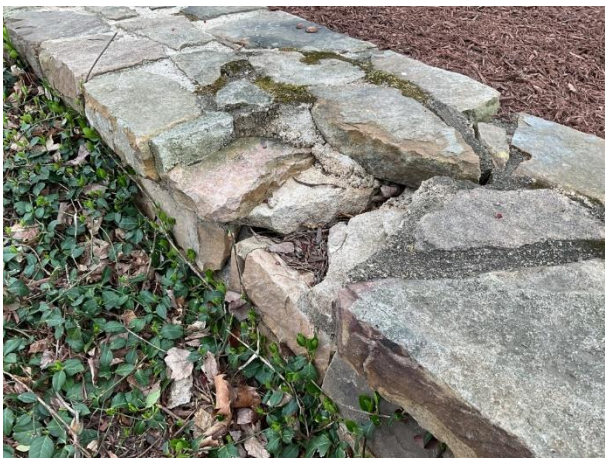
**Missing stones at the stone retaining walls**

**History:** The walls are original to 2006. The Association removed a tree impacting the masonry retaining wall in 2023 and plans to conduct repairs to the stone retaining walls in the near term funded outside of reserves.

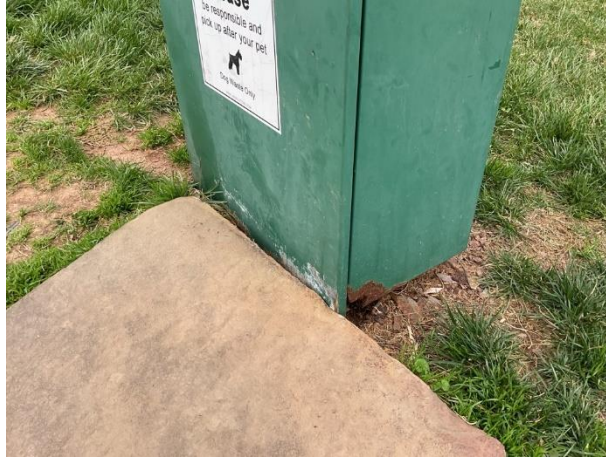
**Finish deterioration and rust evident**

**History:** Various ages. The Association painted the benches and trash receptacles in 2023 and plan to paint the dog waste stations in the near term funded outside of reserves.

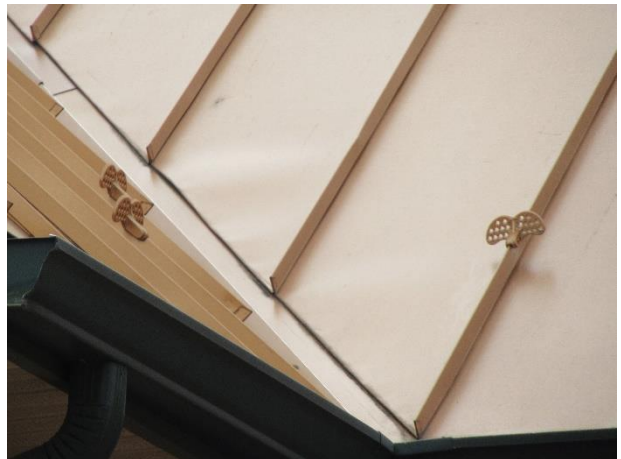
**Condition:** Good to fair overall with warped roofs evident. Management and the Board to not report a history of leaks.

**Warped roof overview**

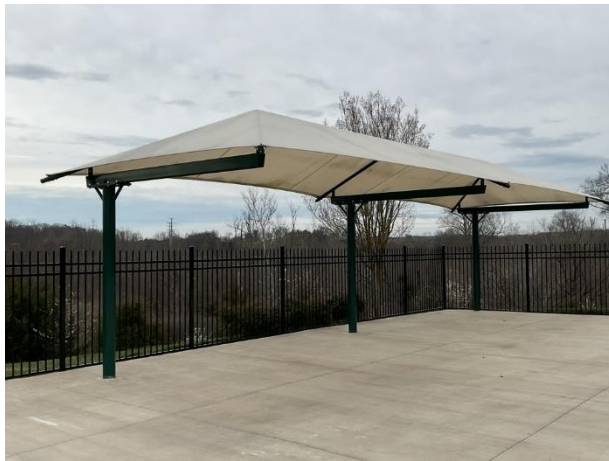
**Condition:** The structures are in good to fair overall condition with finish deterioration and rust evident, and the canvases are in fair overall condition with tears and organic growth evident.

Shade structure overview

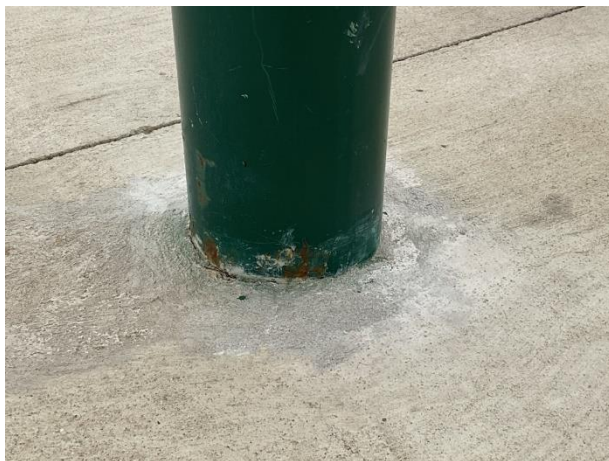
Finish deterioration and rust
