# FULL RESERVE STUDY

## Meadows at Morris Farm Community Association

**Gainesville, Virginia**

**August 28, 2018**

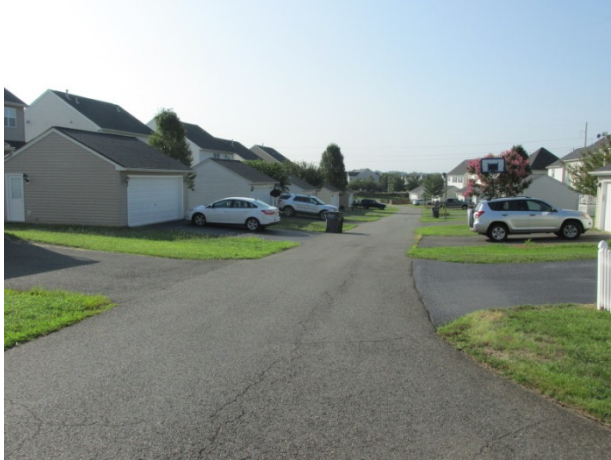
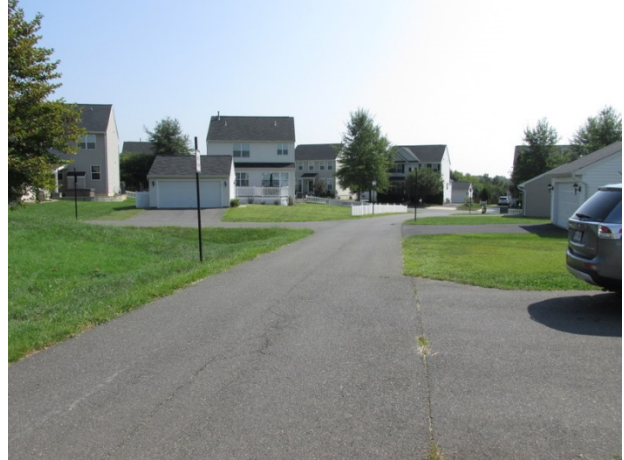
**Condition:** Good to fair overall with cracks evident at the alleys, and cracks and previous repairs evident at the streets and parking areas

**Alley overview**

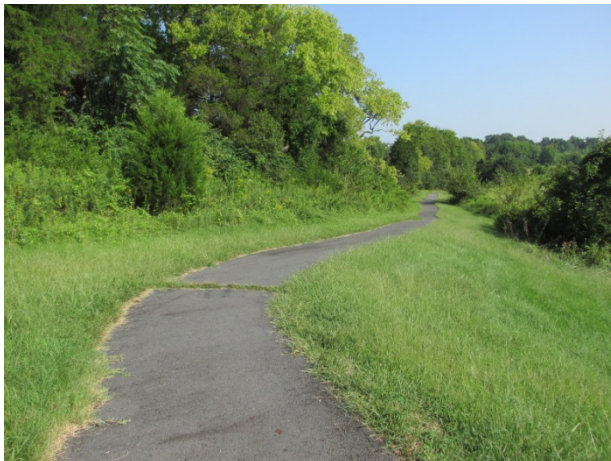
**Condition:** Good to fair overall with cracks and settlement evident

Walking path overview

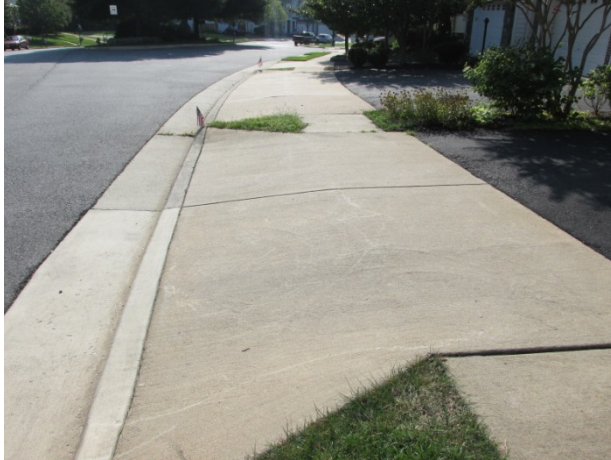
**Condition:** Good overall with isolated cracks evident

**Concrete apron**

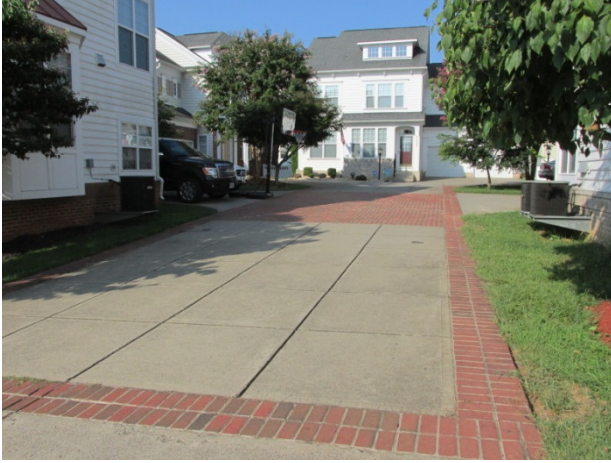
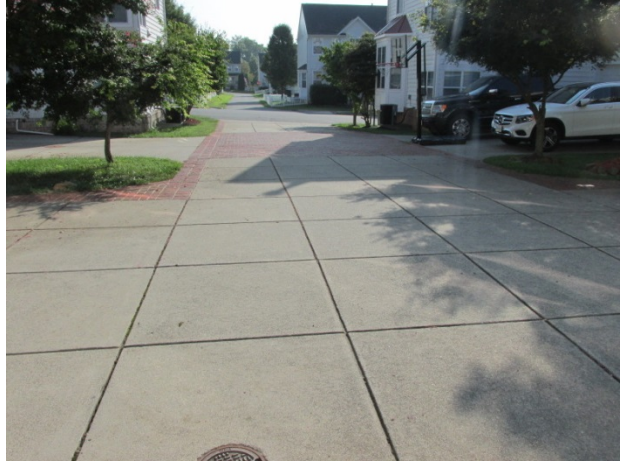
**Condition:** Good to fair overall with spall, cracks and mortar deterioration evident

**Driveway overview**

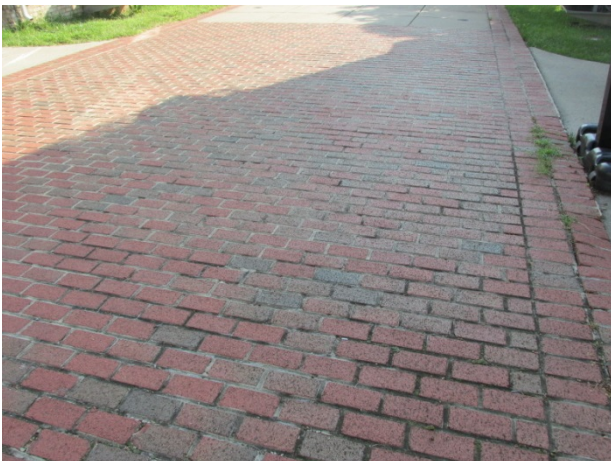
**Masonry pavers**

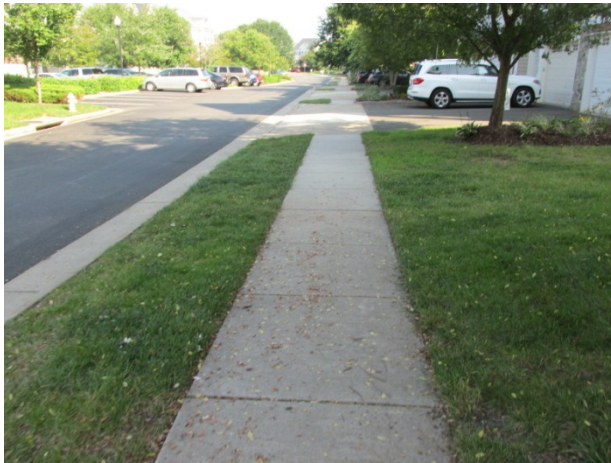
**Condition:** Good to fair overall with spall, deterioration and cracking evident

Concrete sidewalk

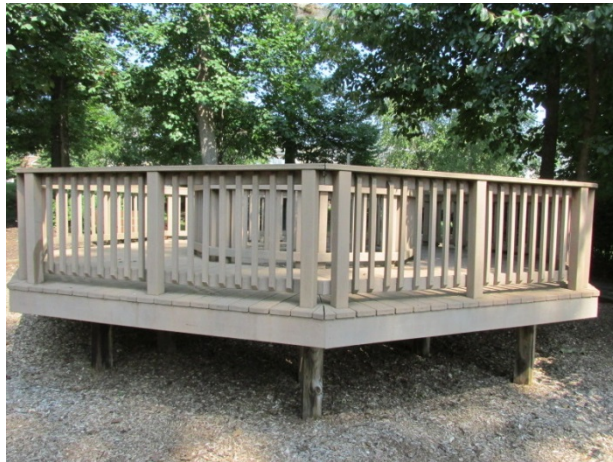
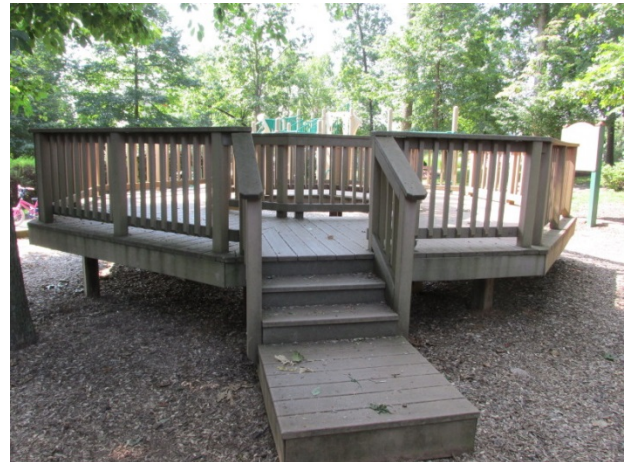
**Condition:** Good overall

Deck overview

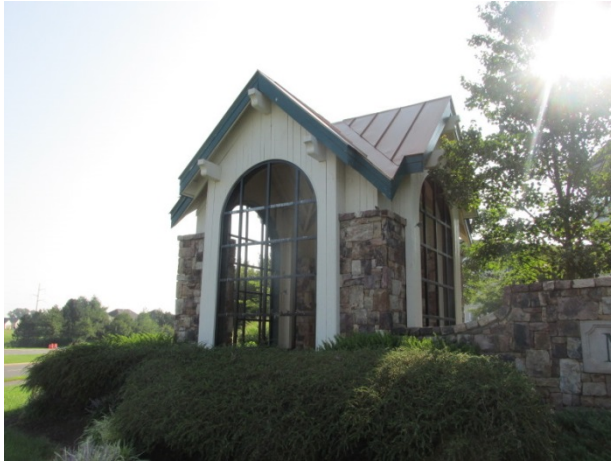
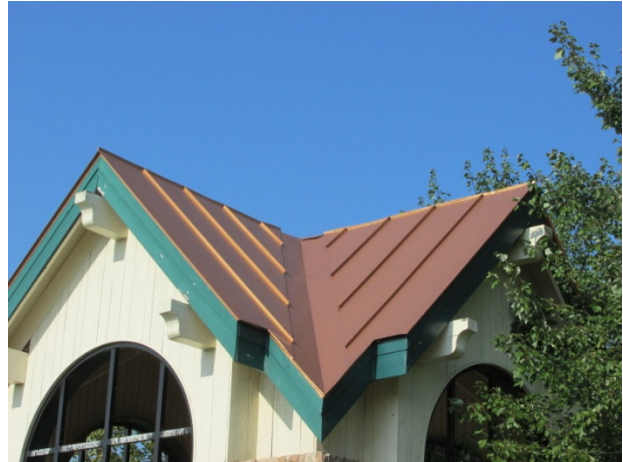
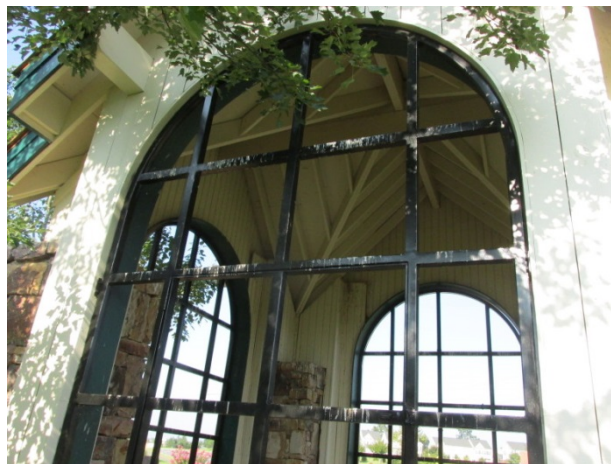
**Condition:** Good overall

**Entrance structure**

**Metal roof**

**Steel bars**

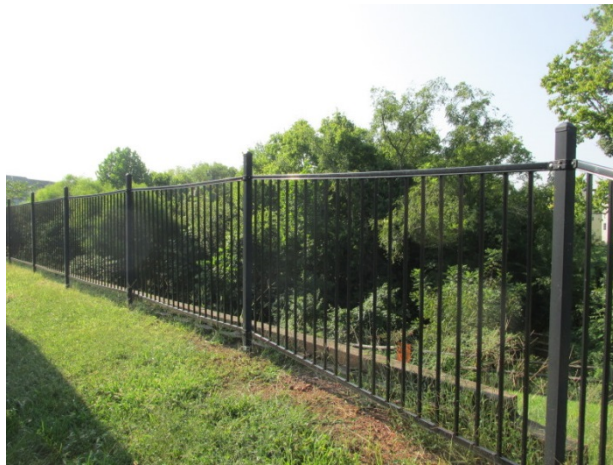
**Condition:** Good overall with isolated damage evident

Aluminum fence

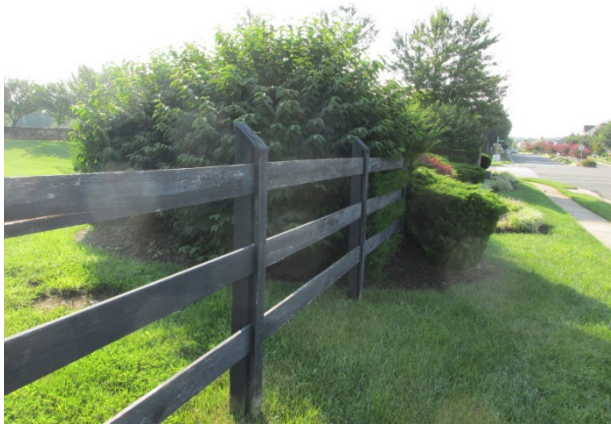
**Condition:** The open rail fences are in fair overall condition with damage and displacements evident. The split rail fences are in good overall condition.

**Open rail fence**

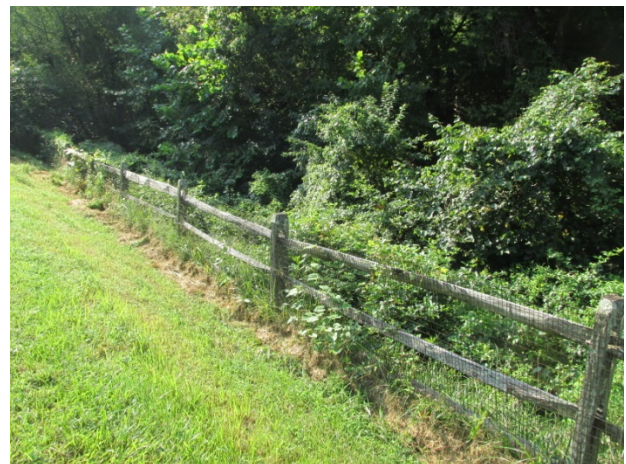
**Split rail fence**

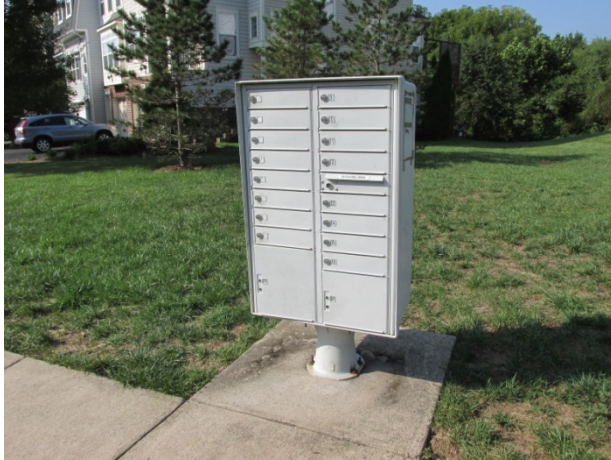
**Condition:** Good to fair overall with finish deterioration and fastener rust evident

**Mailbox station**

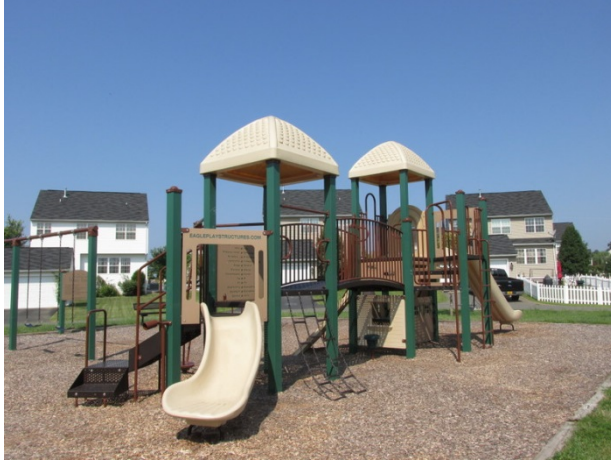
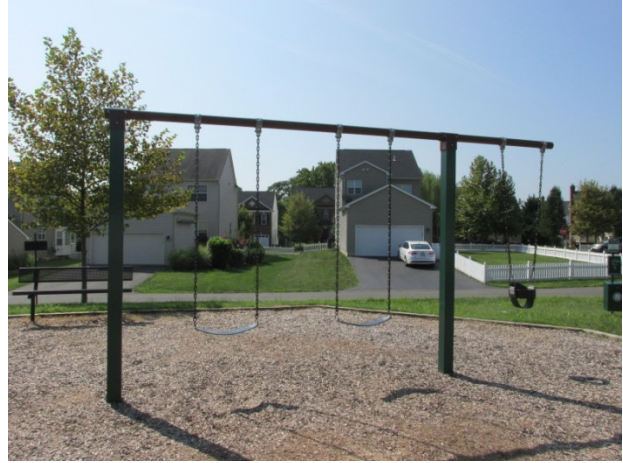
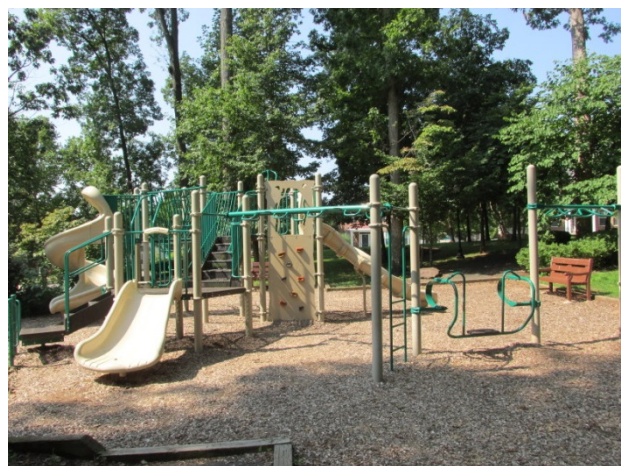
**Condition:** Good to fair overall minor scratches and scuff marks evident

**Playground equipment at Brown Thrasher Court**

**Playground equipment at clubhouse**

**Playground equipment at Parula Way**

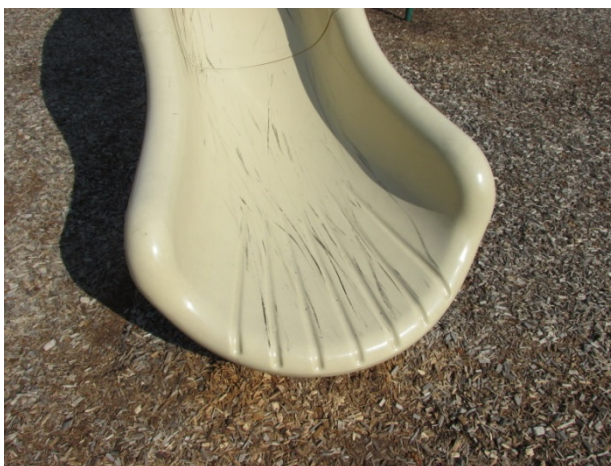
**Scratches and scuff marks at clubhouse playground slide**

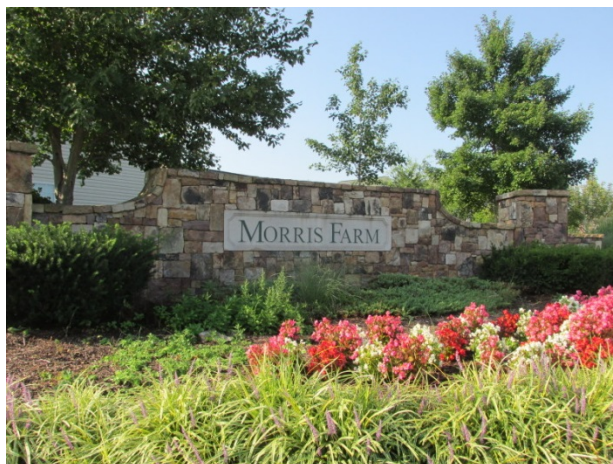
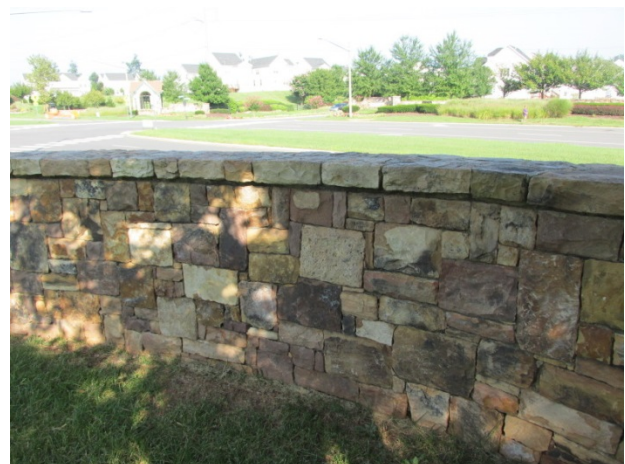
**Condition:** Good to fair overall with missing masonry blocks evident

**Entrance monument overview**

**Masonry wall**

**Arbor and masonry wall at Parula Park**

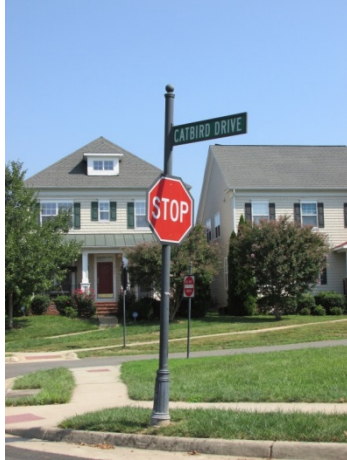
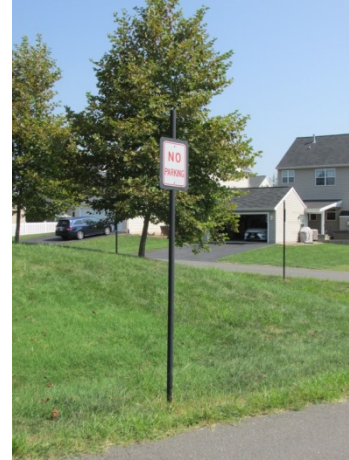
**Condition:** Good overall

Typical signage

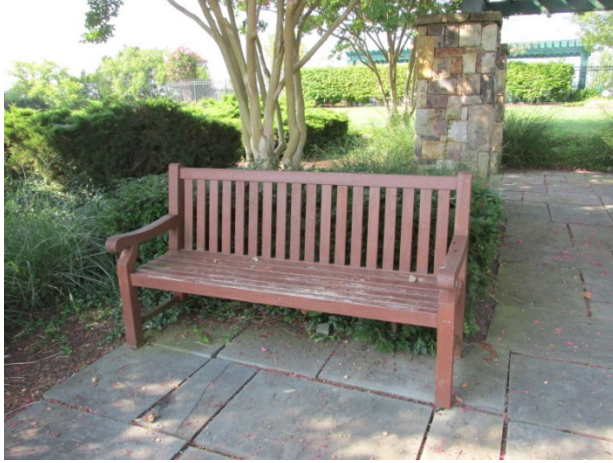
**Condition:** Good to fair overall with finish deterioration evident

**Site furniture**

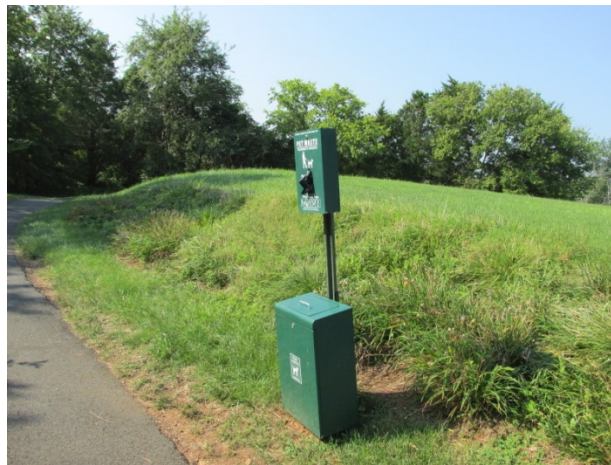
**Pet waste station**

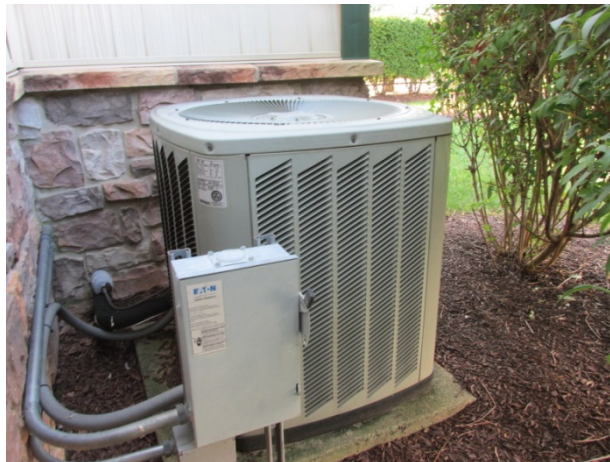
**Condition:** Reported satisfactory

Condensing unit

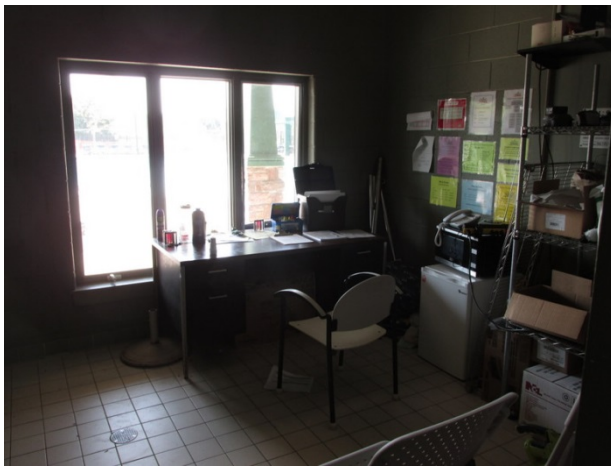
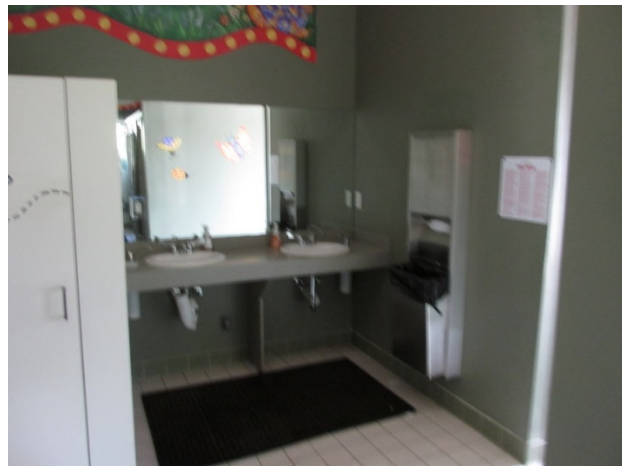
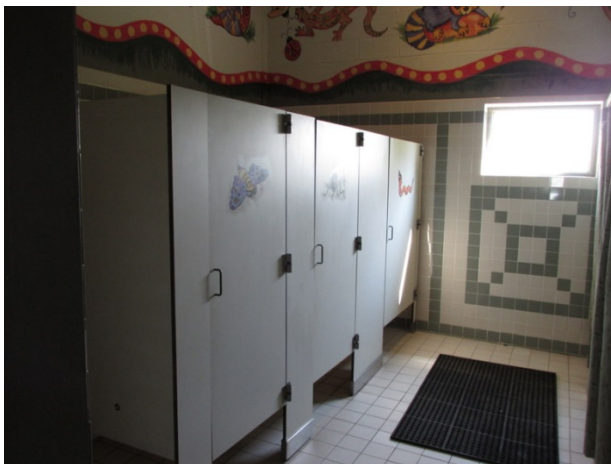
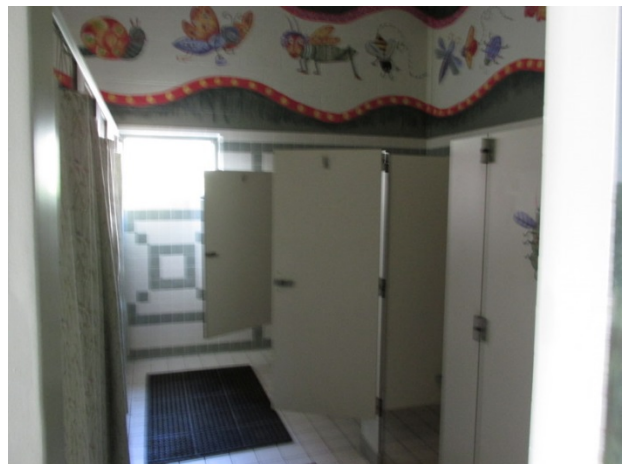
**Condition:** Good overall however; Management informs us the Association plans to renovate the clubhouse interior in the near term.

Clubhouse interior

**Expenditure Detail Notes:** Expenditure timing and costs are depicted in the **Reserve Expenditures** table in Section 3. The complete renovation should include replacement of all the interior components listed above. We recommend the Association budget for interim renovations through the operating budget as needed.

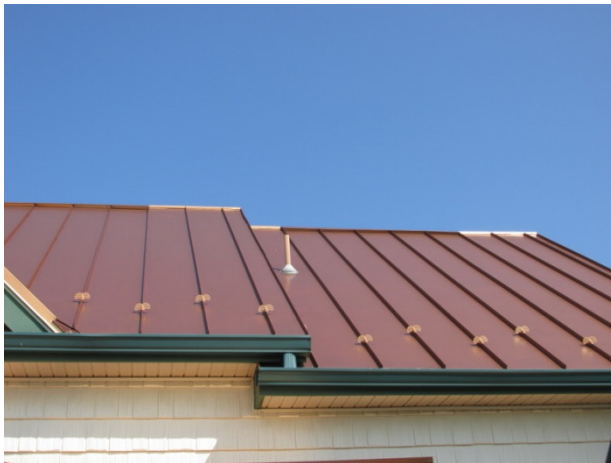
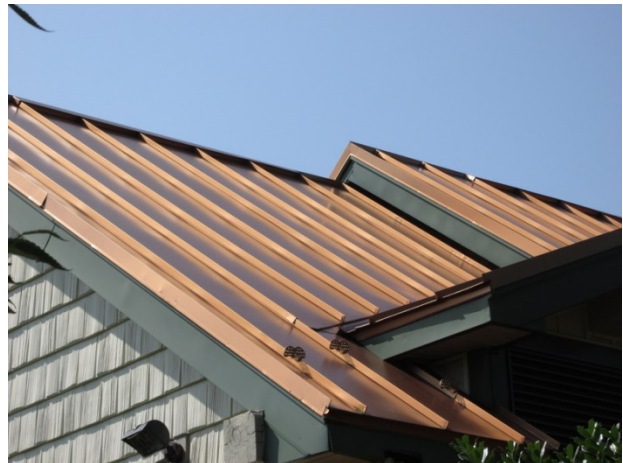
**Condition:** Good overall. Management does not report a history of leaks.

**Metal roof**

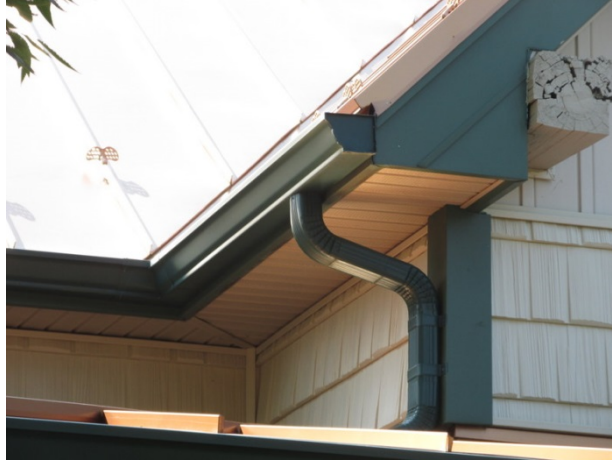
**Aluminum gutter and downspout assembly**

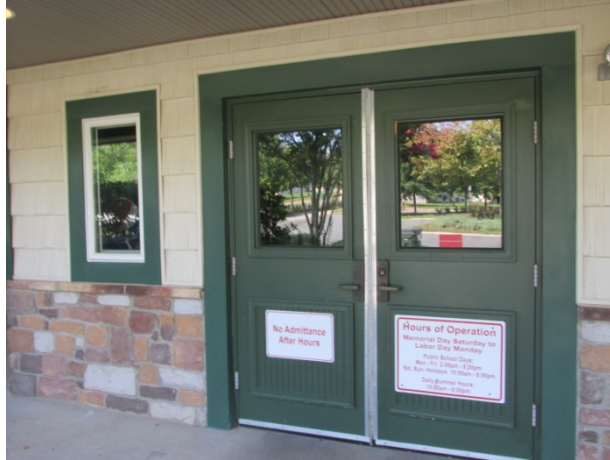
**Condition:** Good overall

**Clubhouse doors and window**

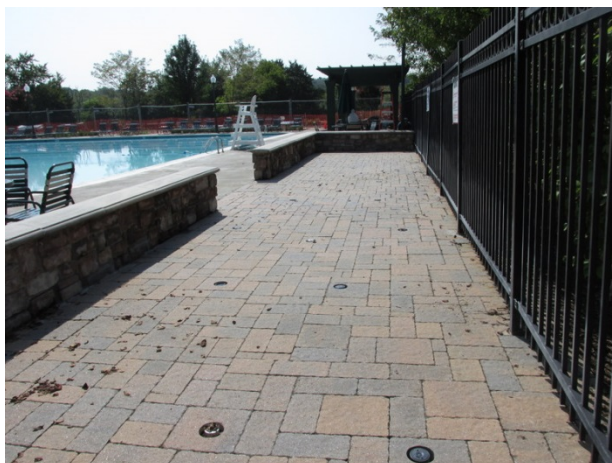
**Condition:** Good to fair condition with cracks evident

**Pavers and fountain system**

- Selective cut out and replacements of up to ten percent (10%) of concrete
- Crack repairs as needed
- Mortar joint repairs
- Caulk replacement
- Resetting of the masonry pavers with replacement of up to ten percent (10%)

**Expenditure Detail Notes:** Expenditure timing and costs are depicted in the **Reserve Expenditures** table in Section 3. We recommend the Association budget for replacement and repairs to the fountain system through the operating budget as needed.

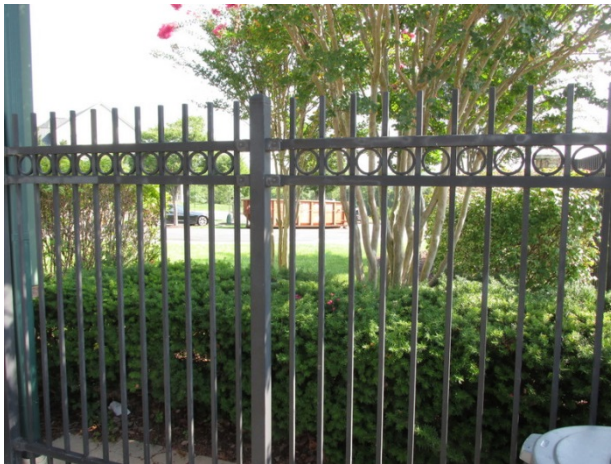
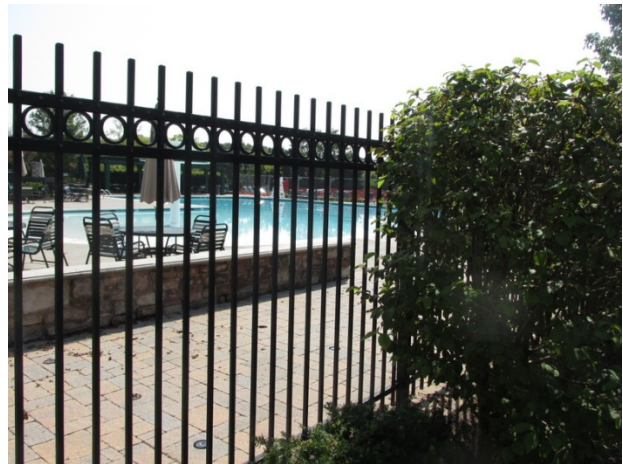
**Condition:** Good overall

Aluminum fence

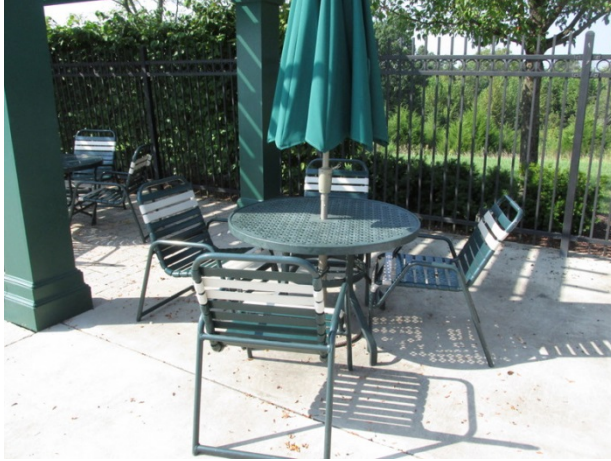
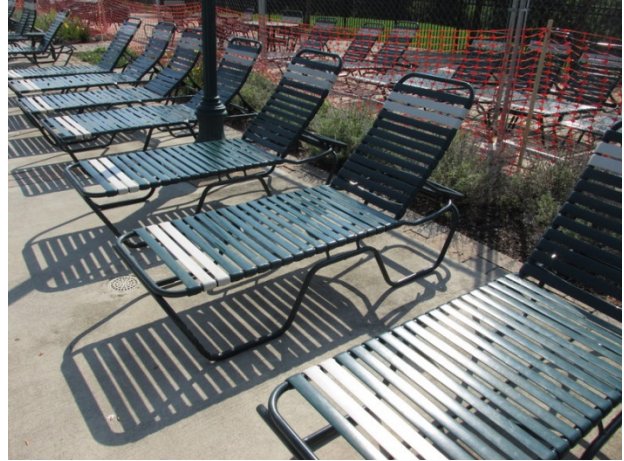
**Condition:** Varying from good to fair overall

**Pool furniture**

**Expenditure Detail Notes:** Expenditure timing and costs are depicted in the **Reserve Expenditures** table in Section 3. We recommend interim re-strapping, refinishing, cushion replacements, reupholstering and other repairs to the furniture as normal maintenance to maximize its useful life.

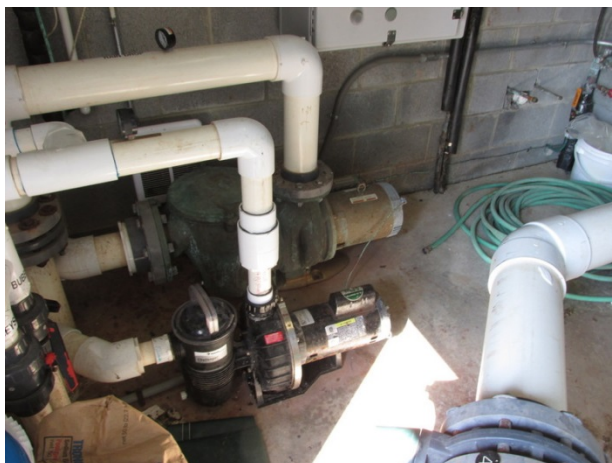
**Condition:** Reported satisfactory

**Main pool filter**

**Pumps**

**Wading pool mechanical equipment**

**Expenditure Detail Notes:** Expenditure timing and costs are depicted in the **Reserve Expenditures** table in Section 3. Failure of the pool mechanical equipment as a single event is unlikely. Therefore, we include replacement of up to thirty-three percent (33%) of the equipment per event. We consider interim replacement of motors and minor repairs as normal maintenance.

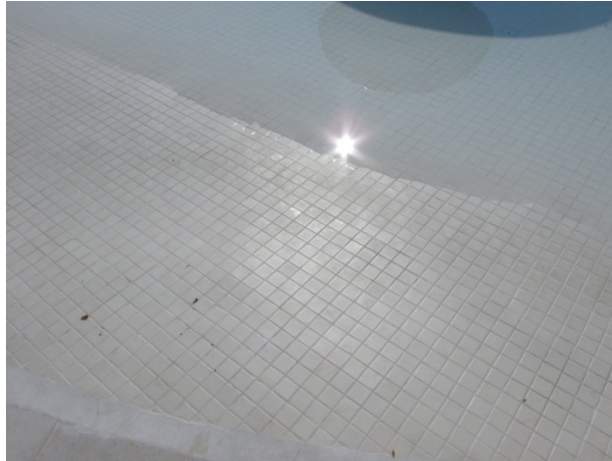
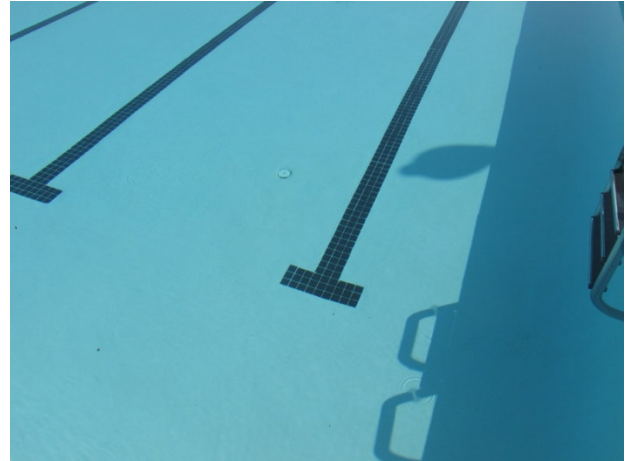
**Condition:** Good overall

**Tile at pool entry**

**Swim lane tile**

- Removal and replacement of the plaster finishes
- Partial replacements of the scuppers and coping as needed
- Replacement of tiles as needed
- Replacement of joint sealants as needed
- Concrete structure repairs as needed

**Expenditure Detail Notes:** Expenditure timing and costs are depicted in the **Reserve Expenditures** table in Section 3. We recommend the Association budget for full tile replacement every other plaster replacement event.

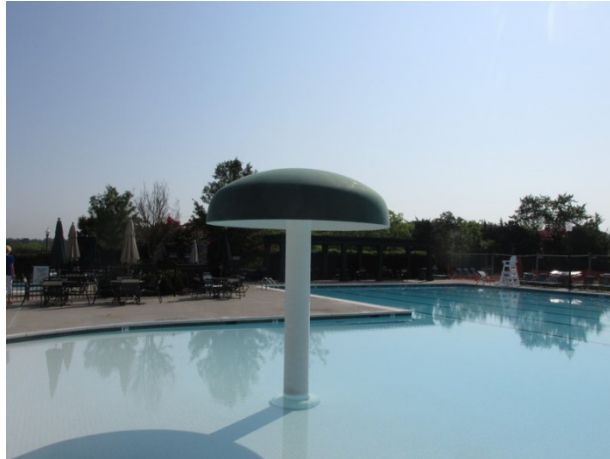
**Conditions:** Reported satisfactory

**Water feature**
