# Meadows at Morris Farm Community Association

March 15, 2024 • Gainesville, VA

RESERVE STUDY

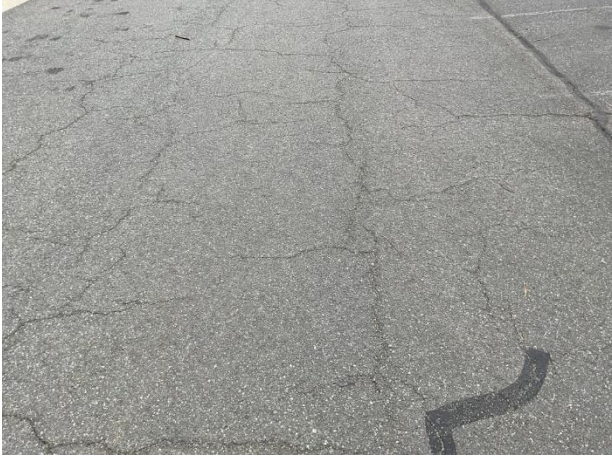
Cracks and prior repairs at the clubhouse parking area

**Component Detail Notes:** Proposals should include mechanically routing and filling all cracks with hot emulsion. Repairs should also include patching at areas exhibiting settlement, potholes, or excessive cracking. The contractor should only apply seal coat applications after repairs are completed. A seal coat does not bridge or close cracks, therefore, unrepaired cracks render the seal coat applications useless. These activities minimize the damaging effects of vehicle fluids, maintain a uniform and positive appearance, and maximize the useful life of the pavement.

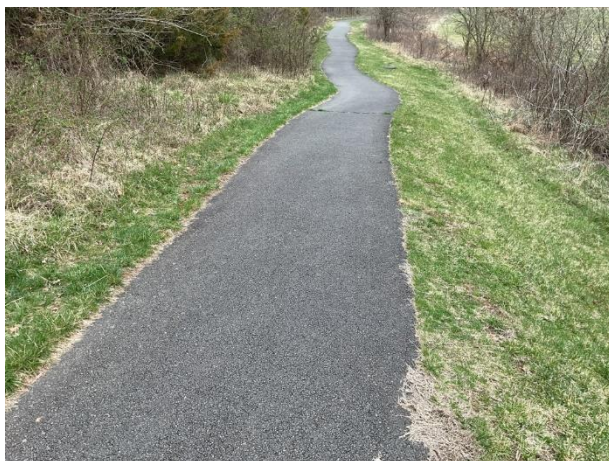
**Condition:** Varying from fair to poor overall with cracks, edge deterioration, organic grow and heaving evident.

**Walking path overview**

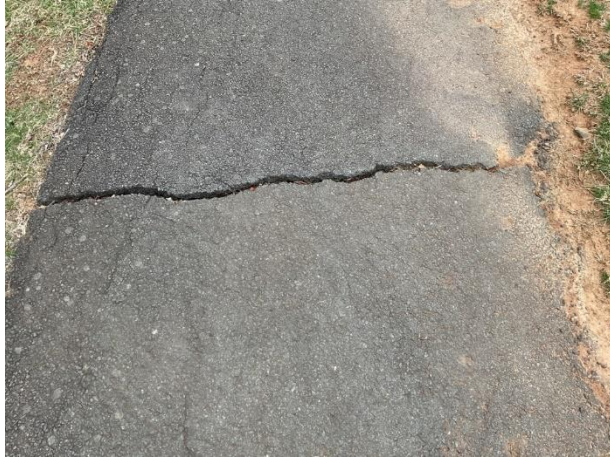
**Pavement cracks**

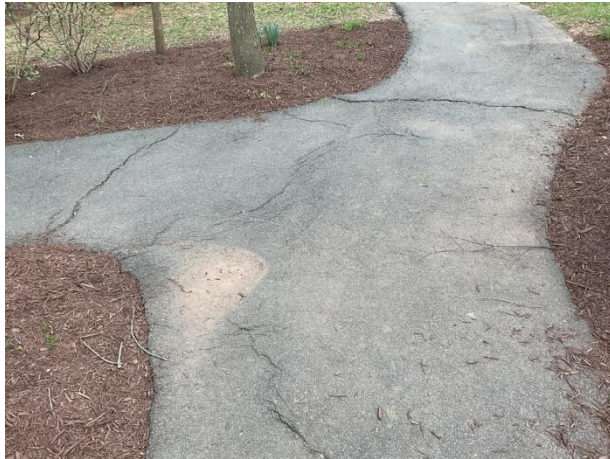
**Pavement cracks**

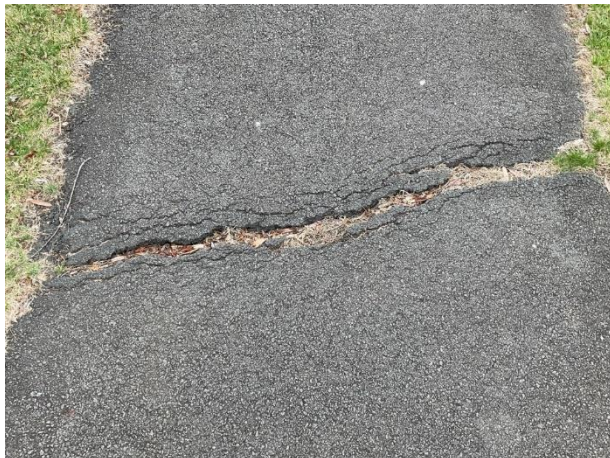
**Pavement cracks**

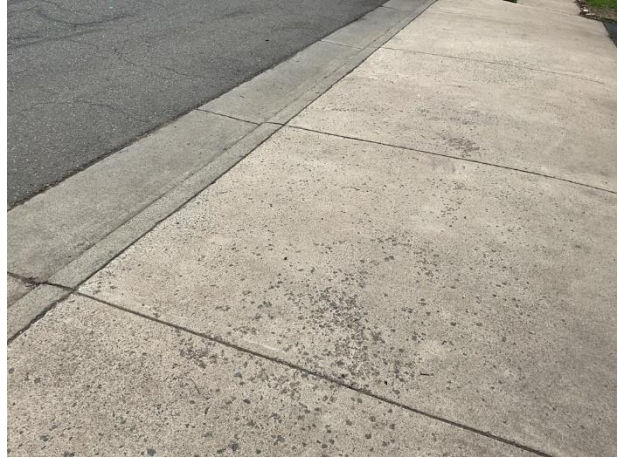
**Scaling**

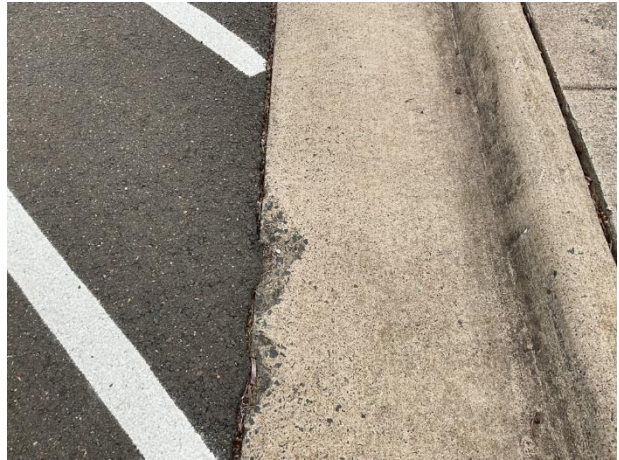
Concrete damage

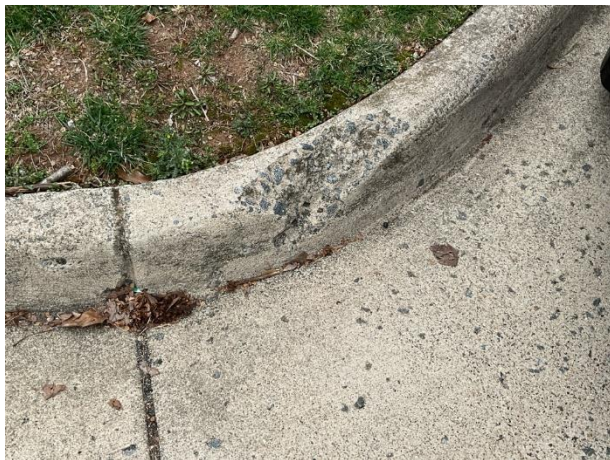
Concrete damage

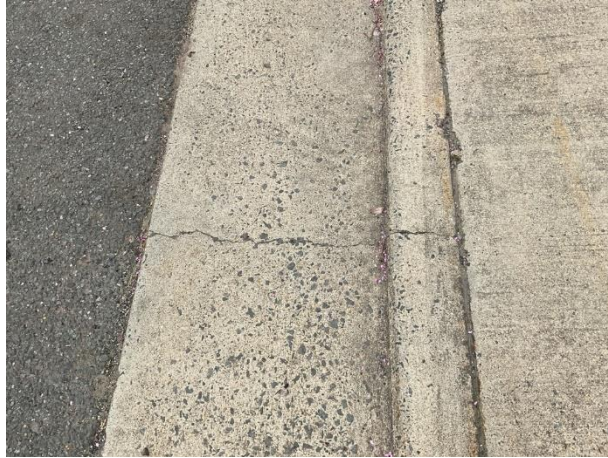
**Concrete crack**

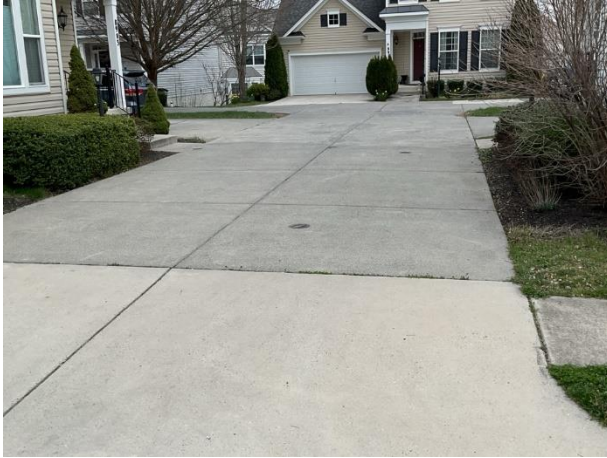
**Condition:** Fair overall with cracks, undermining, damage and scaling evident.

**Concrete driveway overview**

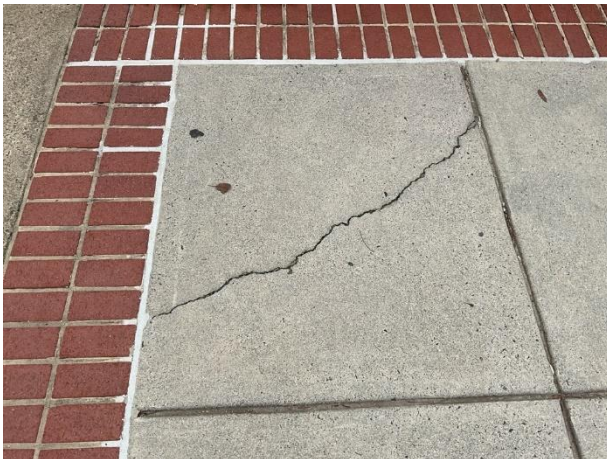
**Concrete crack**

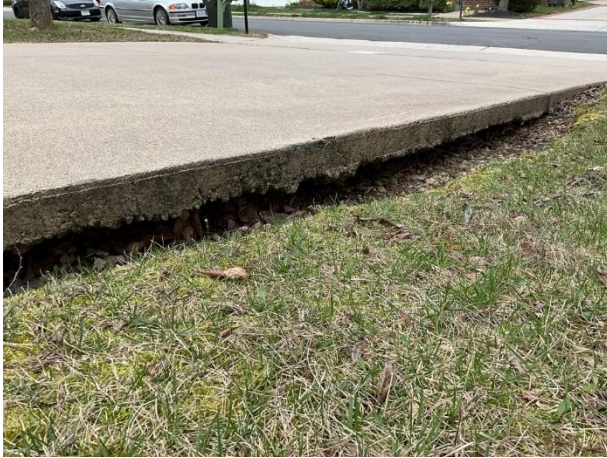
**Undermining**

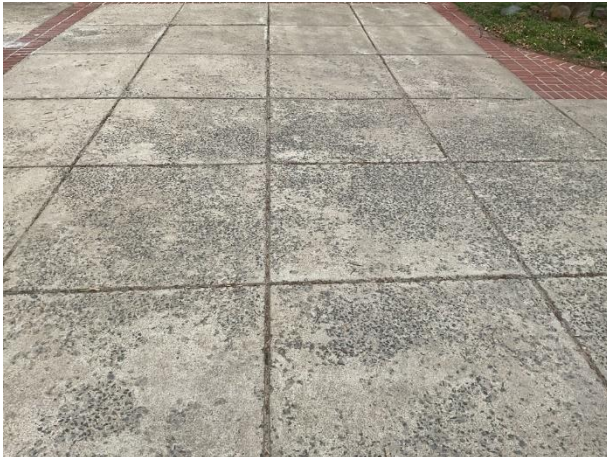
**Scaling**

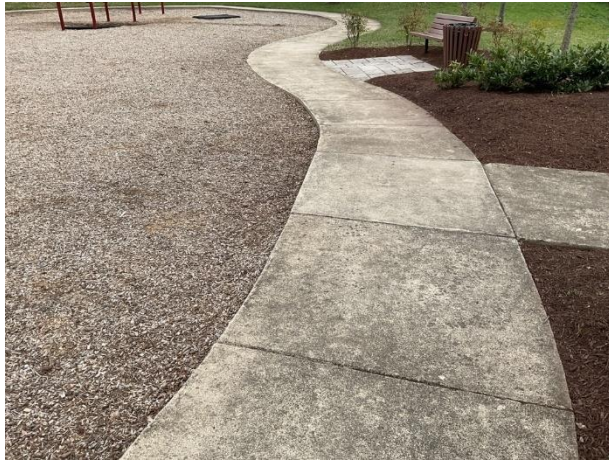
**Condition:** Good to fair overall with scaling and heaving evident

**Sidewalk overview**

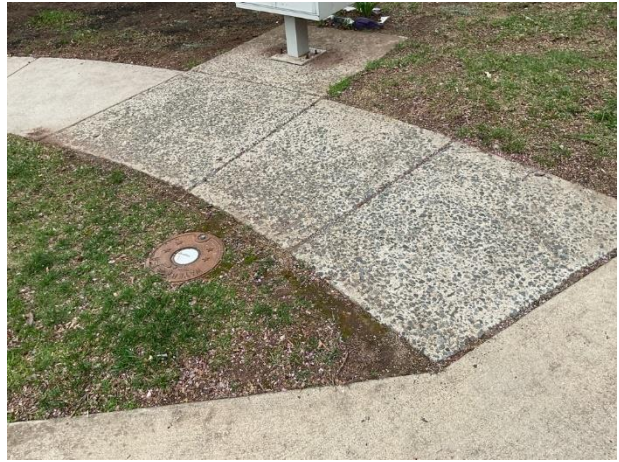
**Scaling**

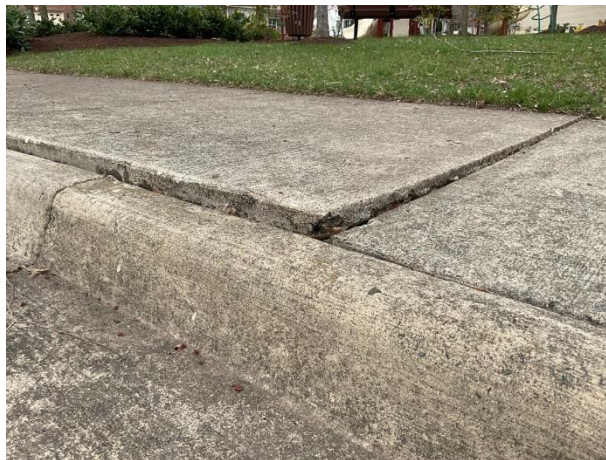
**Heaving**

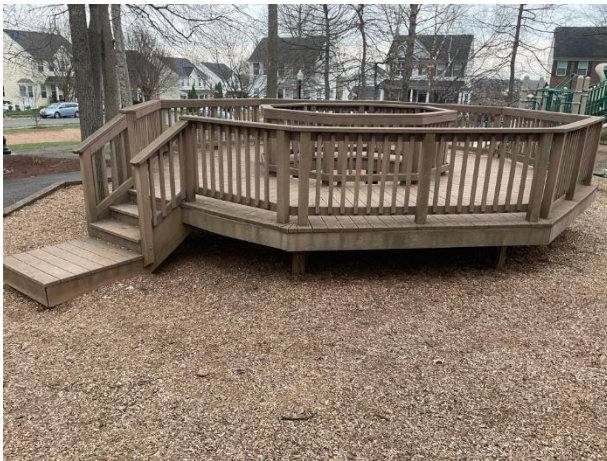
**Condition:** Good to fair overall with railing deterioration, wood split and organic growth evident.

Deck overview

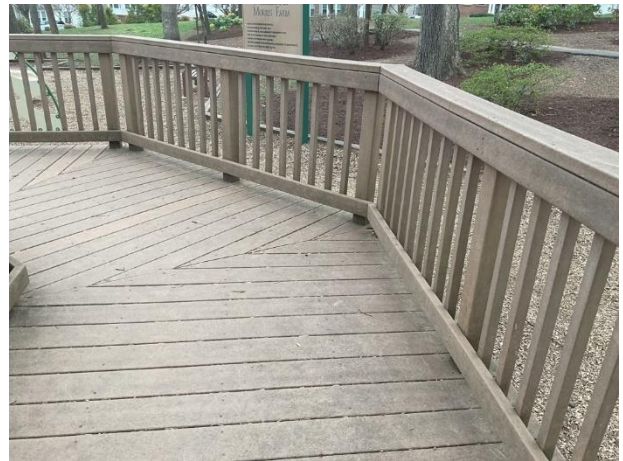
Railings overview

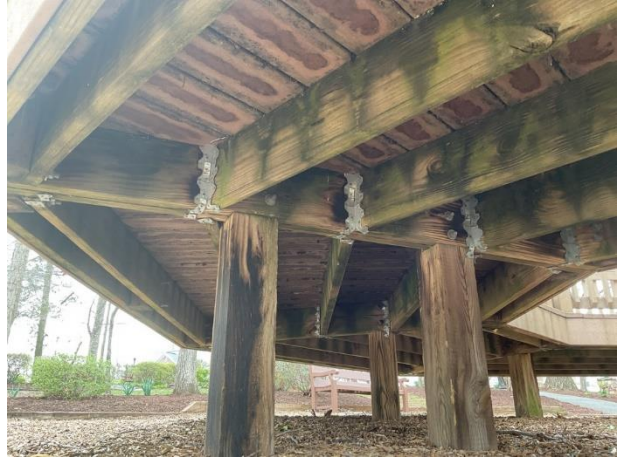
**Structure overview**

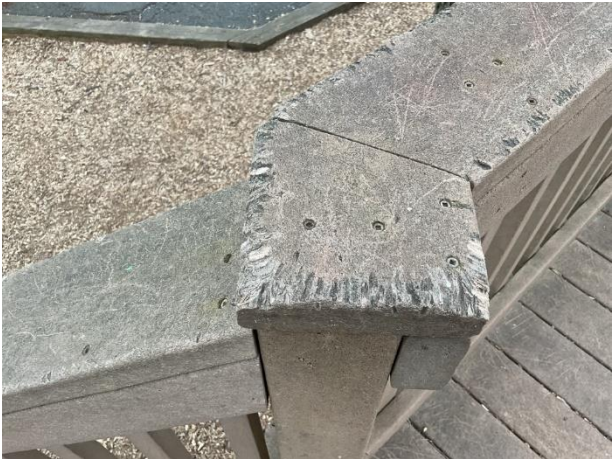
**Railing deterioration**

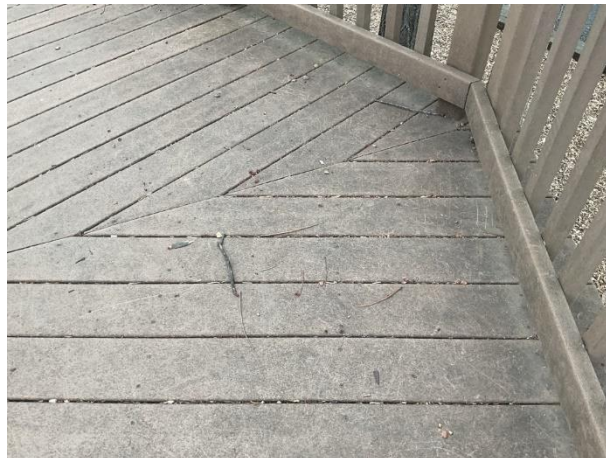
**Organic growth**

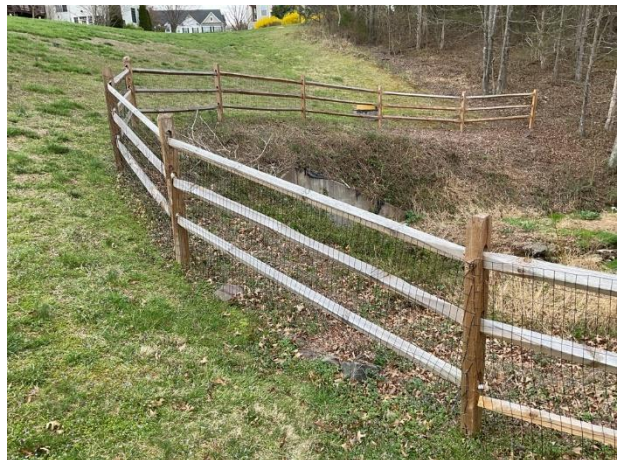
Split rail fence overview

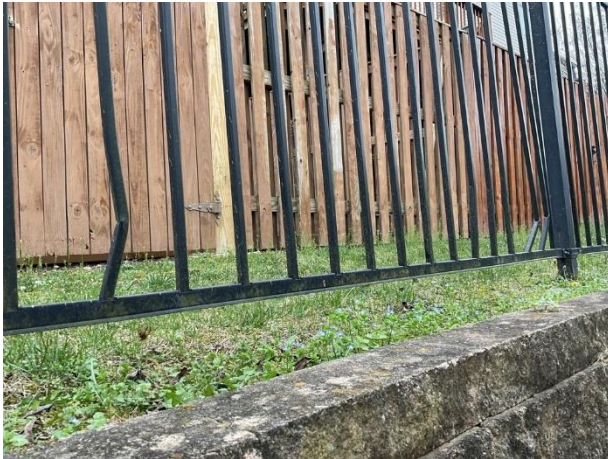
**Condition:** Fair overall with damaged pickets, damaged rail and leaning sections evident.

**Damaged pickets**

- Annually:
  - Inspect and repair loose fasteners or sections, and damage
  - Repair leaning sections and clear vegetation from fence areas which could cause damage

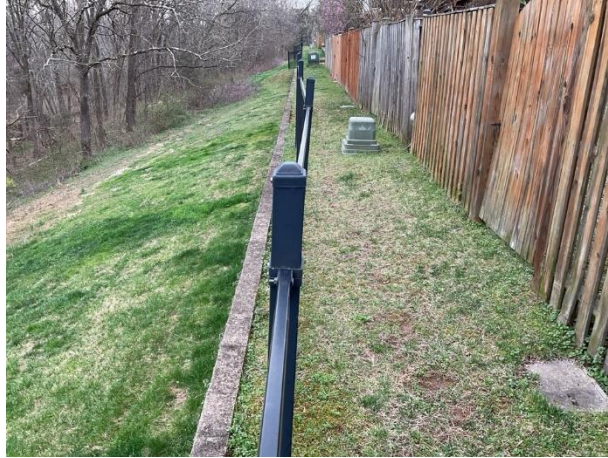
**Leaning fence**

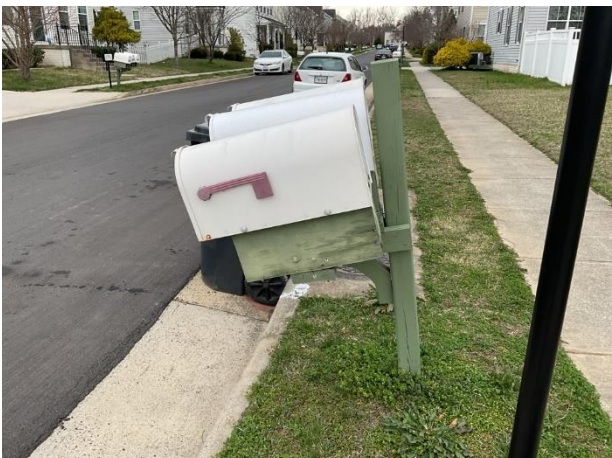
**Condition:** The cluster homes mailboxes are in fair to poor overall condition with missing mailboxes, wood rot, leaning mailboxes, wood split and rust evident. The mailbox stations at the townhomes are in good to fair overall condition with damage and fastener rust evident.

**Leaning mailboxes at cluster mailboxes**

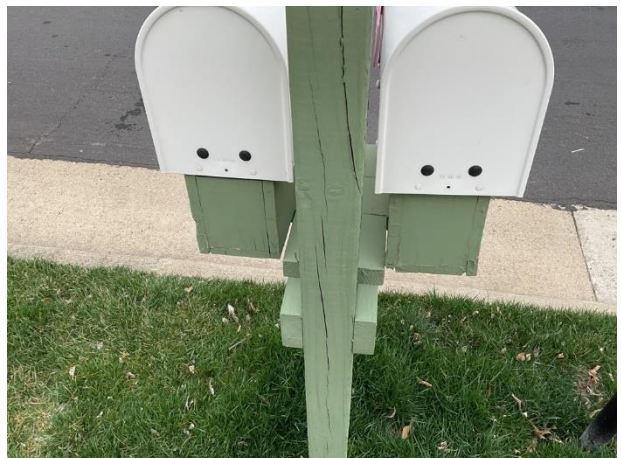
**Wood split at cluster mailboxes**

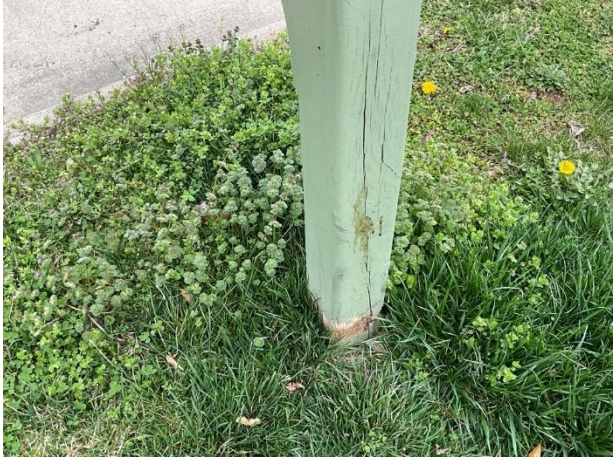
**Wood split at cluster mailboxes**

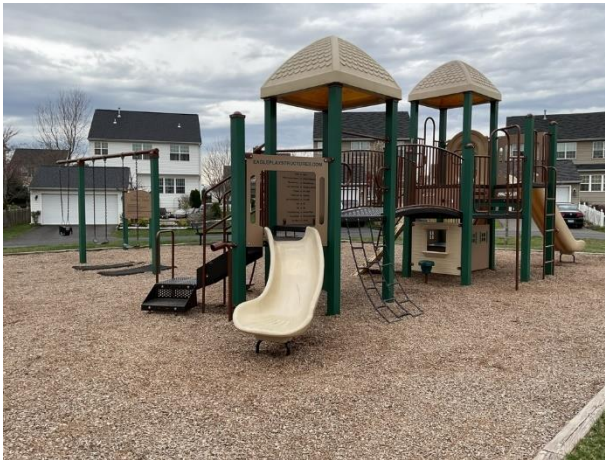
Playground equipment at Brown Thrasher Court

| Location | Year Installed | Condition |
|---|---|---|
| Brown Thrasher Court | 2016 | Good to fair overall with mulch depletion, exposed rocks and wood deterioration evident |

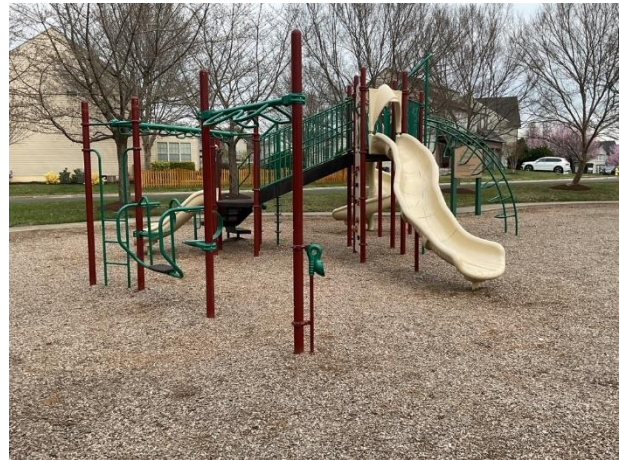
| Location | Year Installed | Condition |
|---|---|---|
| Clubhouse | 2008 | Fair to poor overall with finish deterioration, rust, exposed tree roots and mulch depletion evident |

Playground equipment at clubhouse

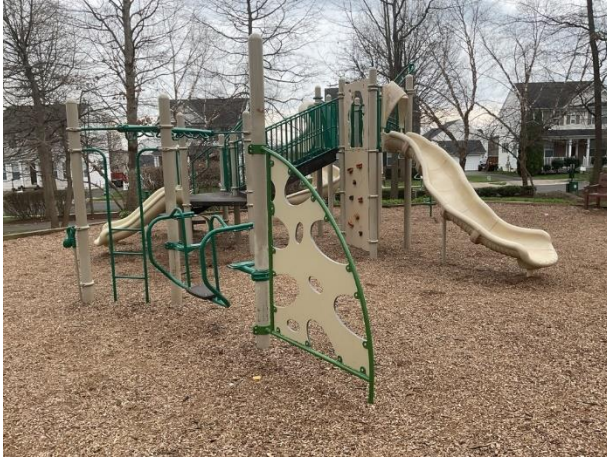
| Location | Year Installed | Condition |
|---|---|---|
| Parula Way | 2008 | Fair overall with puppet rust, finish deterioration, wood split and deterioration evident |

**Playground equipment at Parula Way**

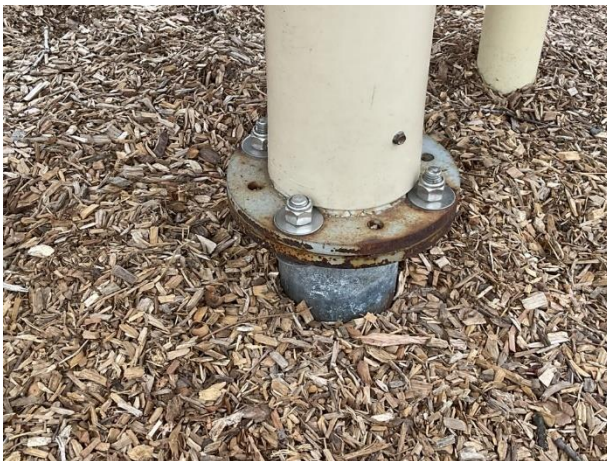
**Support rust at Parula Way playground**

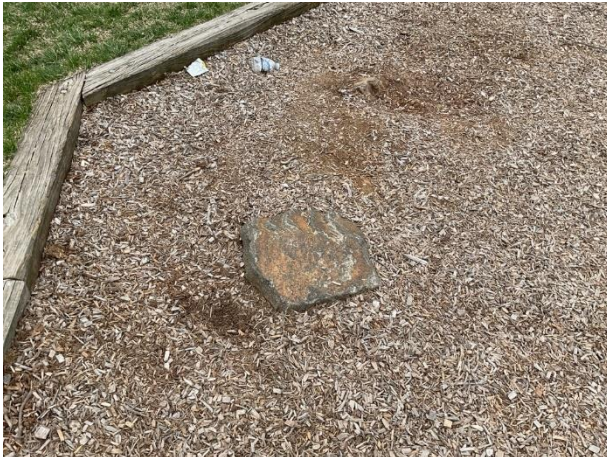
**Mulch depletion and exposed rock at Brown Thrasher Court playground**

The Association plans to replenish the mulch at the playgrounds in 2024 funded outside of reserves. The playgrounds locations, ages and conditions can be found in the table below:

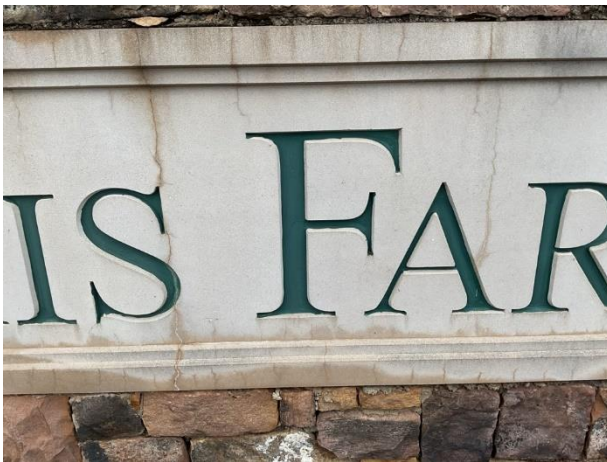
**Condition:** Good to fair overall with sign cracks, missing stones and cracked stones evident

Sign cracks

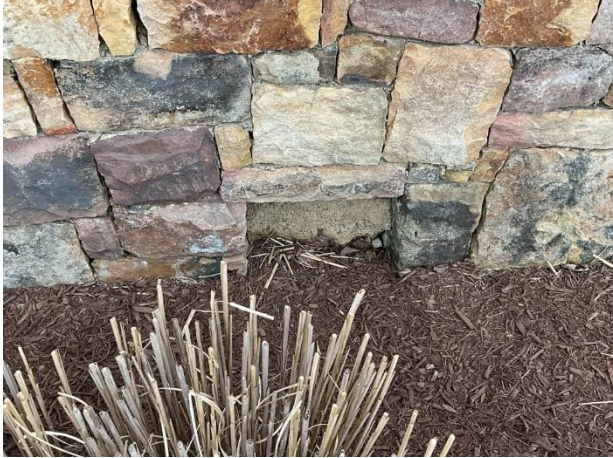
**Missing stone**

- Landscaping as needed
- Repairs to the stone facade
- Replacement of the concrete signs
- Replacement of the light fixtures
- Replacement of the wood arbors

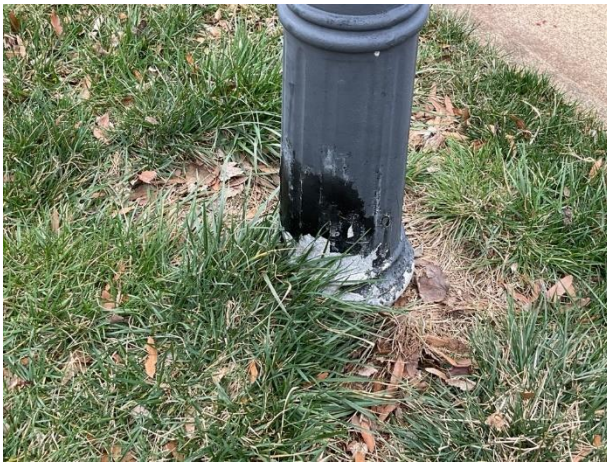
**Finish deterioration**

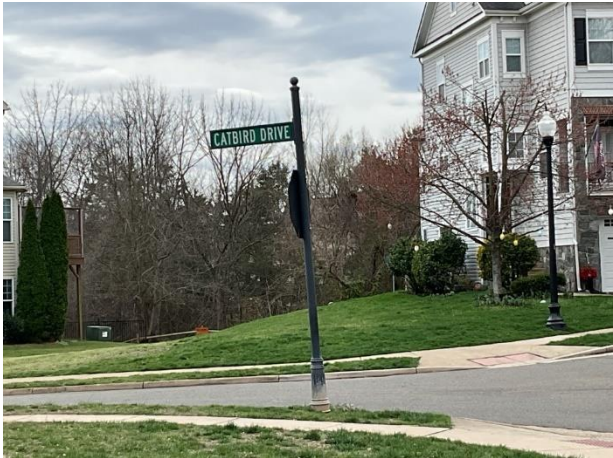
**Leaning sign**

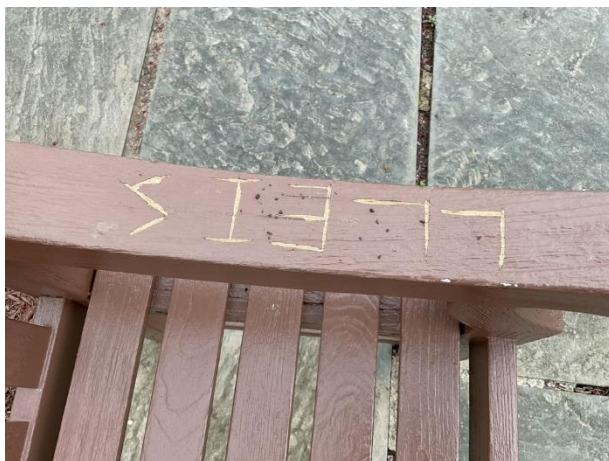
**Vandalized furniture**

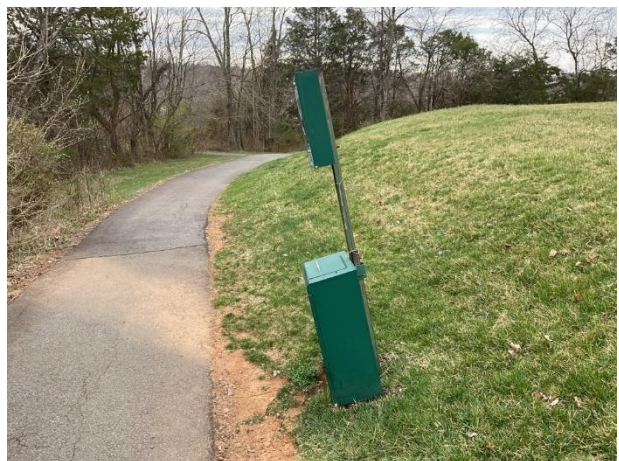
**Leaning dog waste station**

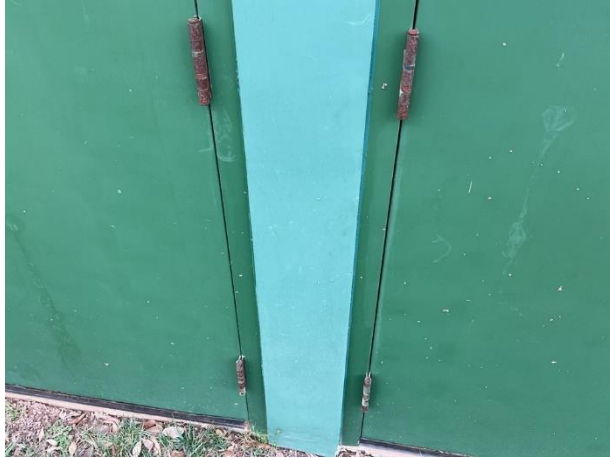
**Condition:** Good to fair overall with hinge rust

**Hinge rust**

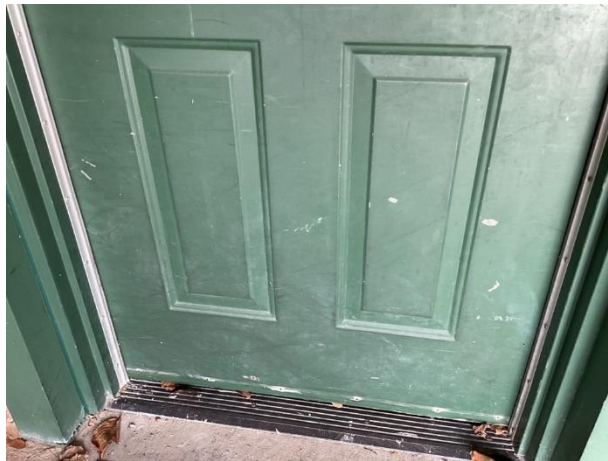
**Finish deterioration**

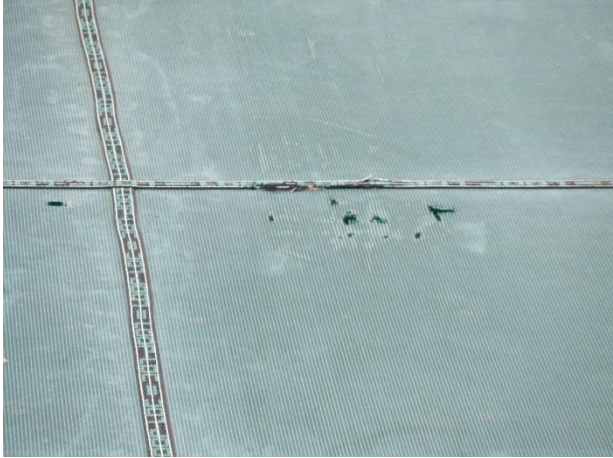
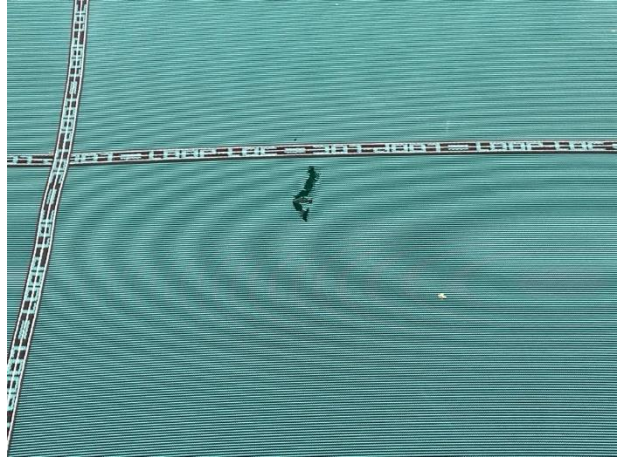
**Condition:** Fair to poor overall with tears evident

**Cover tears**

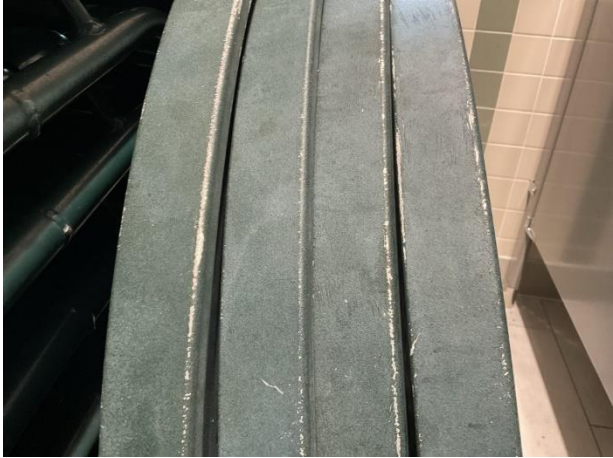
**Condition:** Varying from good to fair overall with finish deterioration, rust and staining evident.

**Finish deterioration**

**Expenditure Detail Notes:** Expenditure timing and costs are depicted in the **Reserve Expenditures** table in Section 3. We recommend interim re-strapping, refinishing, cushion replacements, reupholstering and other repairs to the furniture as normal maintenance to maximize its useful life.

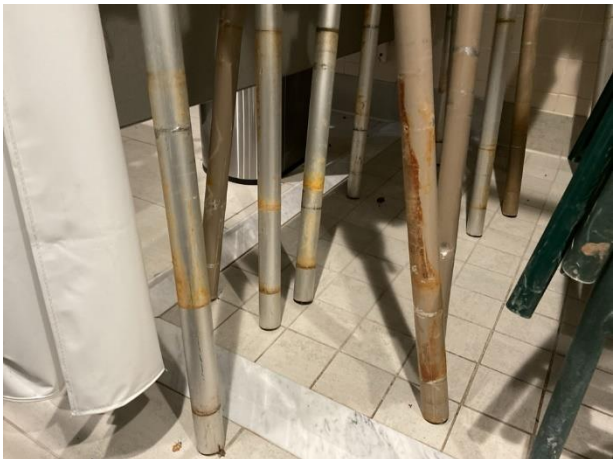
**Umbrella post rust**

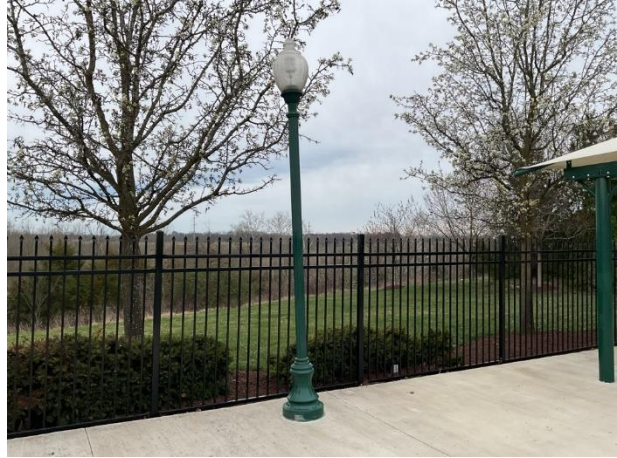
**Condition:** Good to fair overall with leaning poles and finish deterioration evident

**Leaning pole**

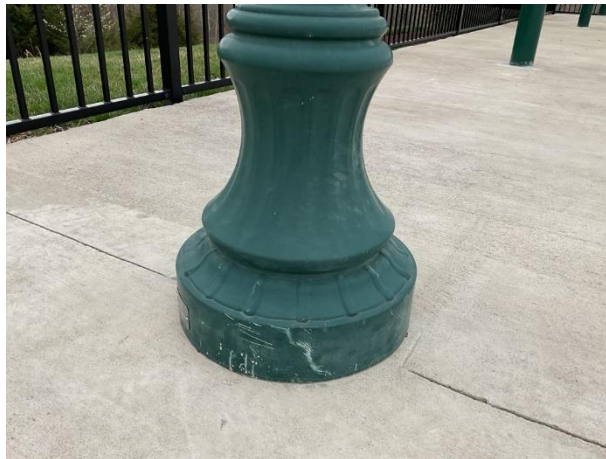
**Finish deterioration**

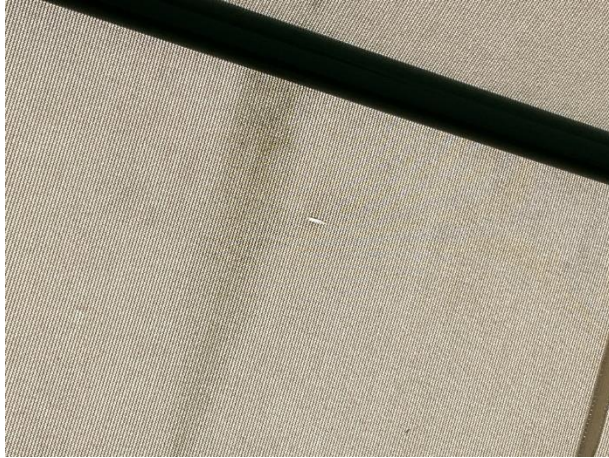
**Condition:** The structures are in good to fair overall condition with finish deterioration and rust evident, and the canvases are in fair overall condition with tears and organic growth evident.

**Canvas tear**

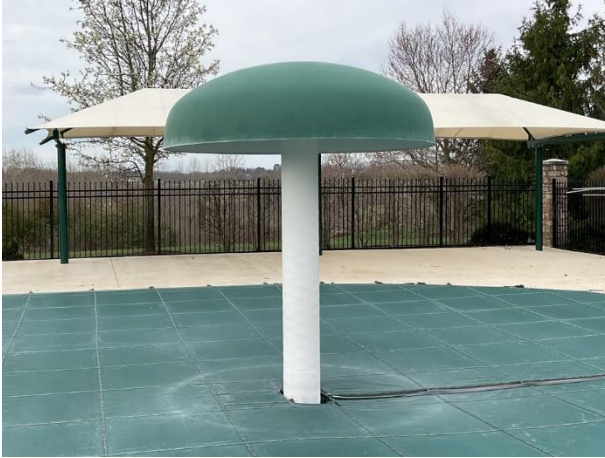
**Conditions:** Good to fair overall with finish deterioration evident.

**Aqua dome overview**

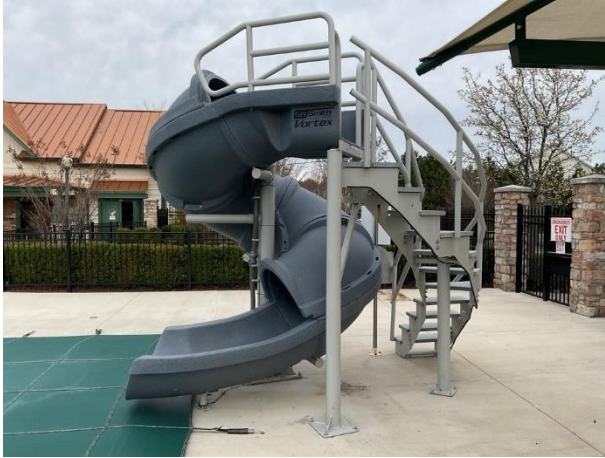
**Conditions:** Good to fair overall with fastener rust and rust stains evident

**Water slide overview**

**Component Detail Notes:** Safety is the major purpose for maintaining the water slide. We recommend an annual inspection of the water slide to identify and repair as normal maintenance loose connections and fasteners or damaged elements. We recommend the use of a specialist for the design or replacement of the water slide environment.
